October 15, 2019

**Re: Application RA19016 – Geotechnical Information
Kramer Dairy Ltd.
SE-02-043-25 W4M
Ponoka County, Alberta**

Title:
Borehole Locations
Site and Soil Assessment
SE¼-Sec. 02-Twp. 043-Rge. 25-W4M
Ponoka County, Alberta

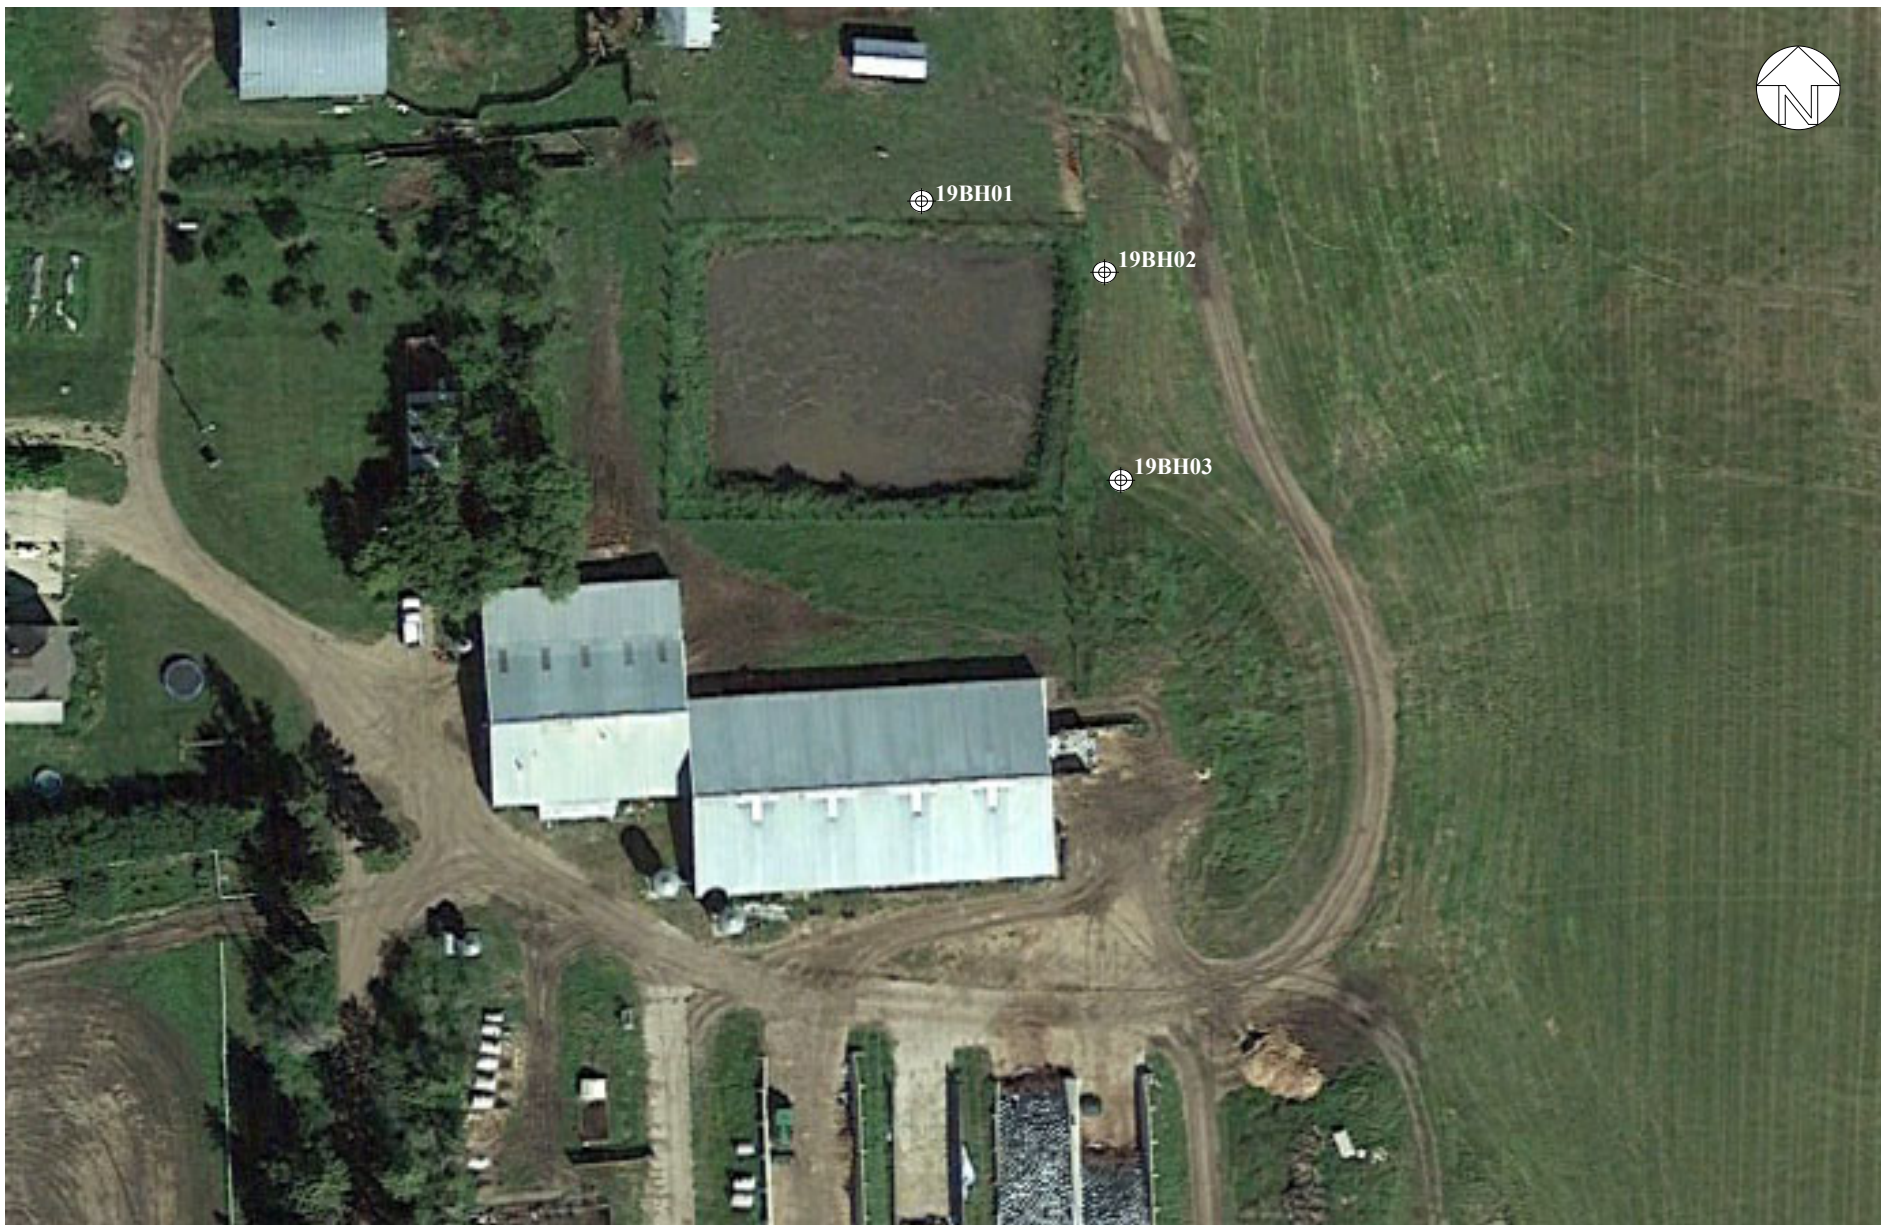
Figure:

Three boreholes were advanced on the suspected down and cross gradient sides of the earthen manure storage (EMS) lagoon. Three boreholes were advanced to accurately triangulate site stratigraphy and depth to groundwater. All three boreholes were completed as monitoring wells to accurately determine groundwater flow direction. The borehole logs documenting lithology and depth to groundwater are attached. Elevation was measured from an on-site benchmark to determine relative depth to groundwater on October 9, 2019. Elevation and depth to groundwater is tabulated in the following table.

Groundwater monitoring wells were completed to 5.0 meters below ground surface with a 3.0 meter screen (2.0 to 5.0 meters). Groundwater flow direction is to the north – northeast.

Through assessment of the lagoon wall slope, lithology and landowner reports it is predicted that the lagoon is approximately 3.75 to 4.5 meters below the northeast grade. The exact depth of the lagoon could not be determined through the soil assessment. Bedrock was encountered in borehole 19BH01 at 11.25 meters below ground surface.
