# COUGAR CREEK, 2013 FORENSIC ANALYSIS AND SHORT-TERM DEBRIS FLOOD MITIGATION FINAL

PROJECT No: 1261-001

Document No: TC13-004

# 2013 FORENSIC ANALYSIS AND SHORT-TERM DEBRIS FLOOD MITIGATION

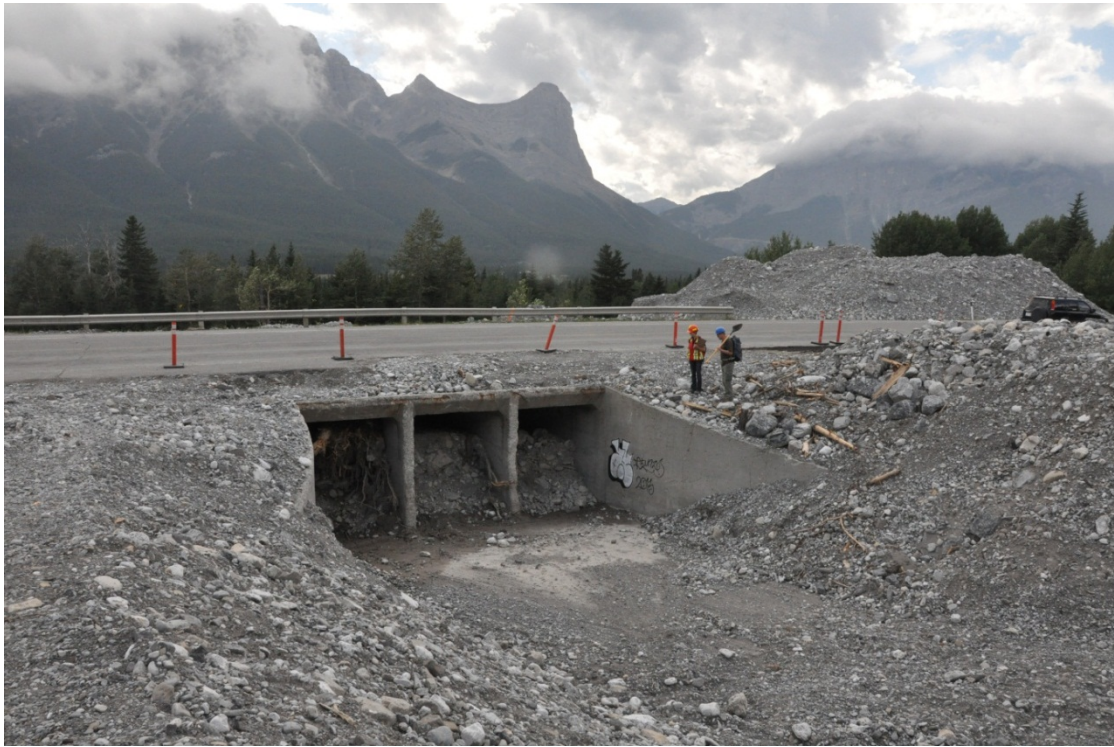
**Photo 2-3. Culvert inlet at Highway 1A. The culvert was full of debris at the time of the site visit. BGC photograph of August 8, 2013.**

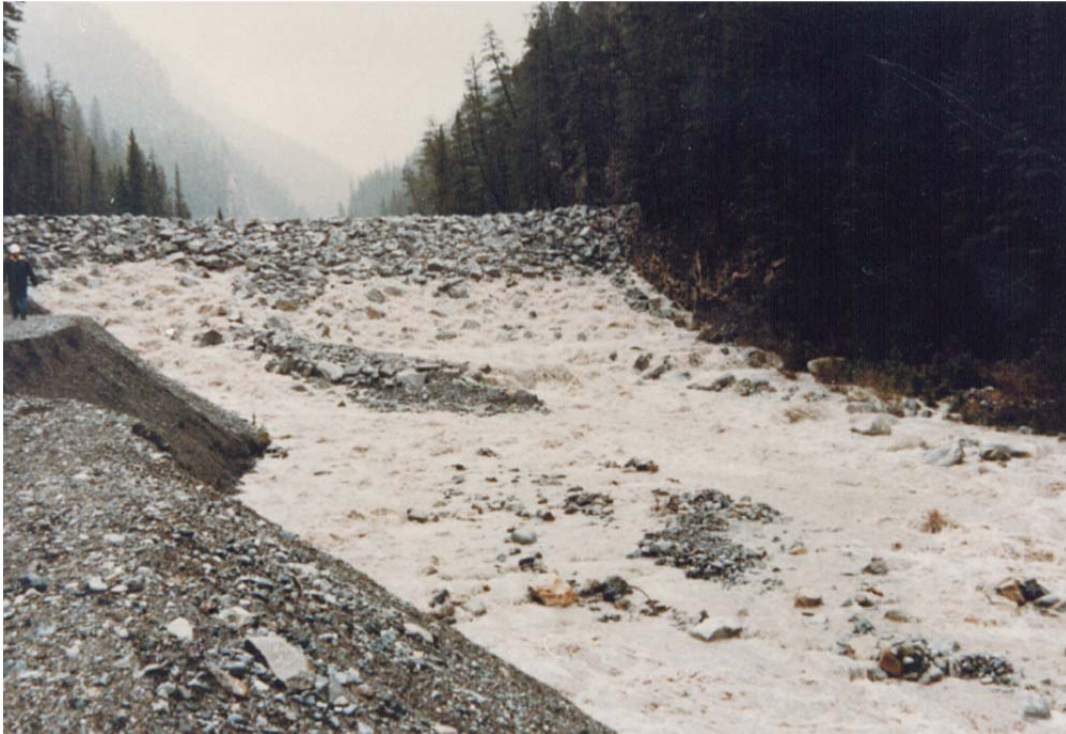
- Approximately 1 hour before failure, water was exiting from half way up the downstream slope and across its entire width and cascading down (Photo 3-1). The water seemed to be coming through and around the dam rather than under or over it.

**Photo 3-1. Upstream view of Cougar Creek Dam 1 hour before the failure. May 25, 1990 (Alberta Environment, 1991).**

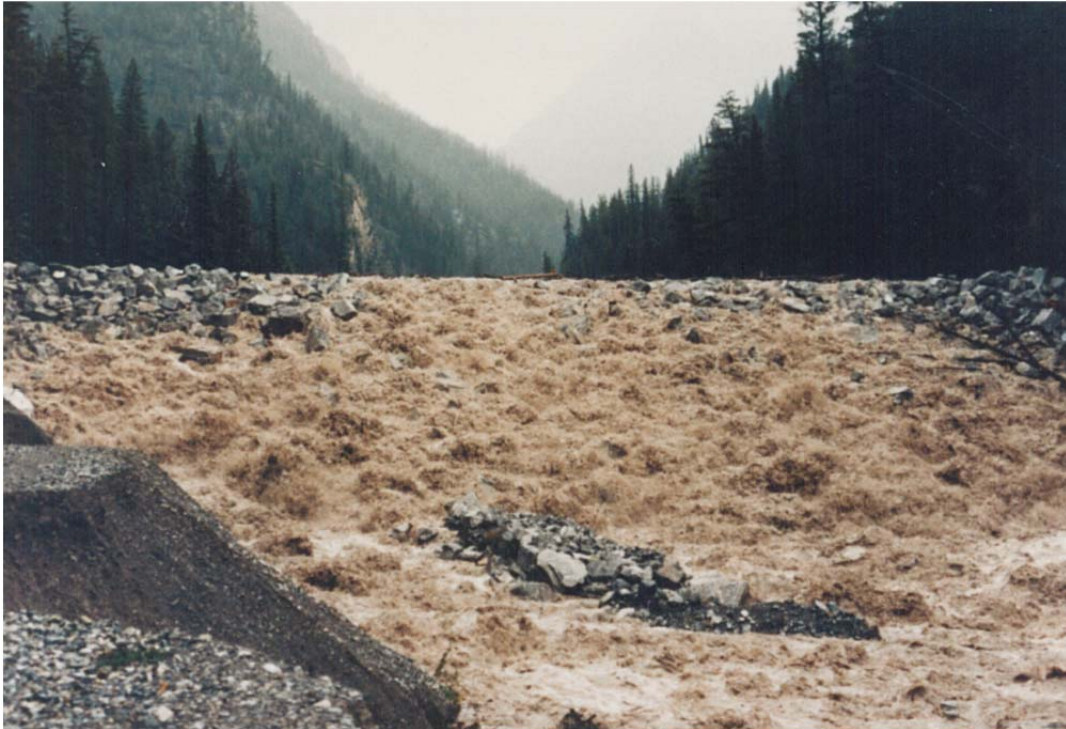
- The reservoir rose 1 m in the hour before the failure and 0.15 m in the hour previous to that.
- As the water level approached the crest, it began to flow through the Class II riprap armouring and cascade down the downstream slope. At no time did water flow over the dam crest (Photo 3-2).

**Photo 3-2. Upstream view of Cougar Creek Dam 10 minutes before the failure. May 25, 1990 (Alberta Environment, 1991).**

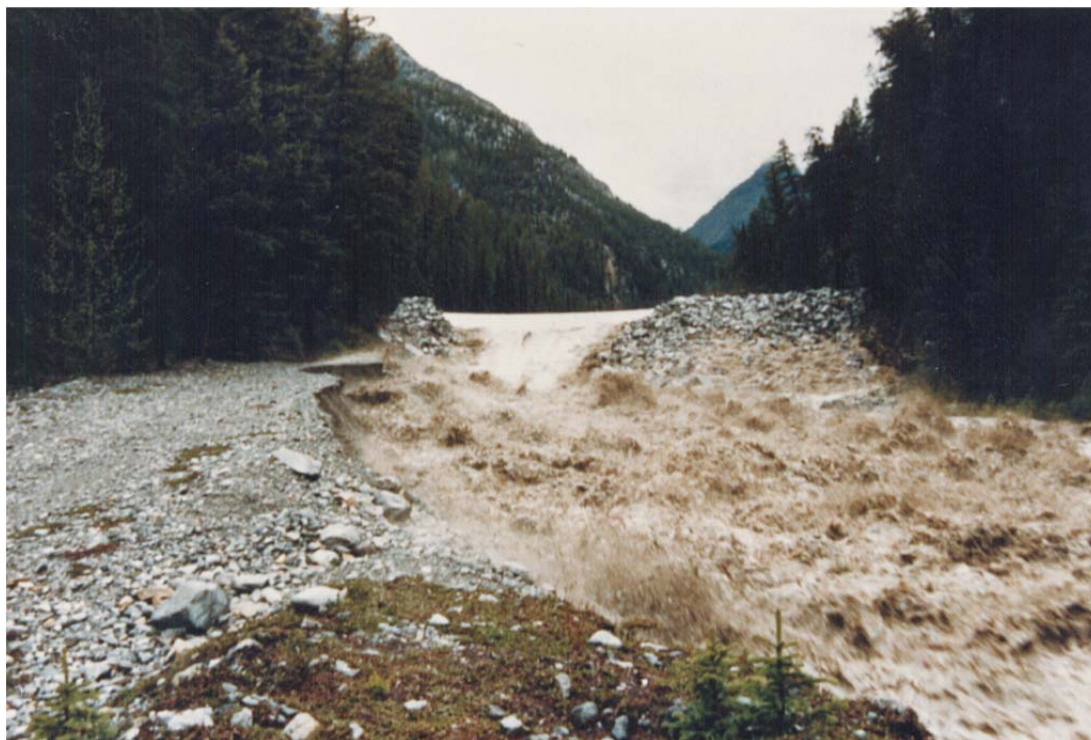
- The failure began on the downstream edge of the crest, forming a V-shaped breach that grew quickly and reached bedrock underlying the dam. The time of dam failure was approximately 5:20 PM (Photo 3-3).

**Photo 3-3. Upstream view of Cougar Creek Dam shortly after the breach initiated. May 25, 1990 (Alberta Environment, 1991).**

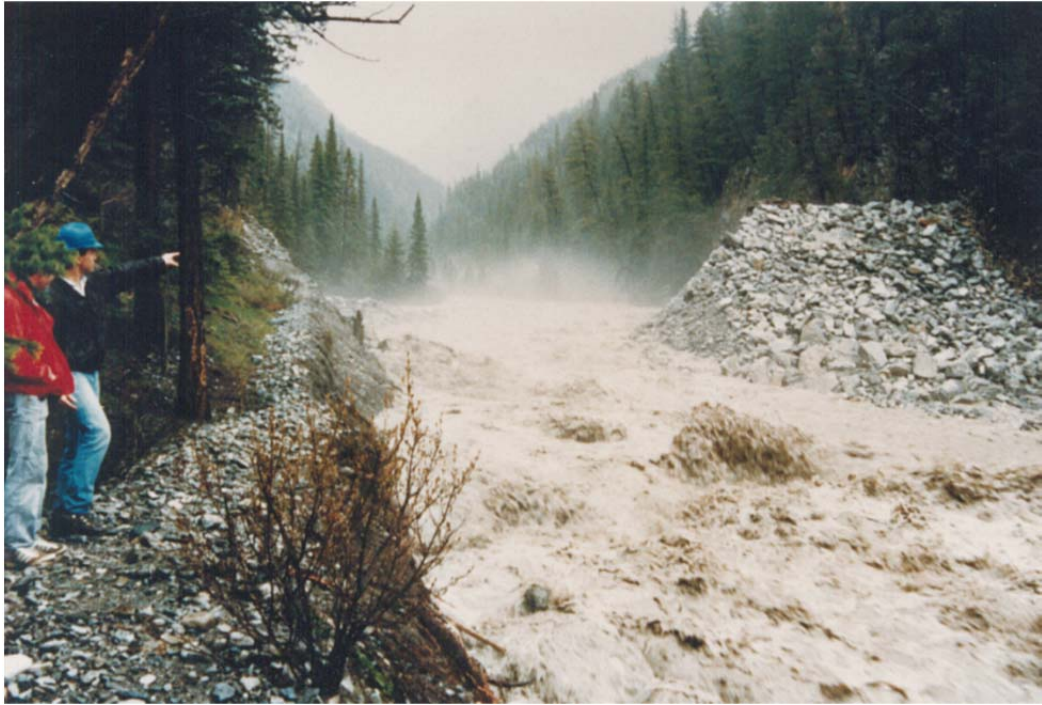
The dam failure caused major erosion downstream. The channel bed was scoured to bedrock in the middle of the breach and most of the dam material was mobilized downstream, except for a portion on the left abutment (Photo 3-4). Remnants of the rockfill dam are still present, as shown on Photo 3-5. The culverts under Highway 1, Highway 1A and the CP Rail tracks were either partly or completely filled with sediment, resulting in a partial washout of the CP Rail tracks. Minor damage also occurred to the shoulders of Highway 1 when the backed up flood waters partially overtopped the road. Damage to the rail tracks was repaired within two hours, although the track remained closed until the next morning while the culverts were unplugged. Photos 3-6 through 3-9 illustrate some of the downstream damage caused by the dam failure.

**Photo 3-4. Upstream view of Cougar Creek Dam about 2 hours after the dam failure. May 25, 1990 (Alberta Environment, 1991).**

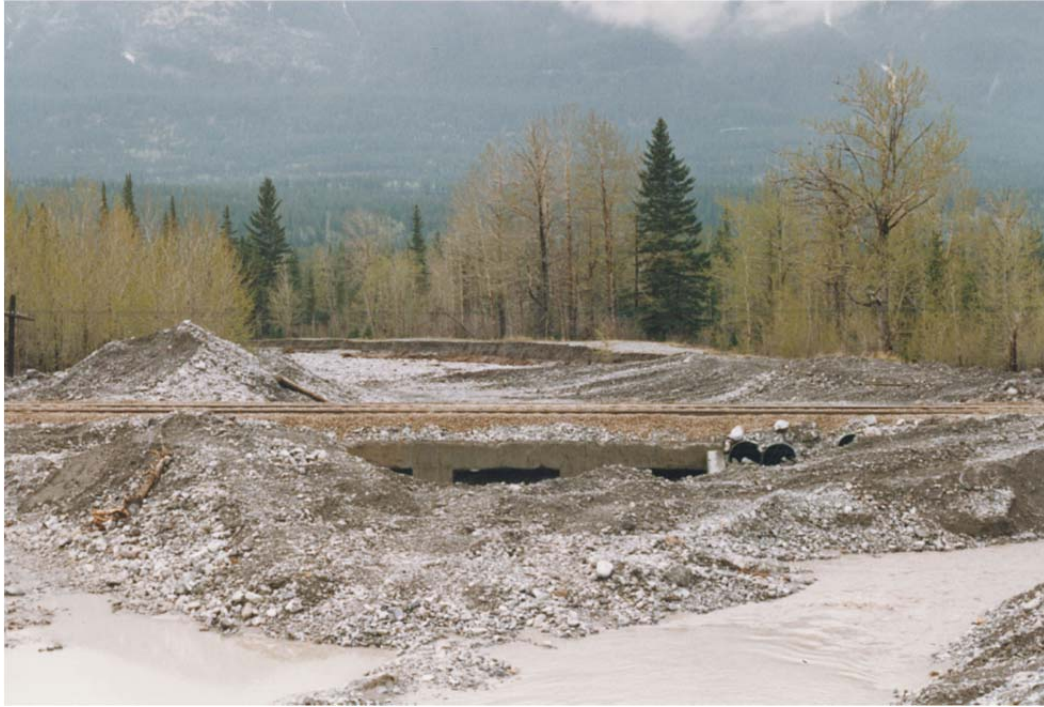
**Photo 3-7. Aggradation at the CP Railway following the 1990 dam failure. Photo courtesy of Kent Berg, Alberta Environment and Sustainable Resource Development. May 26, 1990.**

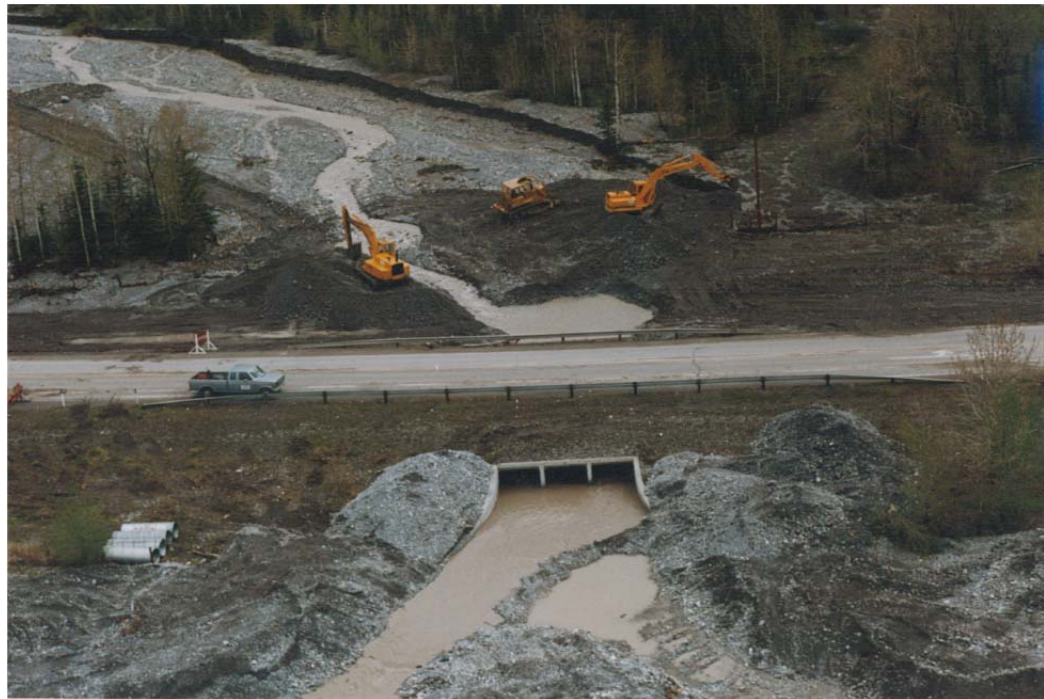
**Photo 3-8. Excavation activities at Highway 1A following the dam failure. Photo courtesy of Kent Berg, Alberta Environment and Sustainable Resource Development. May 26, 1990.**

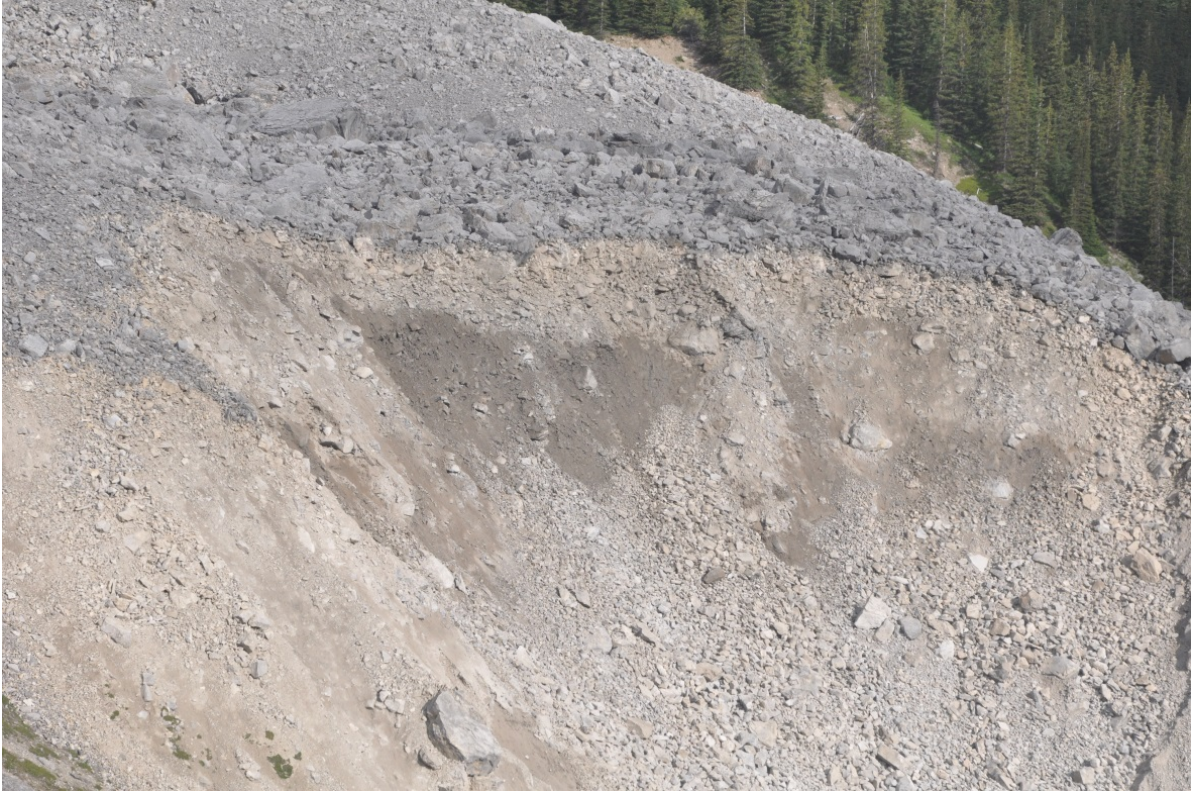
**Photo 5-5. A recent (presumed to occur in June 2013) failure in the active layer of the rock glacier shown in Photo 5-4. The grey line is interpreted as the transition between the active layer and the permafrost body below. BGC photograph of July 24, 2013.**

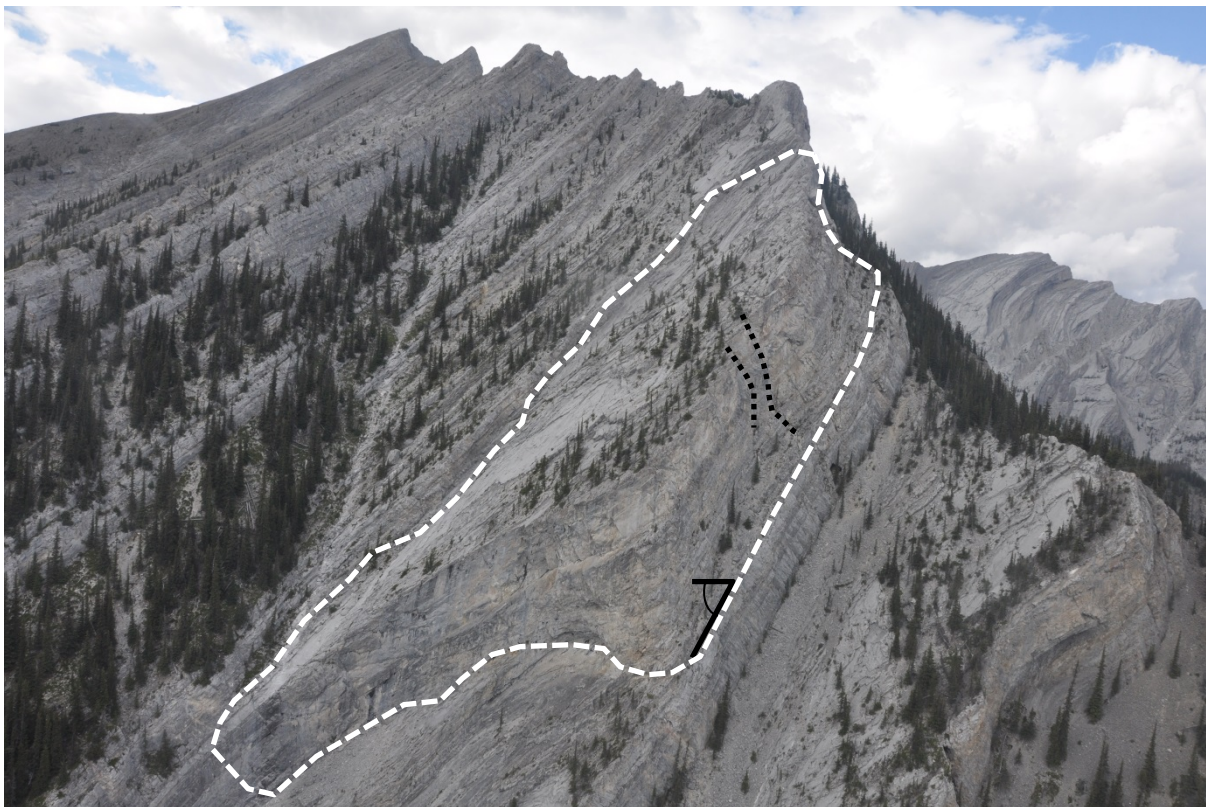
**Photo 5-10. Large, potentially unstable rock mass in the lower (western) Cougar Creek watershed in steeply dipping limestones. BGC photograph of August 7, 2013.**

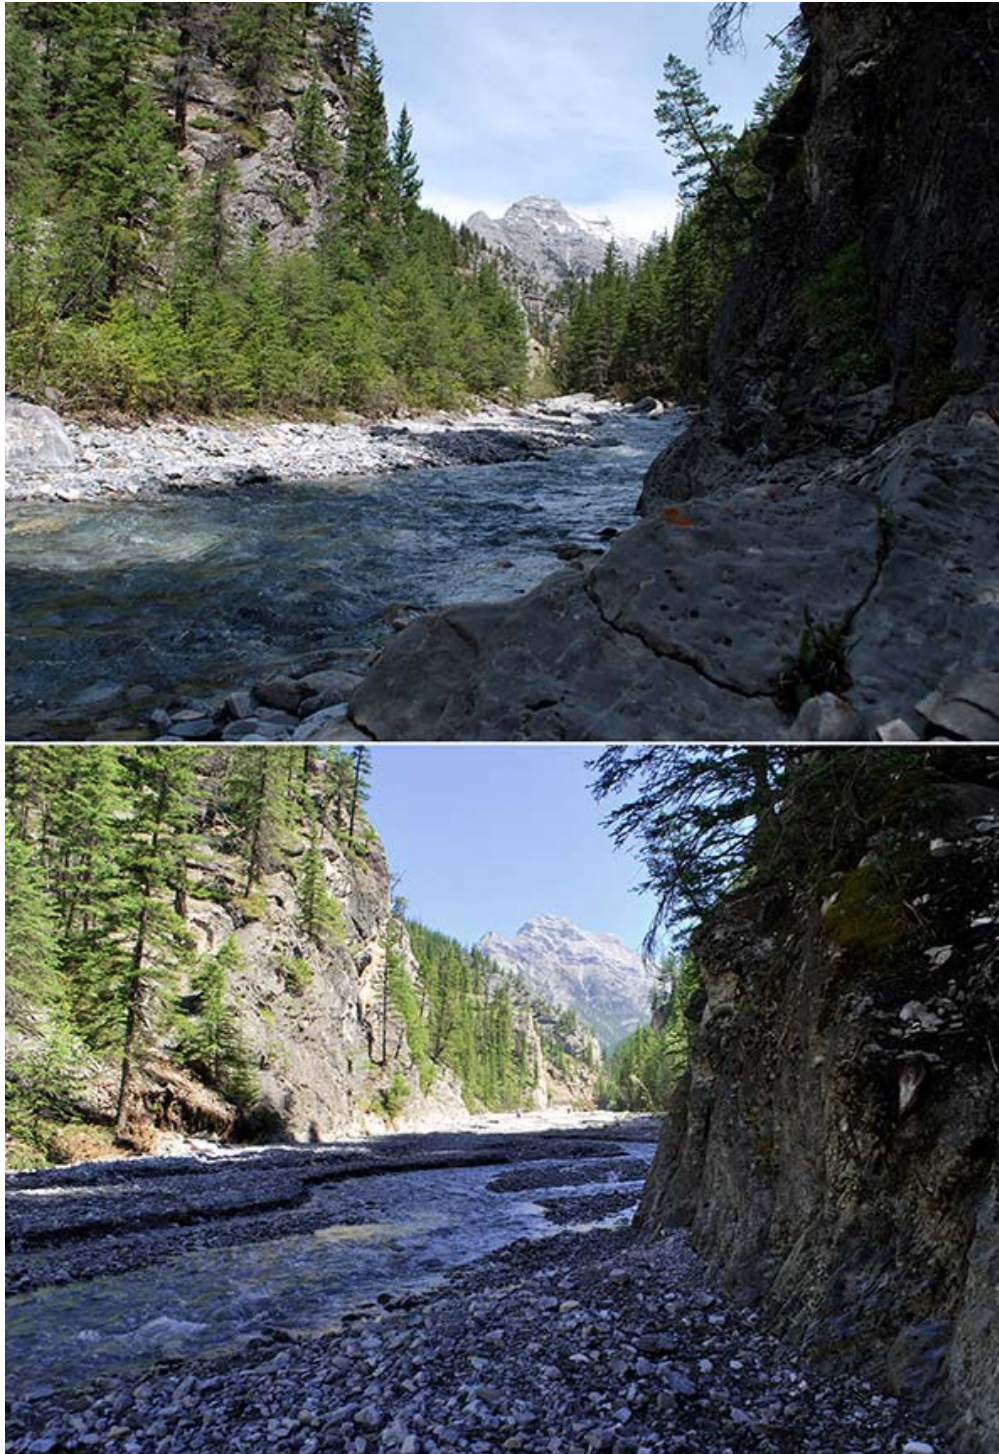
**Photo 5-11. An upstream view of Cougar Creek: before (upper image) and after (lower image) the 2013 debris flood. The lower image clearly shows that the smaller conifers on the left side of the image have been completely eroded by the 2013 debris flood, suggesting on the order of 1 to 2 m of aggradation. Image provide by Patrick LaMontagne.**

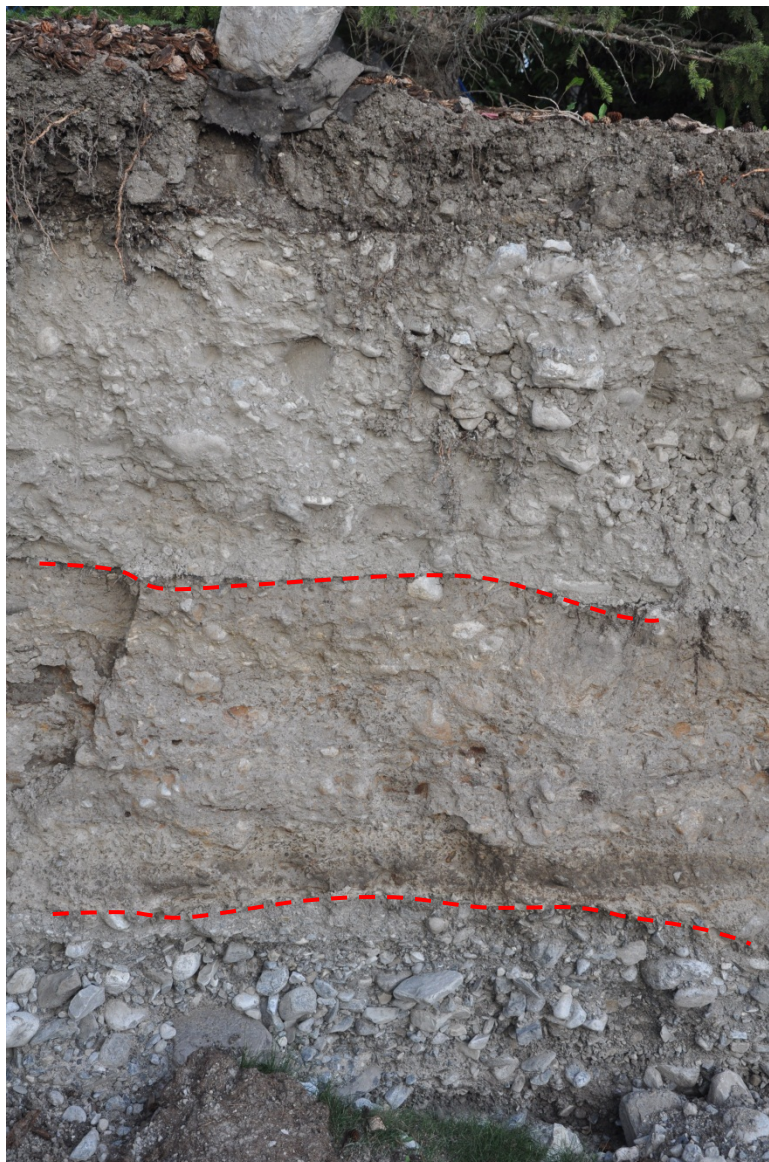
**Photo 5-12. Exposed cut bank along the left bank of Cougar Creek between the pedestrian bridge and Elk Run Boulevard. The dashed red lines separate two massive and matrix-supported debris flood deposits overlying a fluvial deposit. The top dark layer is likely construction fill. BGC photograph of July 23, 2013.**

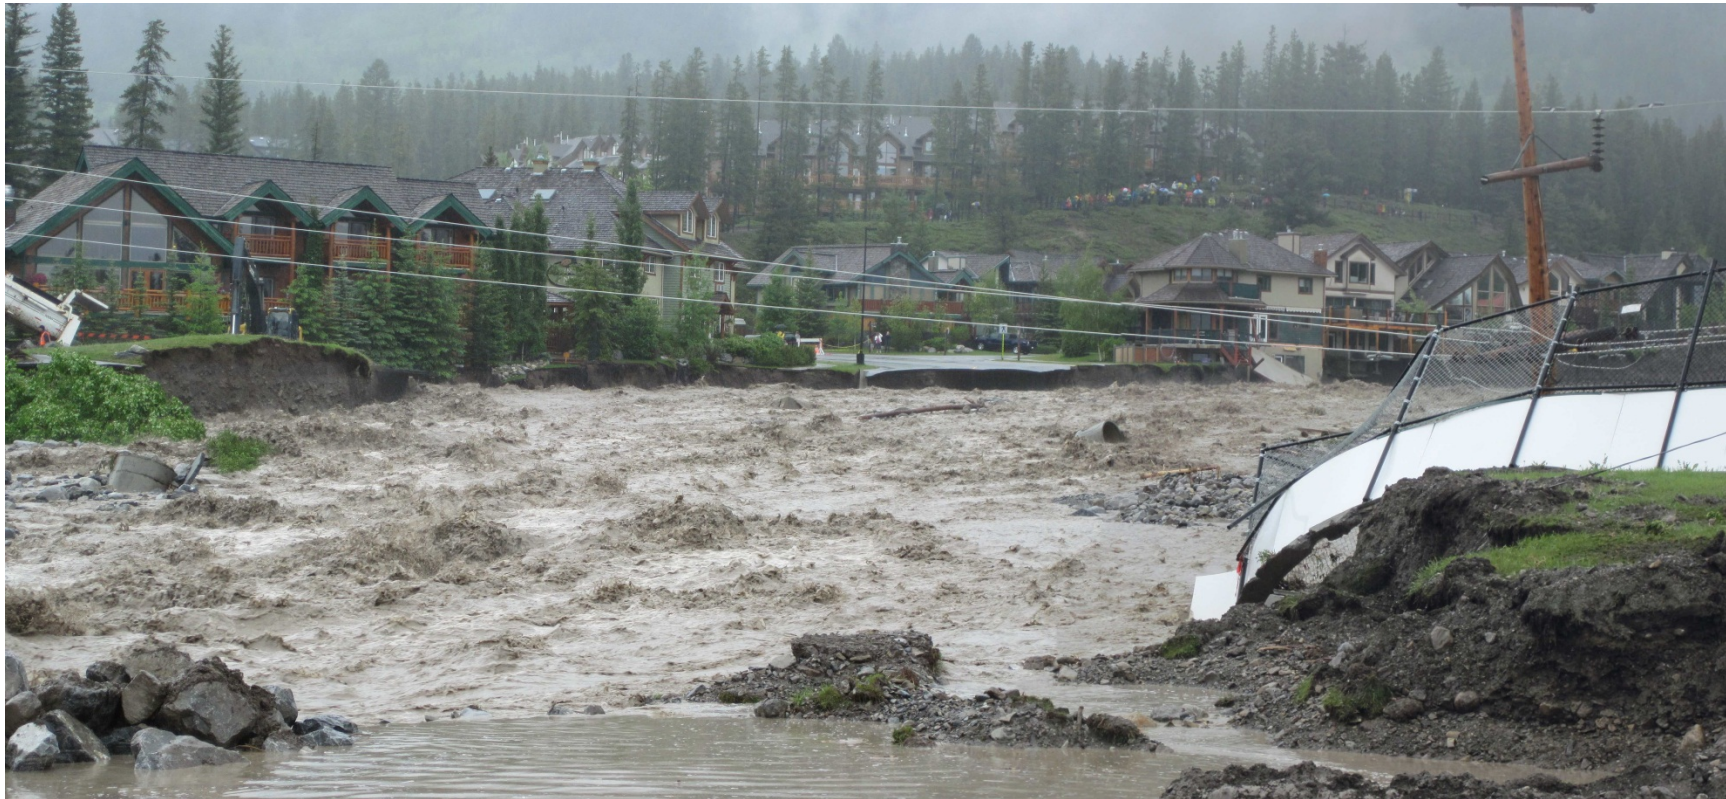
**Photo A-7. Upstream view of Cougar Creek from Elk Run looking over to the right bank and the eroded Benchlands Trail. A severely damaged outdoor hockey rink is visible in the foreground. Photograph courtesy of the Town of Canmore.**

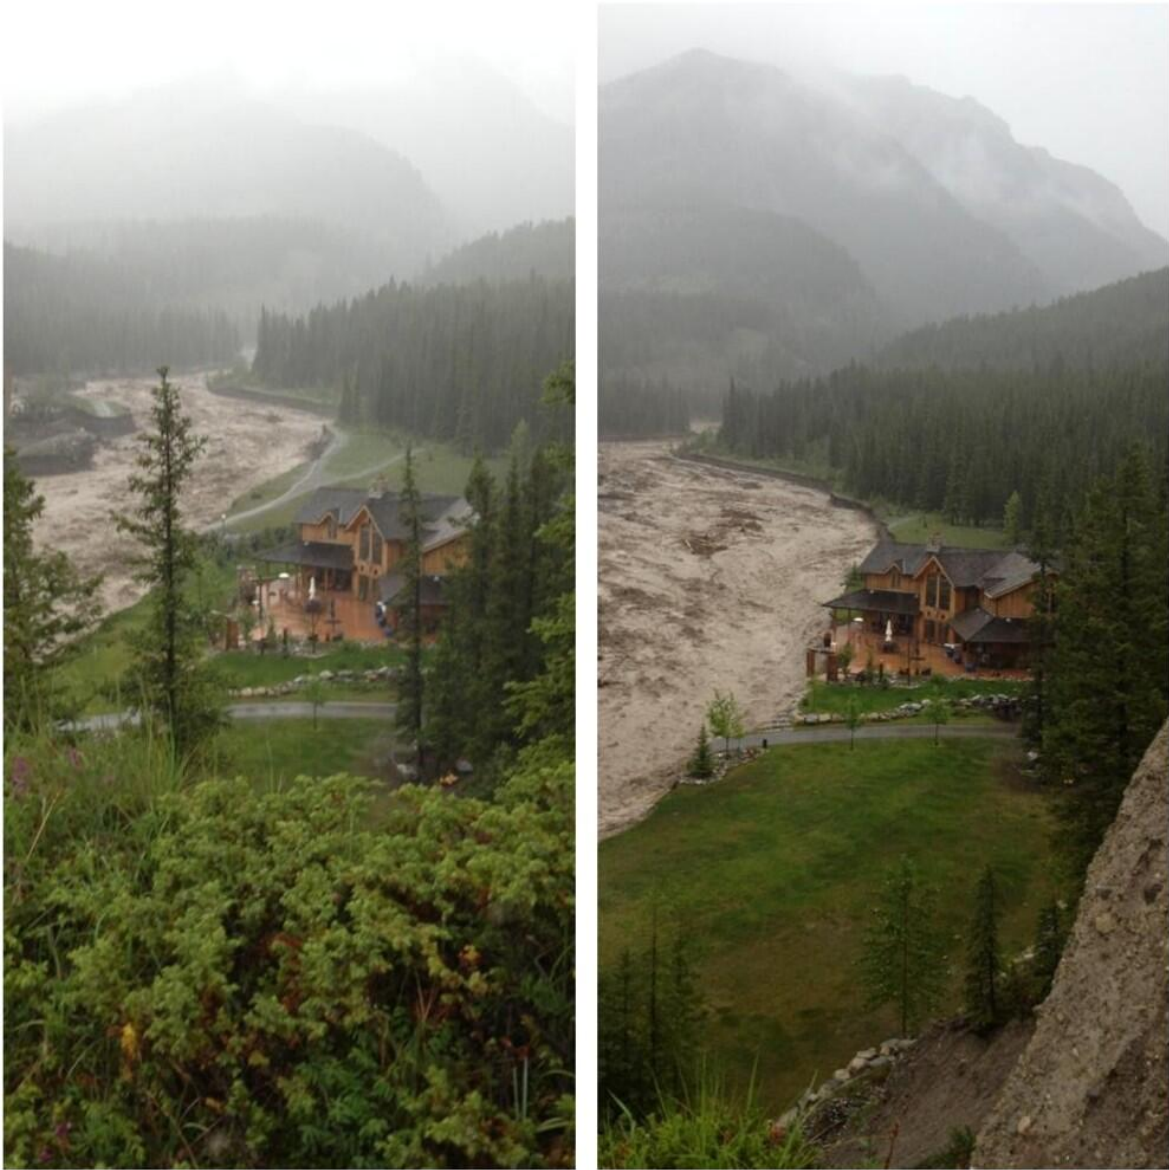
**Photo A-8. Erosion that occurred adjacent to the Winter residence above Canyon Road. Photograph courtesy of the Town of Canmore.**

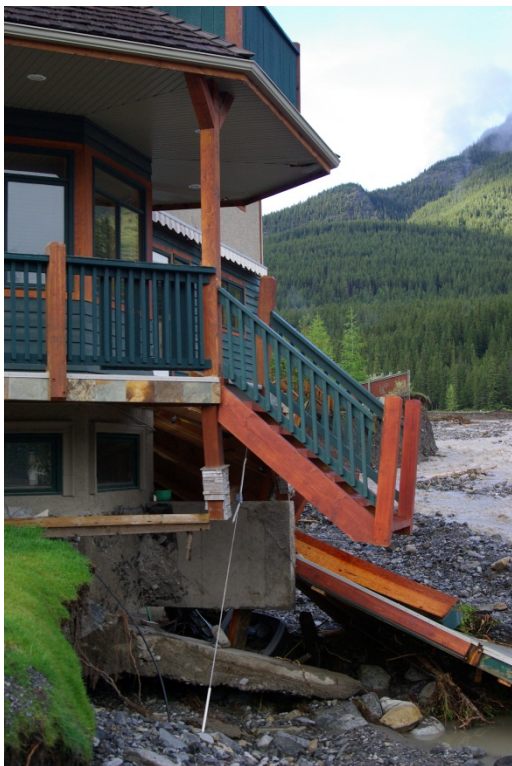
**Photo A-10. Structural damage sustained to home along Eagle Landing. Photograph courtesy of the Town of Canmore.**

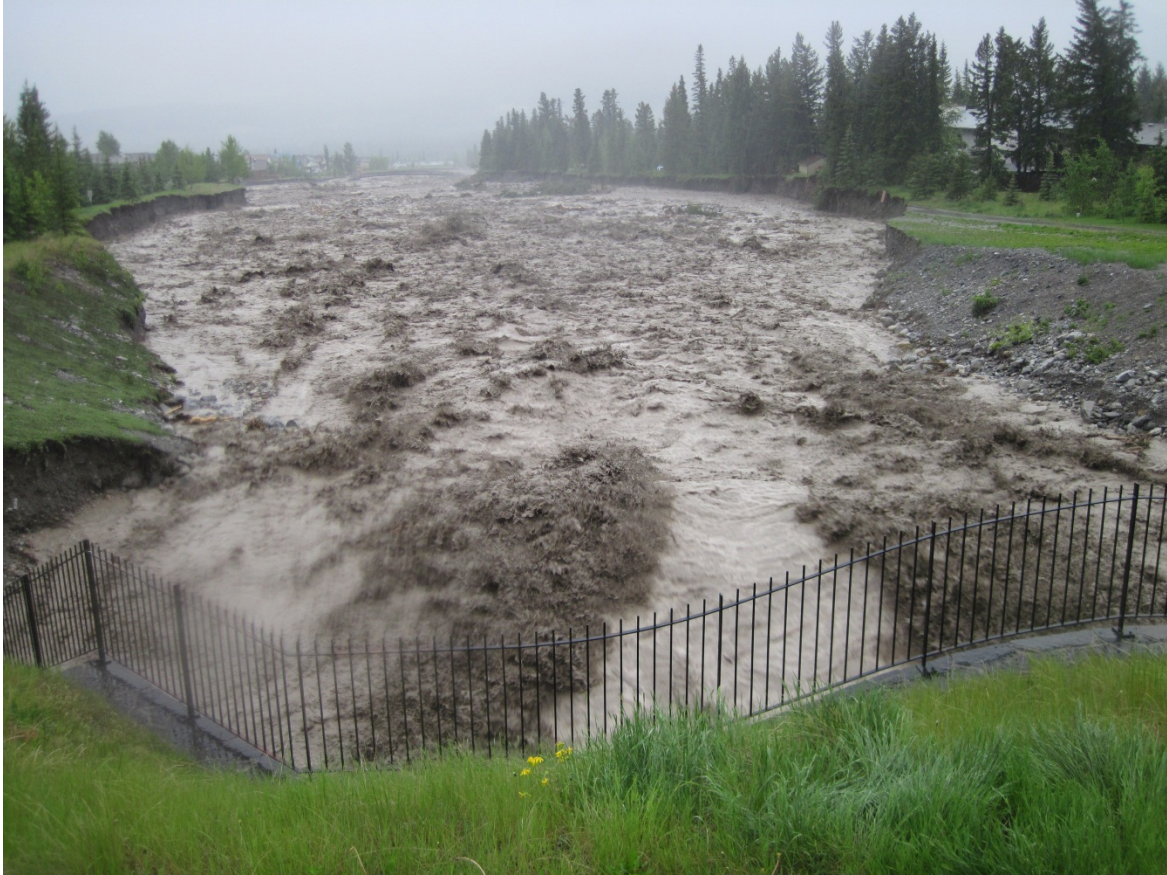
**Photo A-13. Downstream view of Cougar Creek at Elk Run Boulevard during the early onset of the storm. Some bank erosion has occurred by this time. Photograph courtesy of the Town of Canmore.**

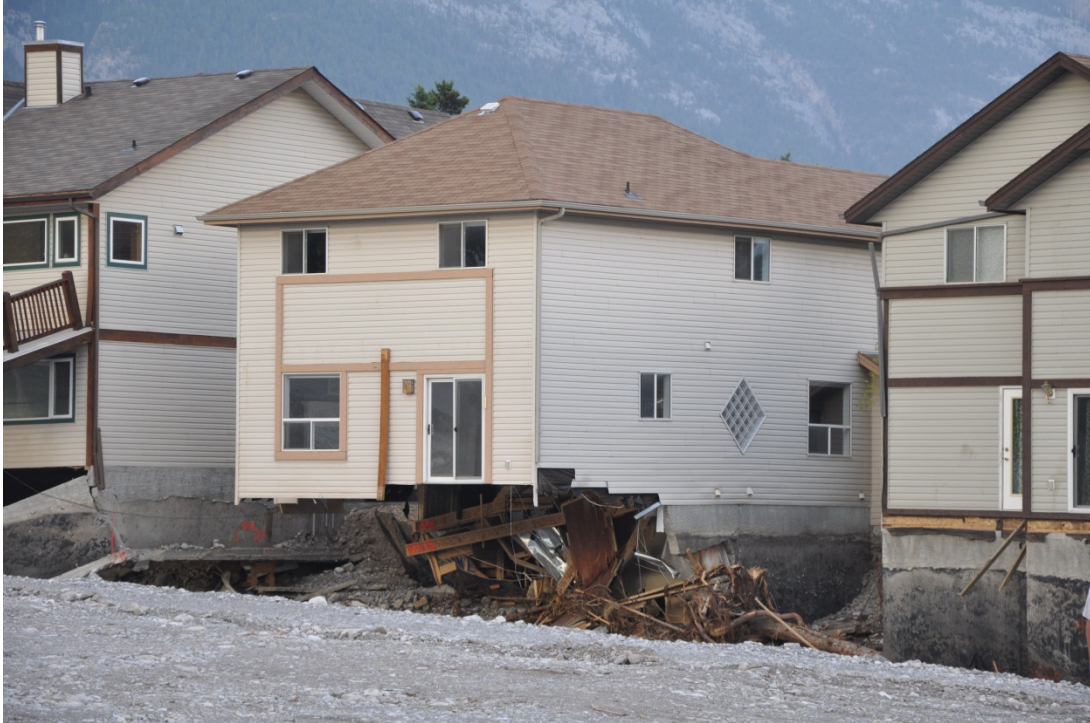
**Photo A-19. Damage sustained to home along the left (east) bank of Cougar Creek along Grotto Road. BGC photograph of July 23, 2013.**

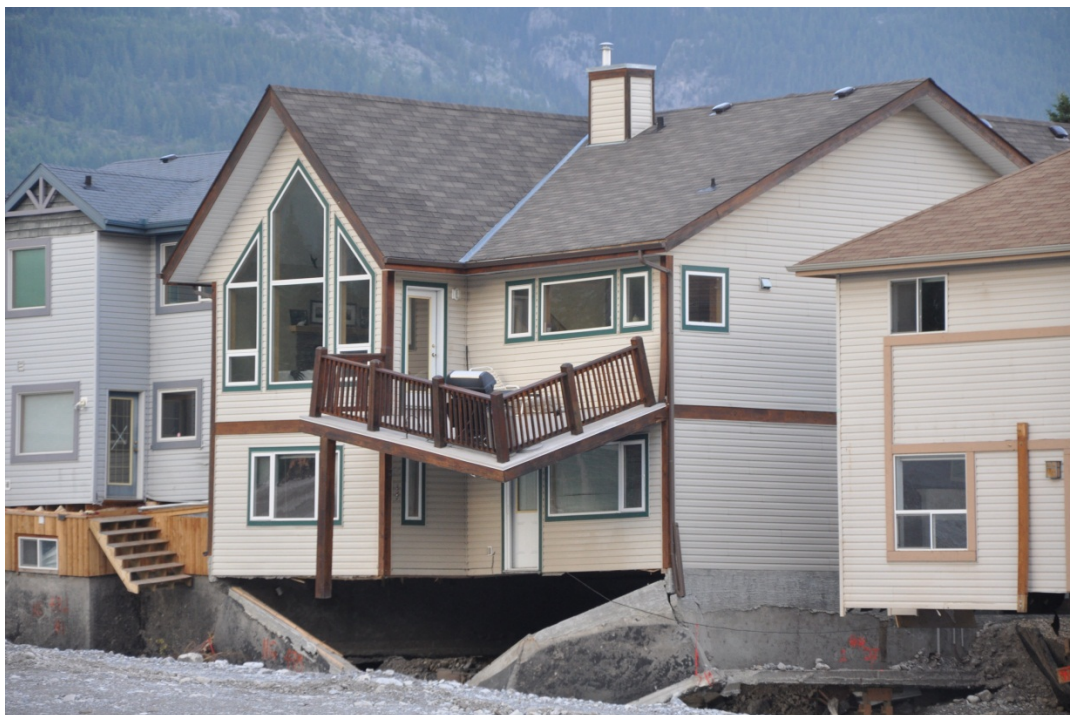
**Photo A-20. Damage sustained to home along the left (east) bank of Cougar Creek along Grotto Road. BGC photograph of July 23, 2013.**

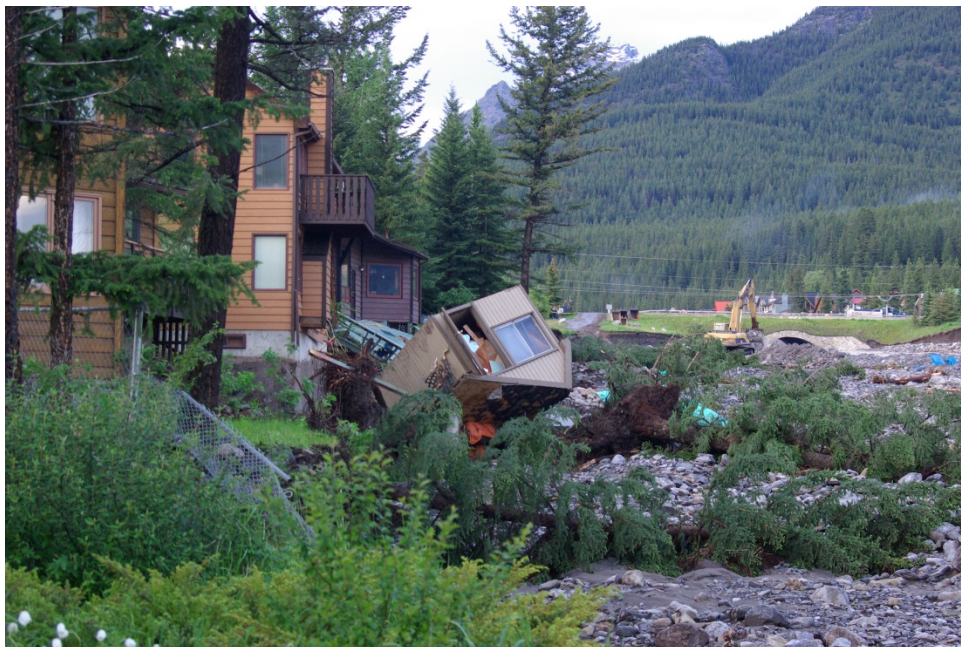
**Photo A-22. Damage sustained to house along the right (west) bank of Cougar Creek along Coyote Way. Photograph courtesy of the Town of Canmore.**

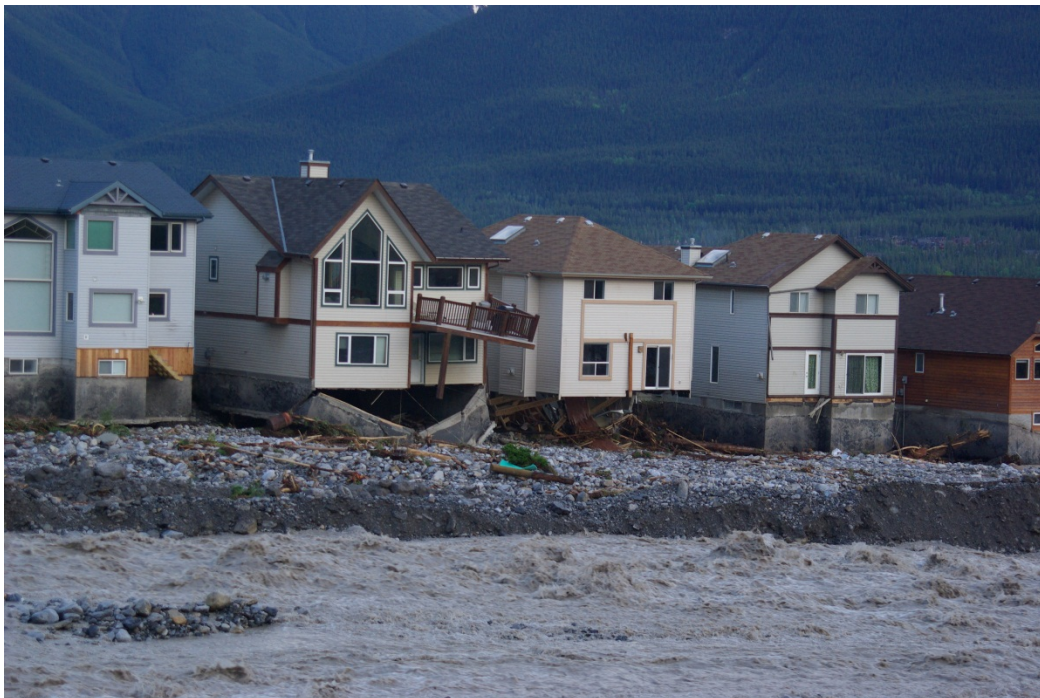
**Photo A-24. Damage sustained to homes along the left (east) bank of Cougar Creek along Grotto Road. Photograph courtesy of the Town of Canmore.**

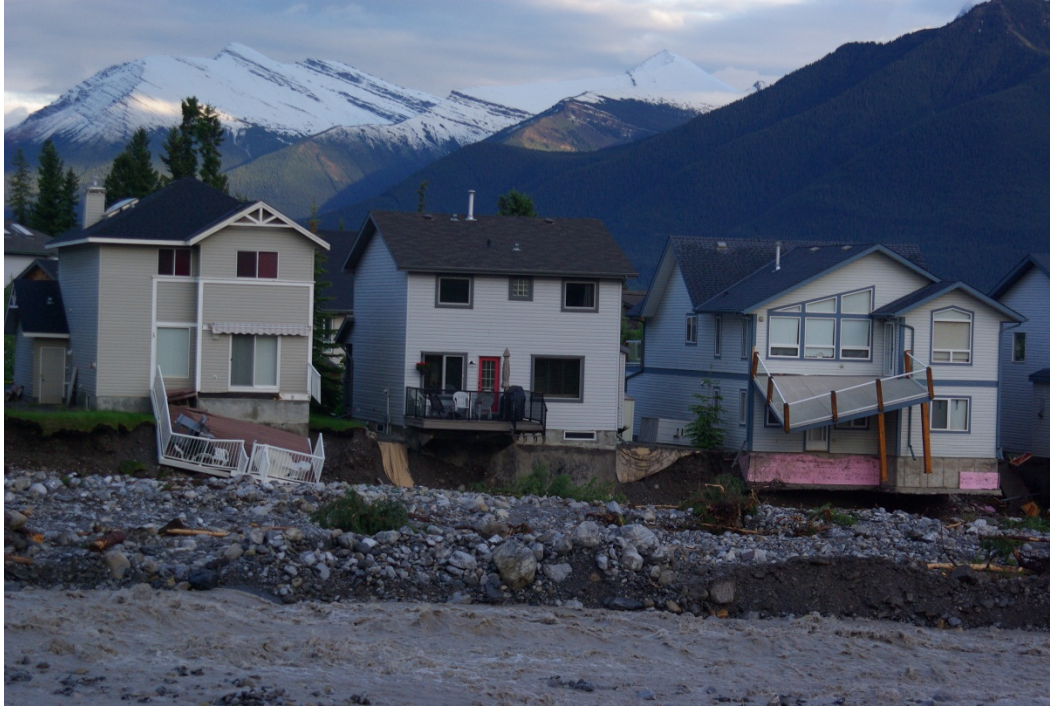
**Photo A-25. Damage sustained to homes along the left (east) bank of Cougar Creek along Grotto Road. Photograph courtesy of the Town of Canmore.**

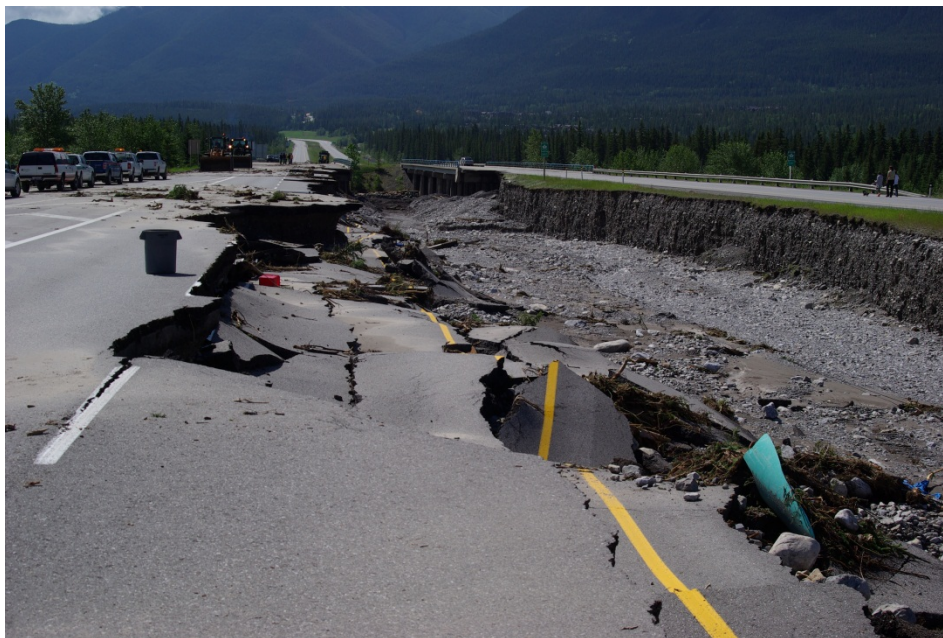
**Photo A-31. Damage to Highway 1 as a result of the 2013 debris flood. View is looking east. Photograph courtesy of the Town of Canmore.**
