TOWN OF CANMORE

COUGAR CREEK DEBRIS FLOOD RISK ASSESSMENT

**FINAL
(REVISED)**

PROJECT NO.: 1261-001
DATE: June 11, 2014
DOCUMENT NO.: TC14-001

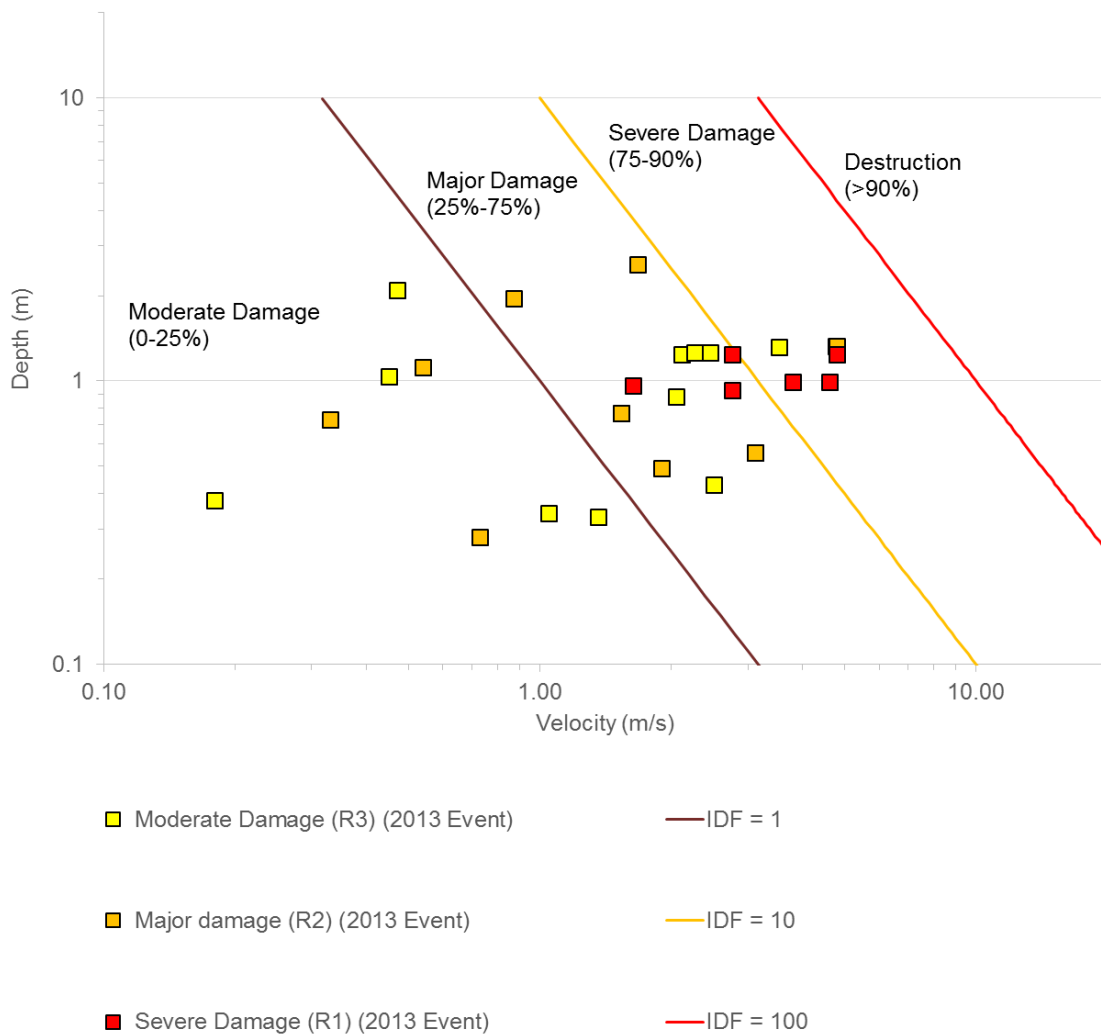
Figure 4-4. Building damage cases reported for the June 2013 debris flow, plotted using modelled flow depth and velocity from debris flood Scenario 6. Damage thresholds are plotted according to Equation [3].

In summary, Figure 4-4 shows some agreement between recorded damage levels and those that might be predicted based on modelled flow velocities and depths, but also substantial differences. Given these differences, building damage cases from the June 2013 debris flood were not added to the building vulnerability criteria shown on Figure 3-2 (Section 3.6.1). Primary factors that could result in these differences include:

- Differences in channel configuration between those used in the model and those from the June 2013 event. BGC attempted to account for channel changes during the June 2013 debris flood by adjusting the channel planform to the state observed towards the latter part of the flood. However, transient channel elevations that are created by cycles of aggradation and degradation cannot be simulated with any accuracy.
- Differences in the actual versus assumed peak discharge of the event. Since discharge was not measured during the event it has to be back-calculated (BGC, 2014) which is uncertain because bed elevations during the event are unknown.
- Bank erosion was a primary factor for land and building damage during the June 2013 event, but there is no reliable model capable of simulating bank erosion and bank encroachment is not an input parameter for debris-flood modelling.

However, it should be noted that the above discrepancies are not necessarily a failure of the model, but rather signify that flows even of similar magnitude may result in different outcomes. For example, Scenario 6 predicts slightly more extensive inundation adjacent to Highway 1 than actually occurred, but this potential outcome is still considered credible. BGC considers modelling uncertainties regarding bank encroachment as more significant for modelling main channel flows compared to avulsions onto relatively erosion-resistant portions of the fan (e.g. areas covered by asphalt, vegetation and houses) as well as a lack of a pre-existing channel. While some erosion cannot be discarded, for un-channelized fan sectors direct flow impact and inundation will be more important for damage assessment. Within the channel, the mitigation measures completed thus far include armoring of channel banks to control erosion, and bank erosion such as that occurring in June 2013 is significantly less likely in the future.
