To: Syed Abbas
Alberta Transportation

From: Hugo Aparicio, PE
Scott Peyton, PE
Stantec

Date: July 22, 2016

Reference: Dam Alignment and Toe Location Relative to the Elbow River

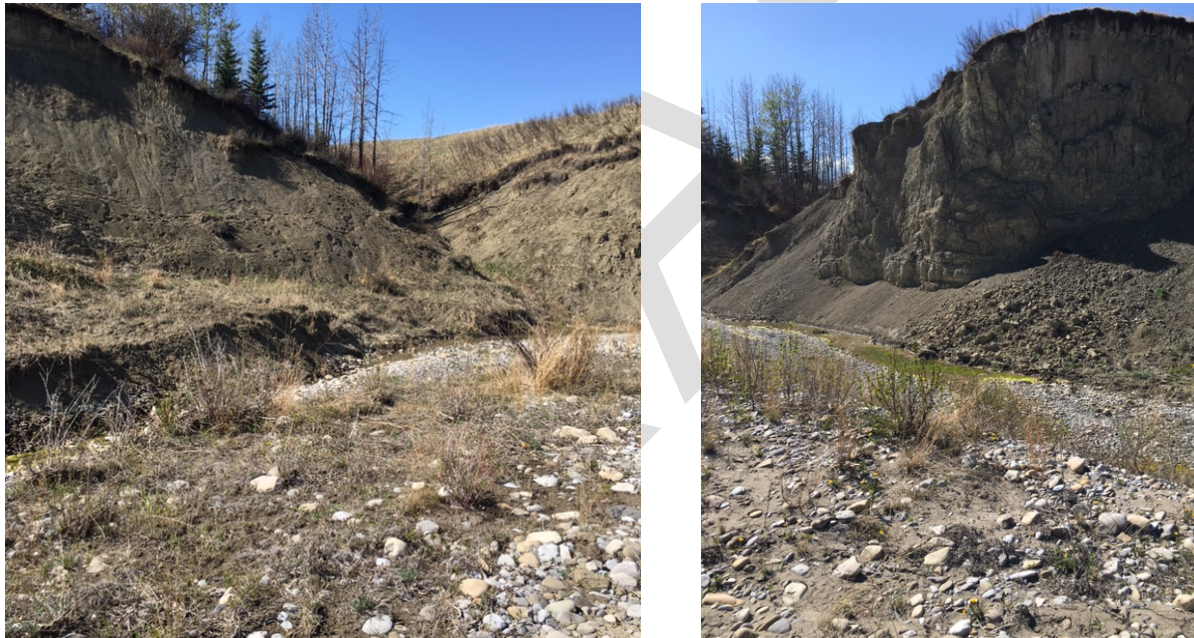
Stantec performed site reconnaissance along the toe of the Elbow River banks near the dam toe area on May 3, 2016. Two gullies were observed near the location where the dam toe is closest to the top of the Elbow River bank. The two gullies are shown in Attachment 1 in plan view. Photographs of the gullies are shown below in Figure 1; the photographs give good perspective on the size and scale of the gullies. The gullies were not reviewed in detail due to land access constraints.

Figure 1. West Gully (left) and East Gully (right).

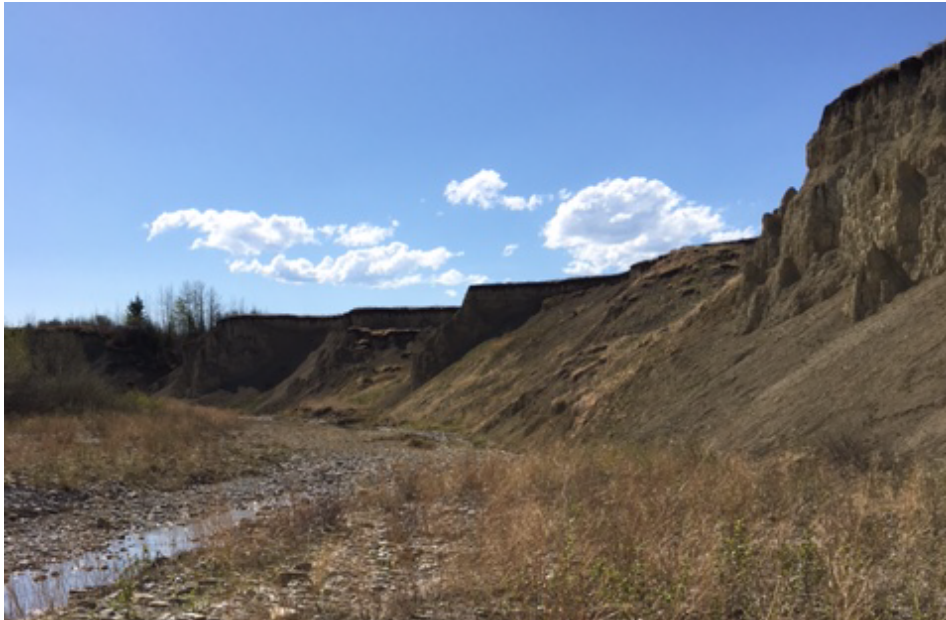
Site walkovers and aerial photographs have indicated that the natural slopes of the Elbow River downstream of the proposed dam toe undergo frequent slope instability, with complex rotational failures being the dominant failure mechanism (Figure 2 shows the river bank near the dam toe). The slopes are a dynamic system, in which equilibrium is recurrently disturbed by channel migration. Observations indicate the following cycle of slope regression:

- Slope at equilibrium;
- Channel migration towards the slope;
- Initiation of erosion of the toe (disturbing agent);
- Over-steepening of the slope with subsequent rotational failure. This forms a localized circular back-scarp in plan view divided by spines of steeper material;
- The steeper spines lose support and material gradually fail as blocks (wedge failure); and,
- Surface water, progressive slumping and establishment of vegetation further modify the slope until it reaches equilibrium

Figure 2. Elbow River Bank near the Dam Toe.

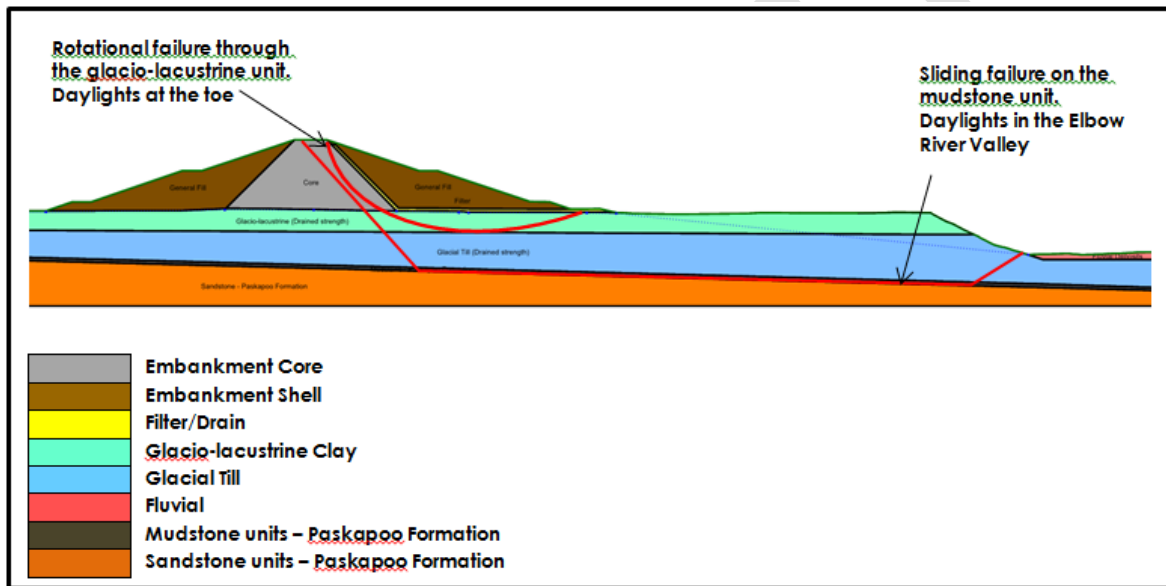
The results of the existing conditions stability analysis are summarized in Table 3 and the generalized location of the failure surfaces are shown in Figure 4.

Figure 4. Generalized Failure Surfaces

The analysis for the current alignment conditions with the dam constructed ignoring potential lateral river bank erosion showed adequate factors of safety (1.5) for long term conditions with the reservoir full using a c/p ratio to characterize the strength of the glacio-lacustrine clay. The critical failure

surface for this scenario was a rotational failure through the toe of dam in the foundation glacio-lacustrine clay.

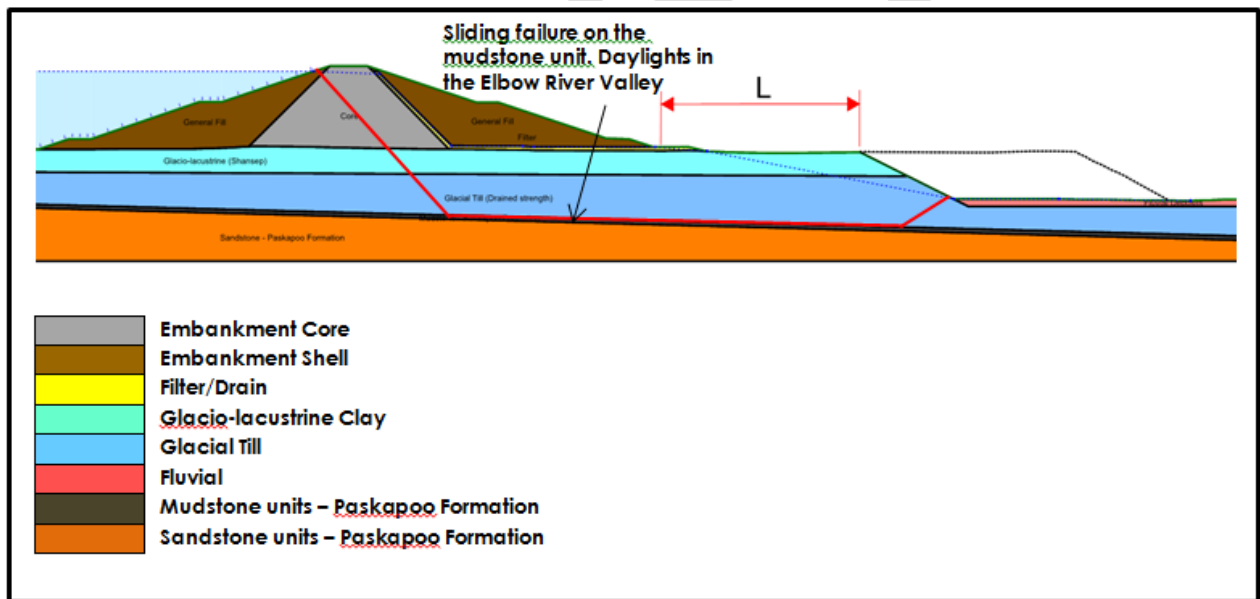
The generalized location of the failure surface is shown in Figure 4. The failure surface goes through the weaker mudstone layer. As the river bank was moved closer to the toe of the dam in order to model future lateral erosion of the river bank, the failure surface continued to go through the mudstone layer.

Figure 5. Iterative Lateral Erosion Analysis

The potential impact of lateral river bank erosion was evaluated. The lateral river bank erosion does not impact the critical failure surface until the top of the river bank is 70 metres from the toe of the dam. This equates to approximately 44 metres of lateral erosion. At this distance, the factor of safety is equal to 1.5 and the critical failure surface is no longer the rotational failure through the toe of the dam but a sliding failure along the mudstone unit in the Paskapoo formation toward the river.
