**COUGAR CREEK LONG TERM MITIGATION PROJECT
GEOTECHNICAL INVESTIGATION FOR PHASE 1 – OPTIONS ANALYSIS**

**Report
to
the Town of Canmore**

Date: November 9, 2015
File: 19-598-440

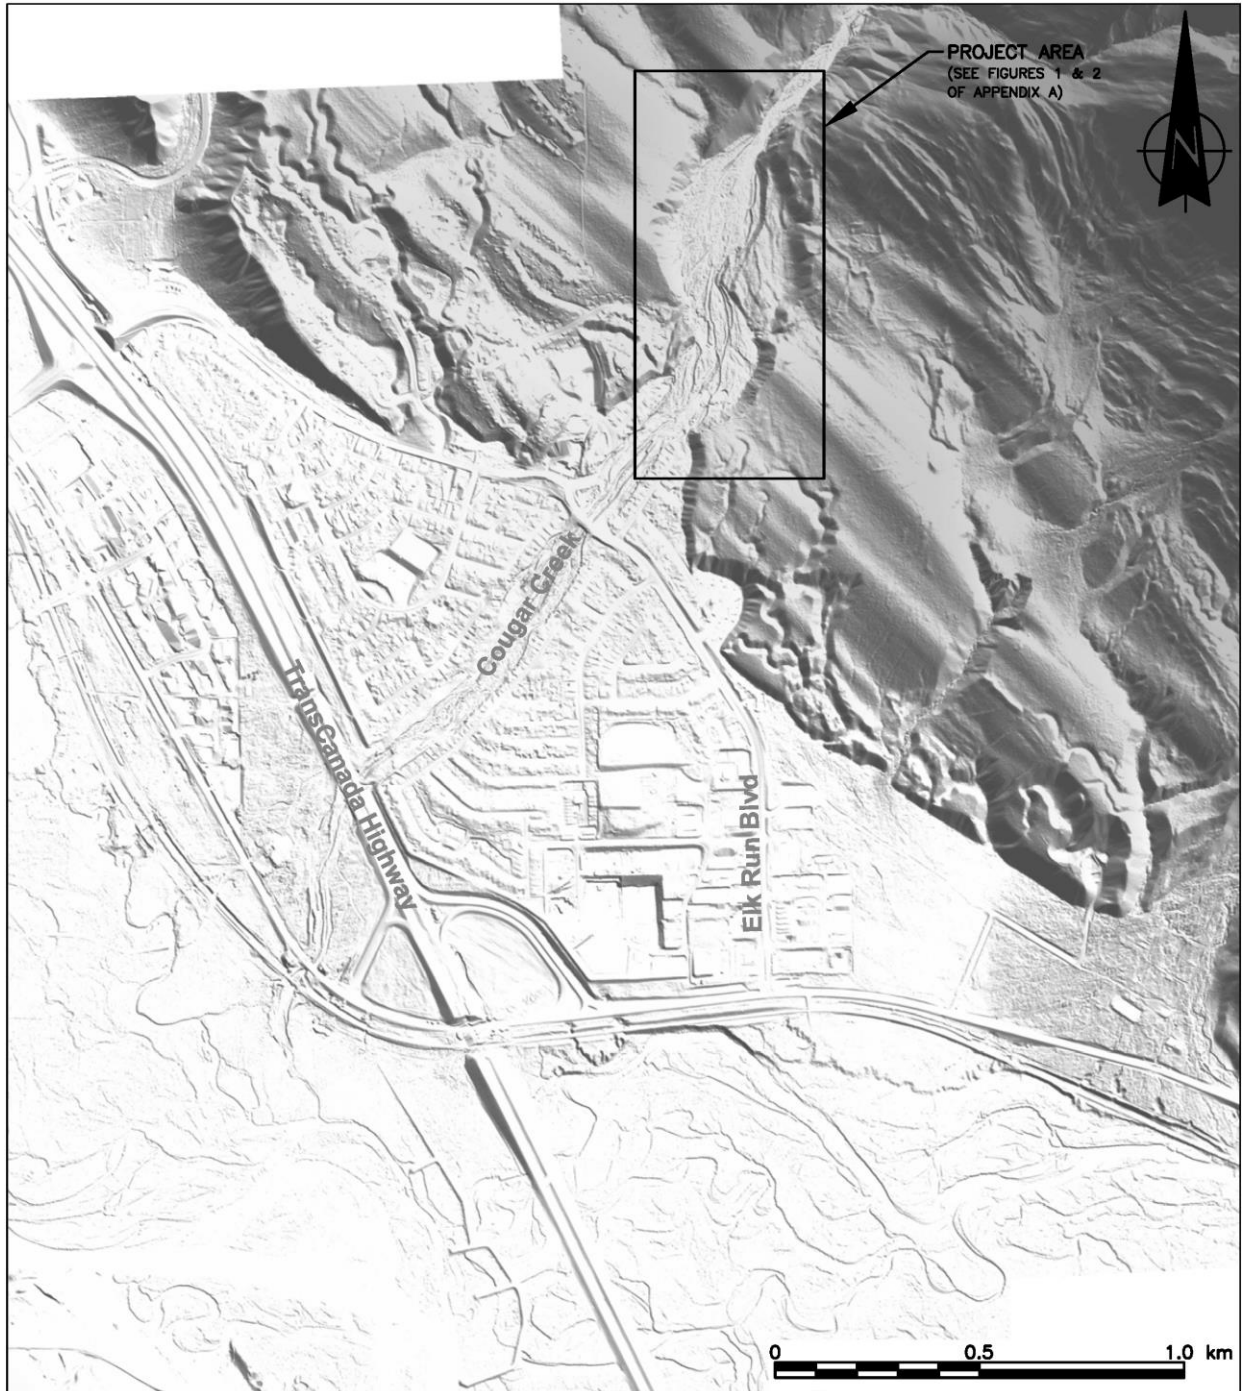
Illustration 3. 2013 post-flood LiDAR imagery provided for the Town of Canmore. Note erosion of the glacial deposits by Cougar Creek (boxed area)

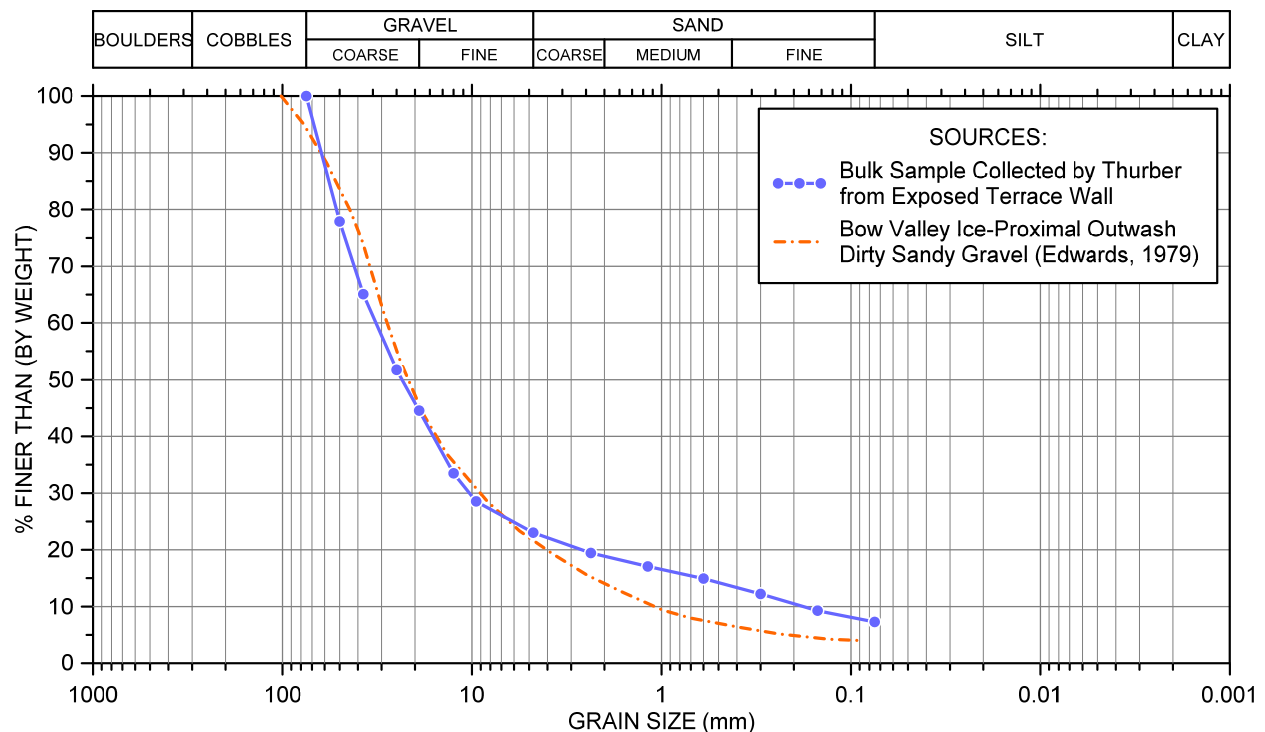
Illustration 6. Grain size curves for the Glaciofluvial Dirty Outwash (“Kame Terrace”)

A grain size analysis was conducted in a sample collected by Thurber from an exposed terrace face. The grain size distribution curve for this material is presented in Illustration 6, together with a curve reported by Edwards (1979) for a sample of Bow Valley “ice proximal outwash dirty sand gravel” (exact location unknown). Both samples display up to about 80% gravel size and under 10% fines, which is consistent with Edwards's observations. It should be noted that some breaking of the smaller clasts was induced during sample preparation.

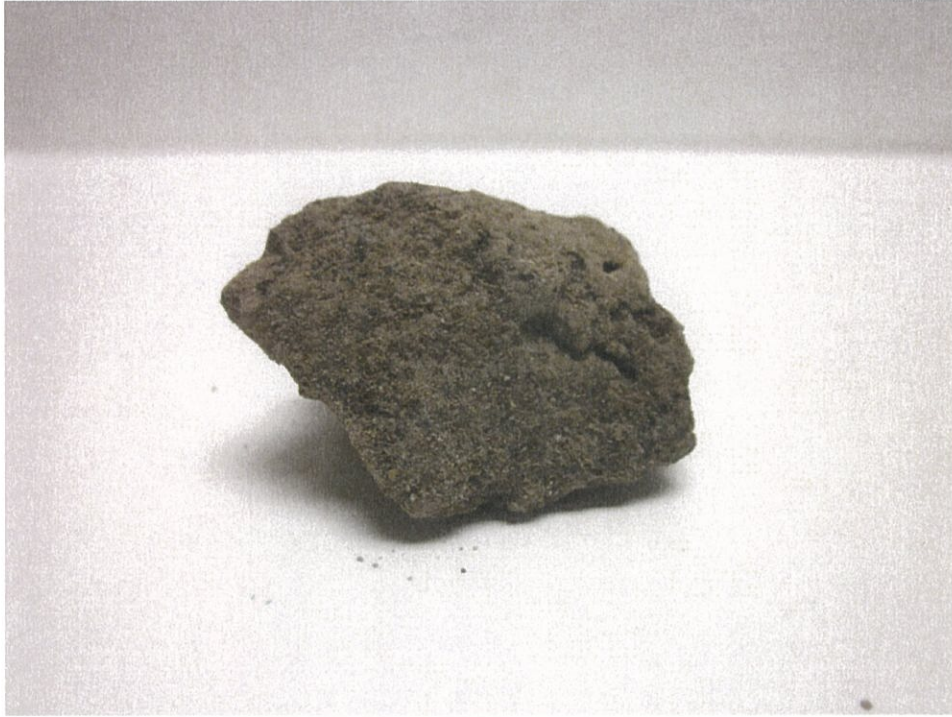
Photo 1: Crumb Test Sample 1 (Valley Wall) – Before Immersion

Jar slake tests and crumb tests were conducted on the bulk soil sample obtained from the terrace wall and on a “buried” sample obtained from TP14-6 at 4.3 m. These tests were conducted with both distilled water and creek water, with a maximum immersion time of 24 hours. The results of these tests, summarized in Appendix C, indicate these materials present a surficial “fines” phase, with high potential for degradation and erodibility, and a deeper “coarse” phase, which is cemented and less prone to degradation and erosion. It should be noted that a significant portion of the cementation bonds were broken due to washing of the bulk sample, suggesting a relatively high potential for erodibility of these deposits when exposed to flowing water.

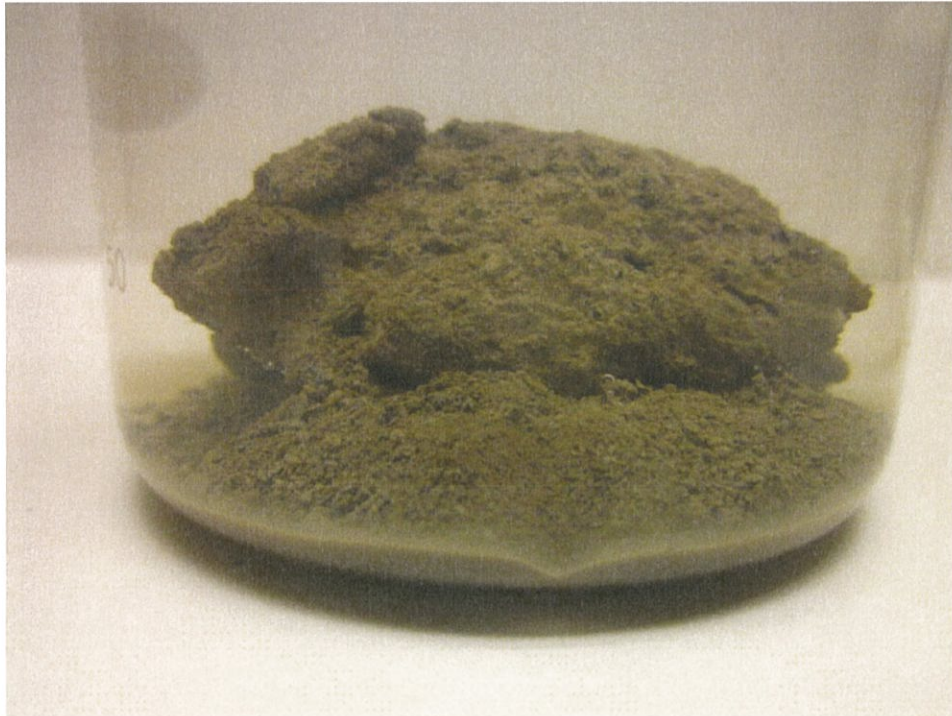
Photo 2: Crumb Test Sample 1 (Valley Wall) – After 24 hrs Immersion

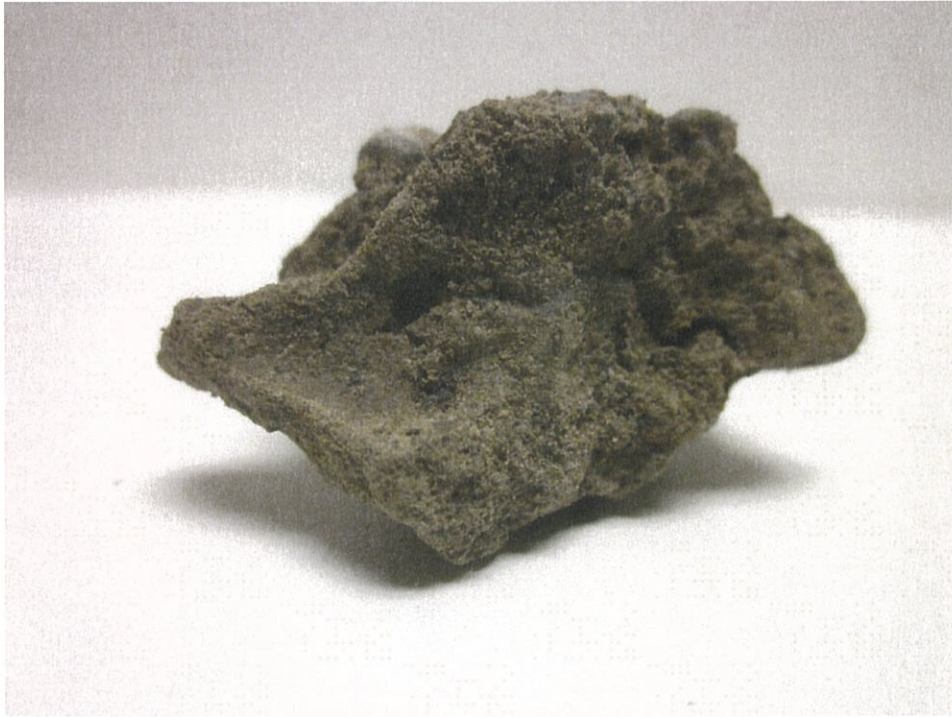
Photo 3: Crumb Test Sample 2 (Valley Wall) – Before Immersion

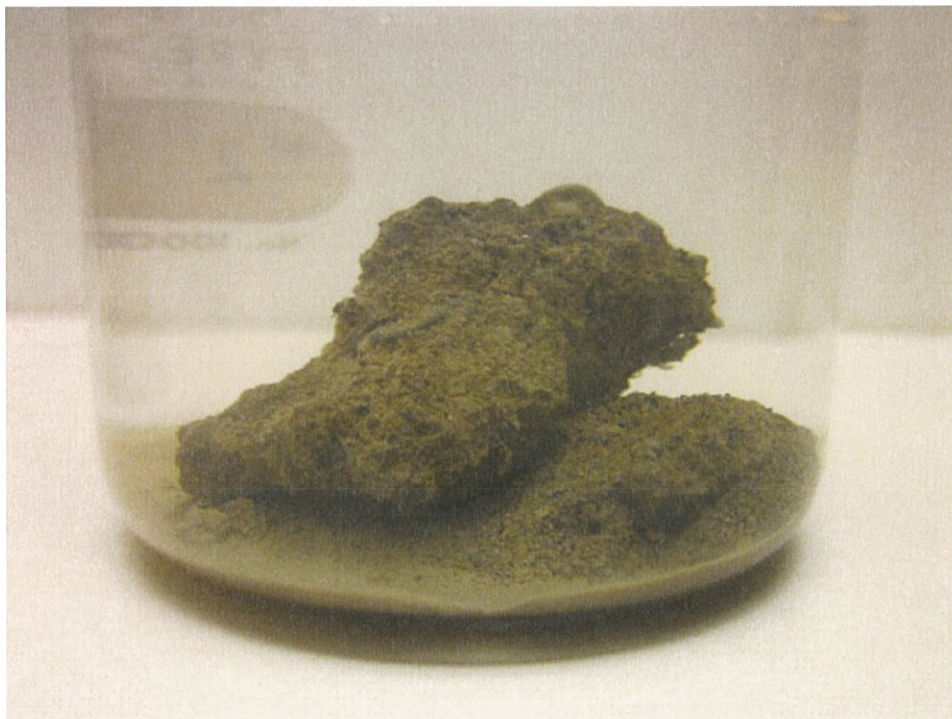
Photo 4: Crumb Test Sample 2 (Valley Wall) – After 24 hrs Immersion

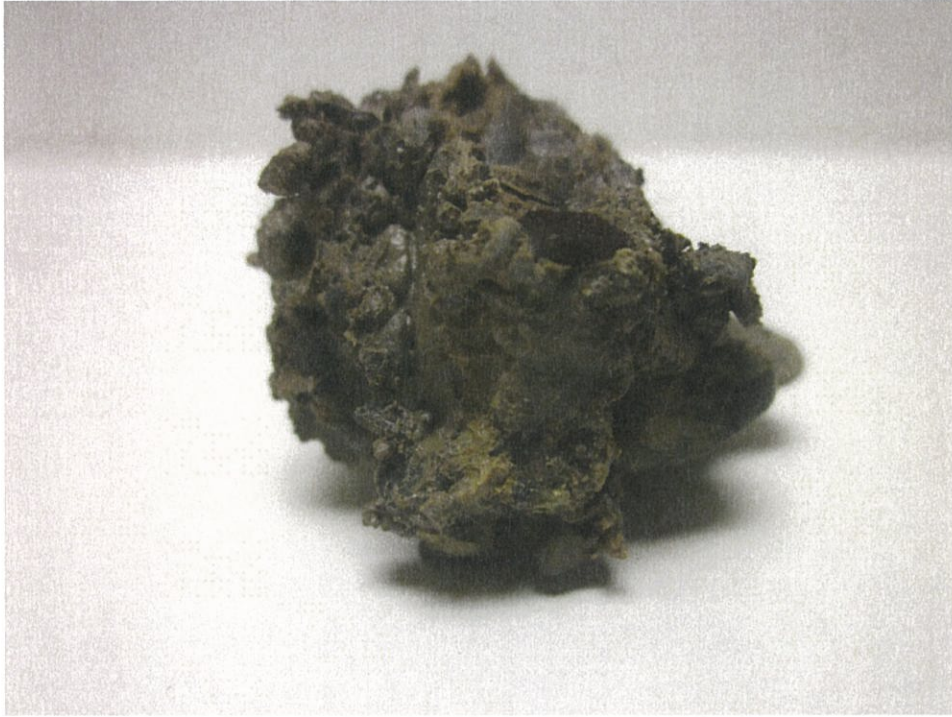
Photo 5: Crumb Test Sample 3 (TP14-06) – Before Immersion

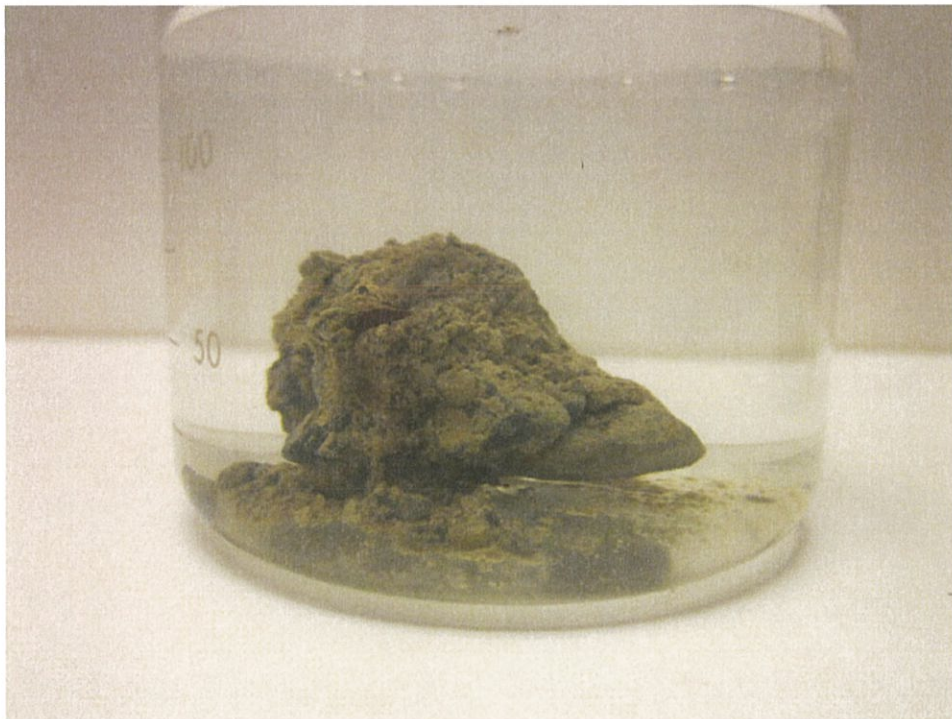
Photo 6: Crumb Test Sample 3 (TP14-06) – After 24 hrs Immersion

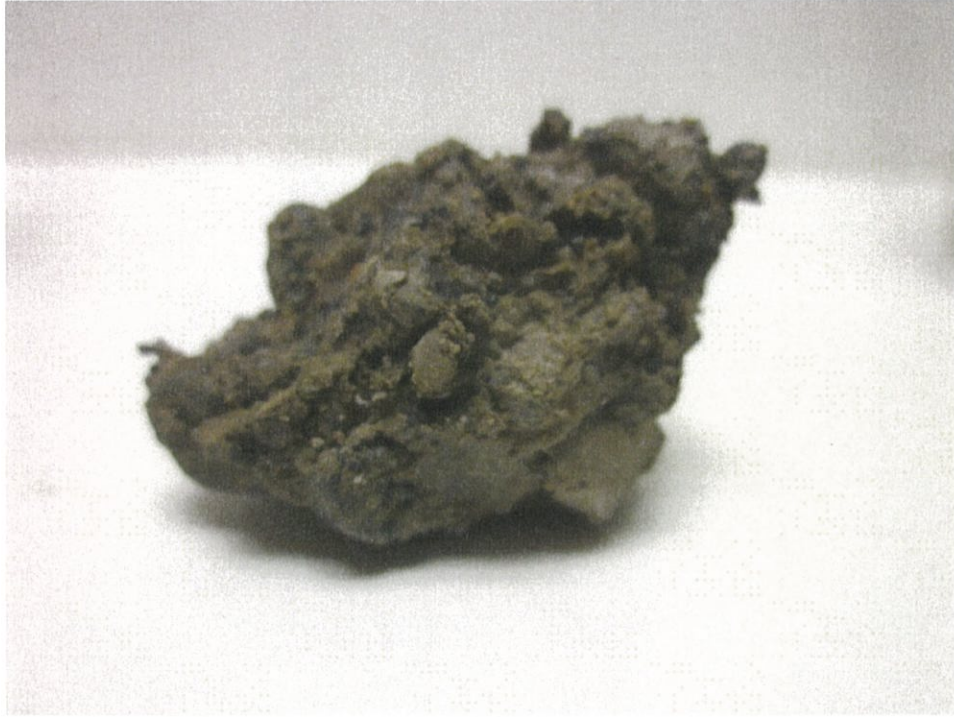
Photo 7: Crumb Test Sample 4 (TP14-06) – Before Immersion

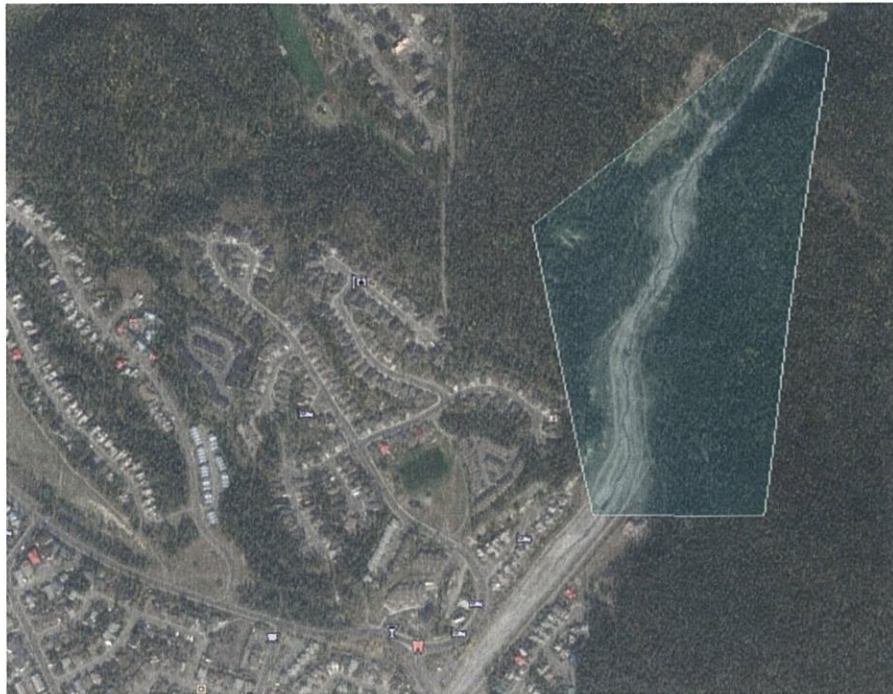
Figure 1-1: Cougar Creek aerial image outlining survey area (source Google Earth)

The Cougar Creek area is in the vicinity of Canmore, AB. The 15 hectare zone of investigation traverses the creek bed, up the banks, and along parts of the flood plain. The creek bed areas are open, but the tops of the banks are heavily forested. Figure 1-1 highlights the area of investigation and Figure 1-2 shows its proximity to the city of Canmore AB.

Figure 1-3 shows the survey location that is highlighted in Figure 1-1. All data in this report was processed and reported using the NAD83 datum with the UTM Zone 11 projection. Table 1-1 shows the geophysical methods used on each line.

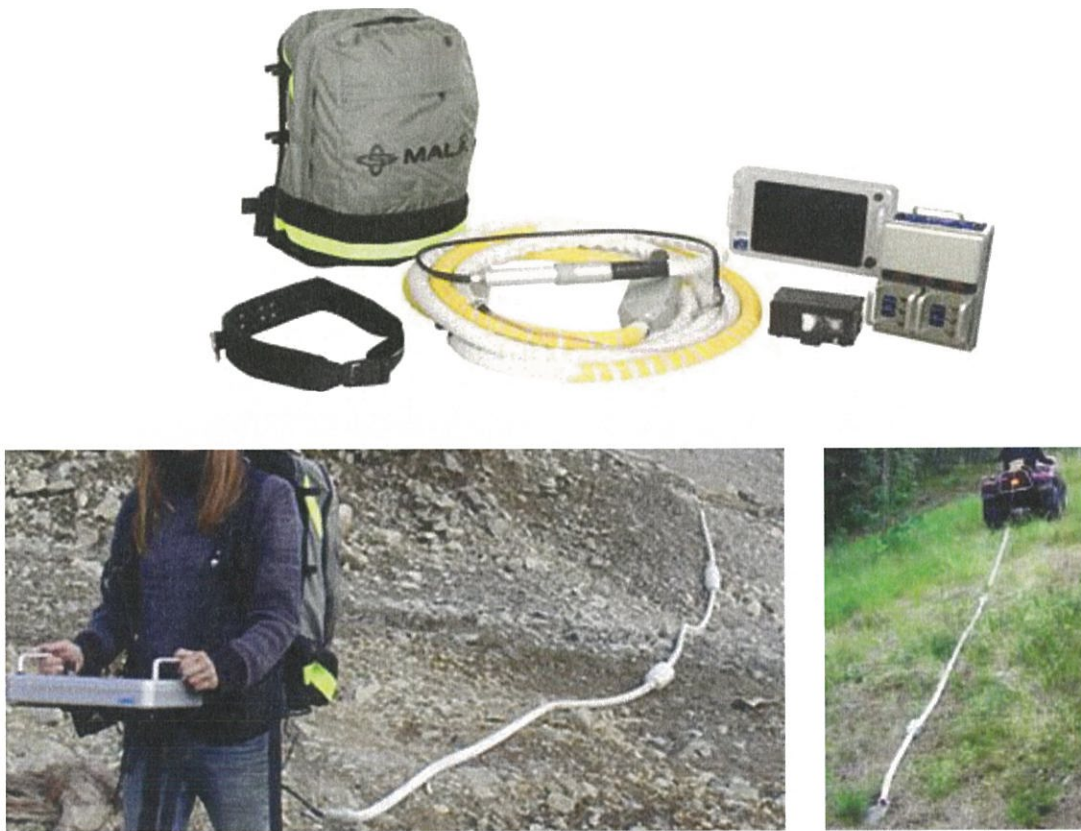
Figure 2-3 Top – MALA 100 MHz RTA (Rough Terrain Antenna) and survey components. Bottom Left: Operator manually dragging a rough terrain antenna. Bottom Right: ATV dragging a rough terrain antenna.

A 100 MHz rough terrain antennae as shown in Figure 2-3 was used for all the GPR lines surveyed. This antenna provides a good balance of depth and resolution while also being rugged enough to work effectively in rough terrain.

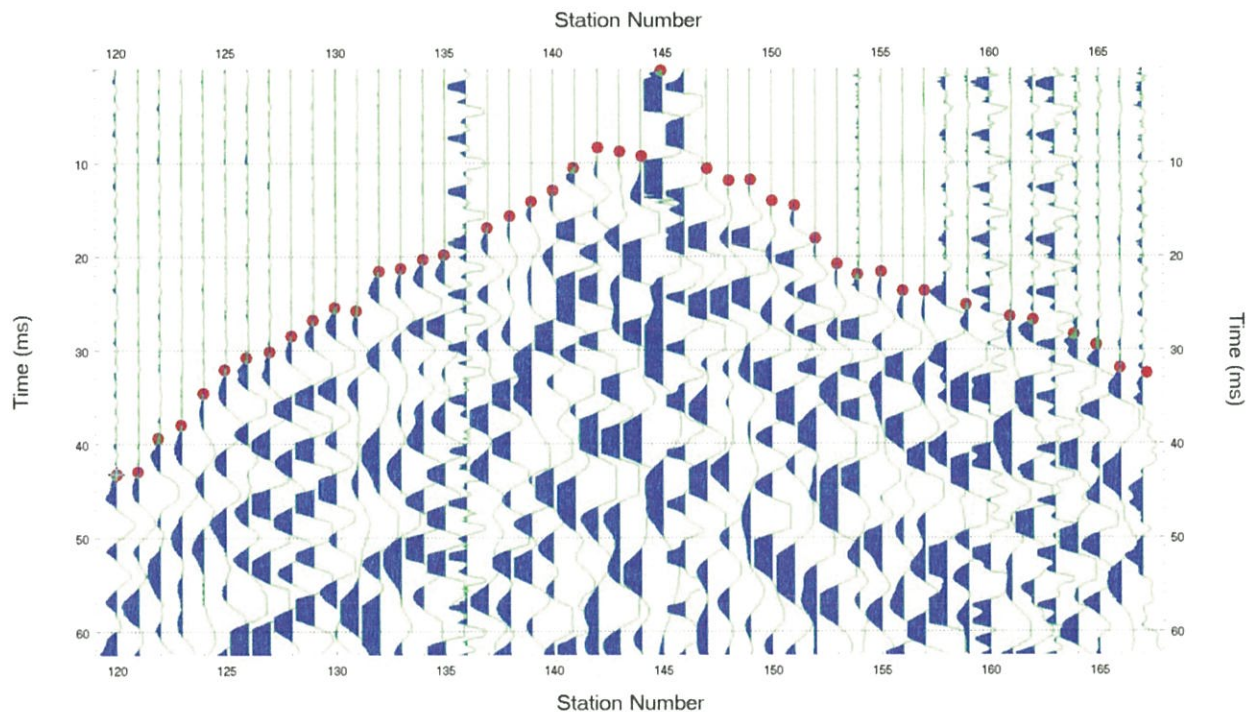
Figure 3-1: Geophone traces gathered for one shot. The red dots mark the selected first arrival time for each geophone.

In general, the signal to noise ratio of the data was relatively high. Figure 3-1 shows an example of geophone traces from one shot on line G2. Background noise can be seen on the right most traces as signal that is arriving before the selected first arrival time. In this project, the main sources of noise were the City of Canmore and water flowing down Cougar Creek. Geophones that were planted near these sources will have a greater impact from the noise.

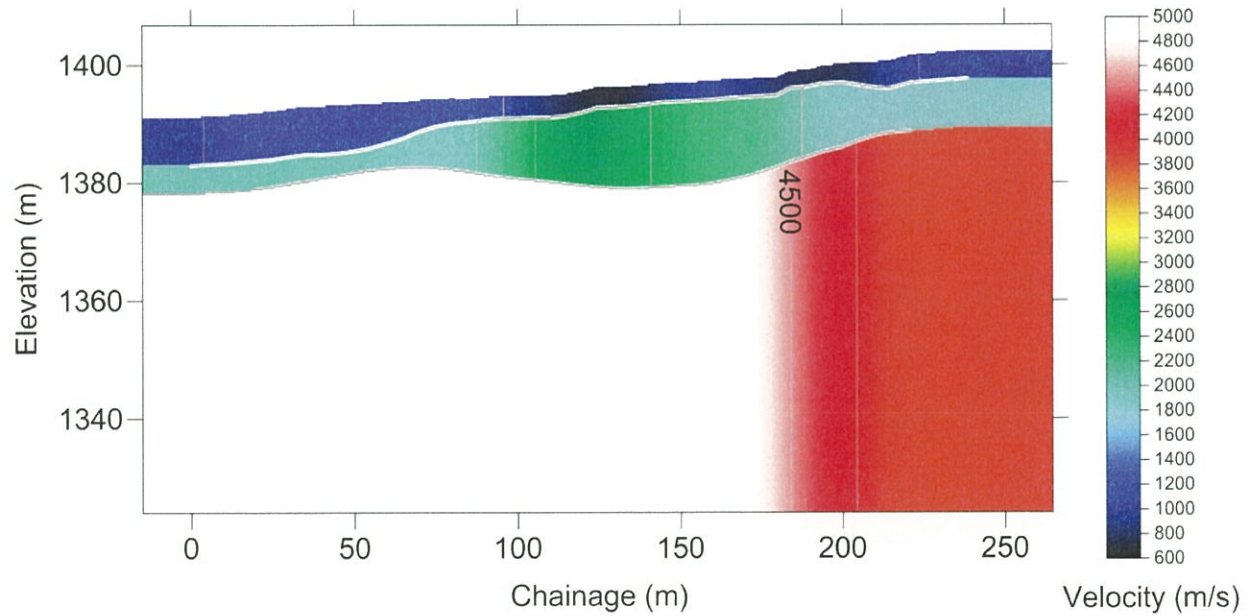
Figure 3-3: A plus-minus initial model for line G4a.

These different initial models give the final section a different character. Figure 3-2 shows the gradient initial model that was used on line G2 and Figure 3-3 shows the plus-minus model that was used on line G4a.

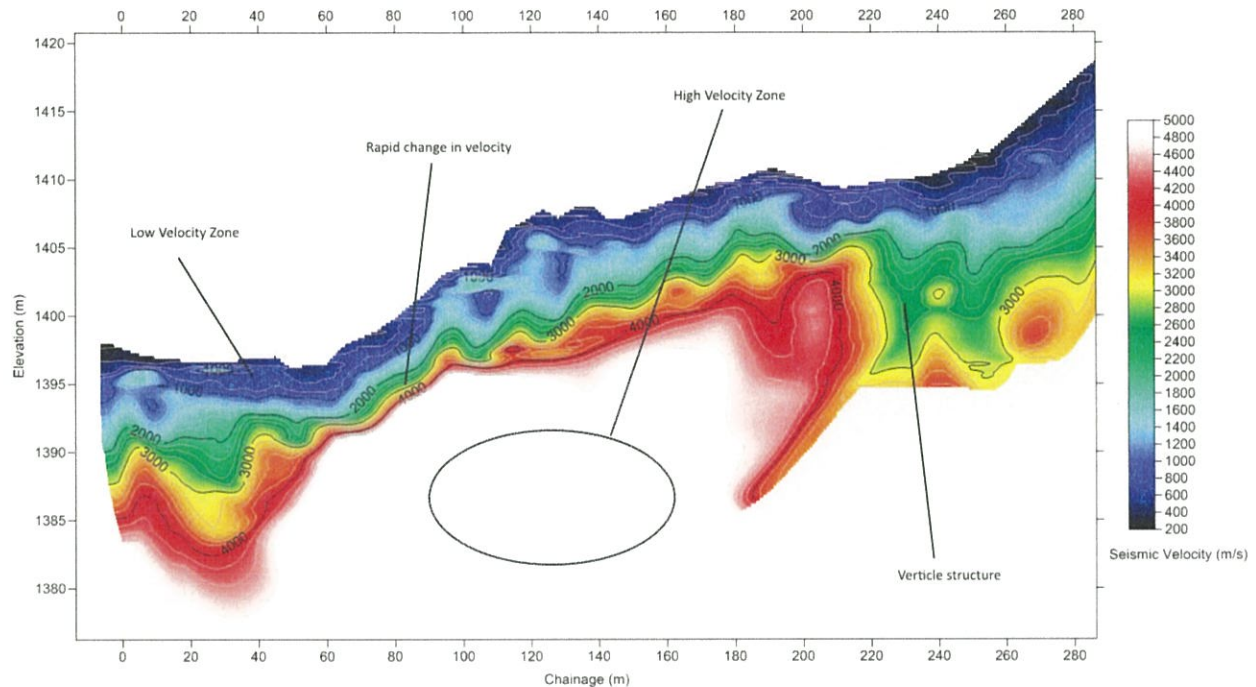
Figure 3-4: Velocity model on line Option C exhibiting likely bedrock in the high velocity zone and unconsolidated materials in the low velocity zone. This figure also exhibits vertical features on both sides.

The final seismic velocity models are generated by an iterative tomographic inversion algorithm (Rayfract). Figure 3-4 shows the velocity model generated for line Option C.
