## TOWN OF CANMORE

### COUGAR CREEK

## DEBRIS FLOOD HAZARD ASSESSMENT

PROJECT NO.: 1261-001  
DATE: March 7, 2014  
DOCUMENT NO.: TC13-010

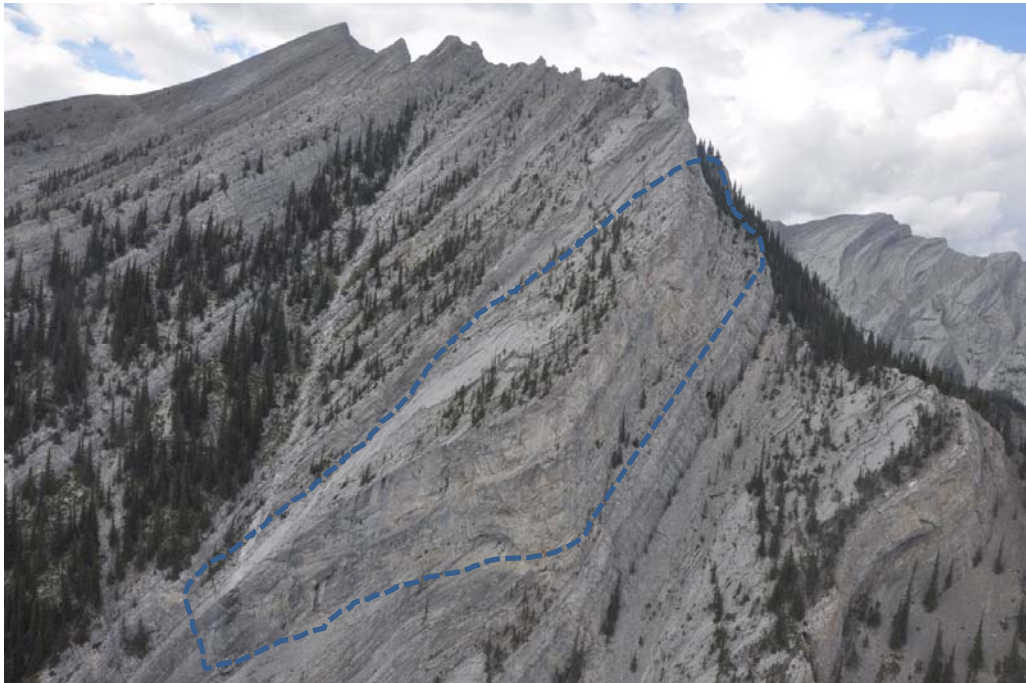
**Figure 2-2.** Large, potentially unstable rock mass in the lower (western) Cougar Creek watershed in steeply dipping limestones. The unbuttressed rock mass (dashed blue line) in mid photograph is approximately 180 m long, 80 m wide, 10-20 m thick and approximately  $35^\circ$  steep. BGC photograph of August 7, 2013, looking west.

From C to D (Drawing 1), the Cougar Creek watershed crosses the Etherington, Mount Head and Livingstone Formations with interbedded limestone, dolomite, sandstone, shale and siltstone. These formations are important as they supply rock-fall derived sediment to the lower tributaries of Cougar Creek from where they are remobilized as episodic debris flows. These episodic debris flows are the principal geomorphic process delivering tributary sediment to the mainstem of Cougar Creek. On the southeast flank of Mount Lady MacDonald, rocks of these groups expose steeply ( $\sim 35^\circ$ ) southward dipping limestone beds, some of which lack buttressing against the opposing strike slope. The steep dips, in combination with lack of lateral confinement on the east side, make such beds candidates for large rock slope failures. For example, Figure 2-2 shows a location in the lower (western) Cougar Creek watershed where this process could result in a failure of up to 300,000 m<sup>3</sup>.

A rock slope failure of this magnitude would quickly narrow in the downstream gully likely bulking in volume through erosion of surface sediments. In this case, the travel distance would be approximately 1 km over a relief of approximately 600 m (from the landslide toe). By the time the rock slide reached the valley bottom, it is conceivable that the mass movement would create a landslide dam.

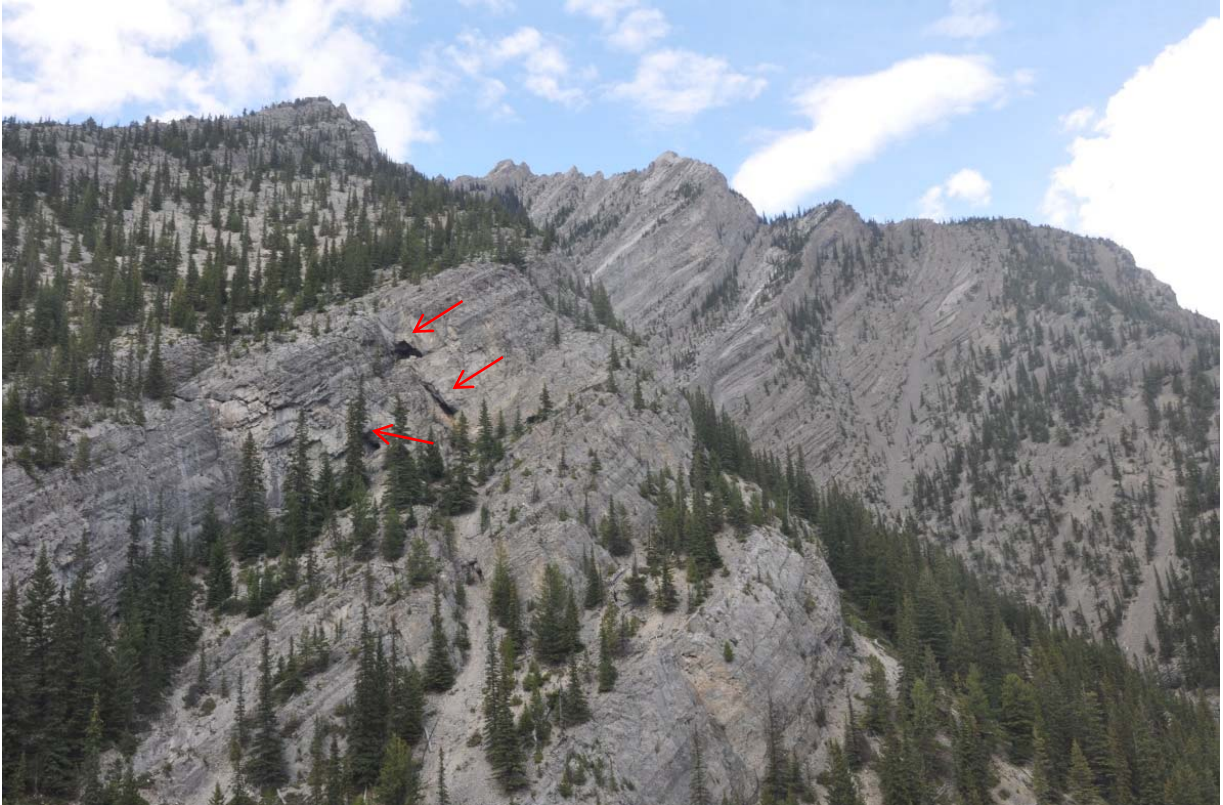
**Figure 2-3. Outcrops of the Etherington Formation with karst formation (caves) in the lower (northern) portions of the Cougar Creek watershed. Red arrows denote caves. BGC photograph of August 7, 2013, looking north.**

Despite the abundance of limestone in the Cougar Creek watershed, karst<sup>7</sup> was observed in only a few cases (Figure 2-3). No correlation could be drawn between known landslide occurrence and karst development.

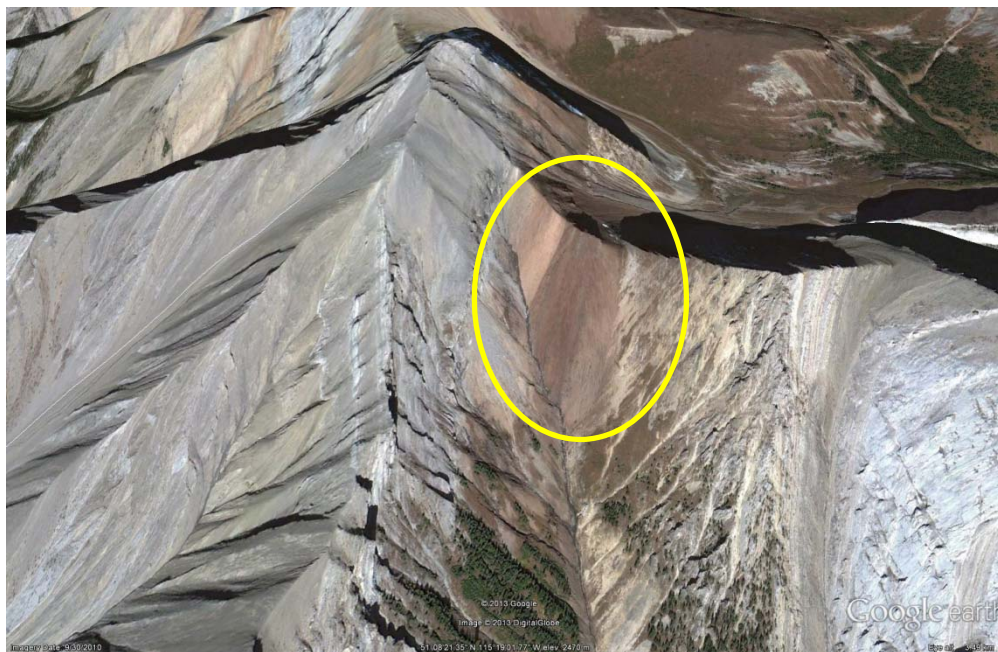
**Figure 2-4. Outcrops (circled in yellow) of the Triassic Spray River and Ishbel and Spray Lakes Group Rocks on the eastern flanks of Mount Lady MacDonal. Google Earth image.**

elevation, outcrops of these sedimentary rocks are susceptible to heavy frost weathering and have formed largely smooth talus slopes. Unlike the more competent limestone and dolostones of the adjacent Etherington and Mount Head formations, these Triassic sedimentary rocks are less prone to cliff formation and thus have lower susceptibility to rockfall.

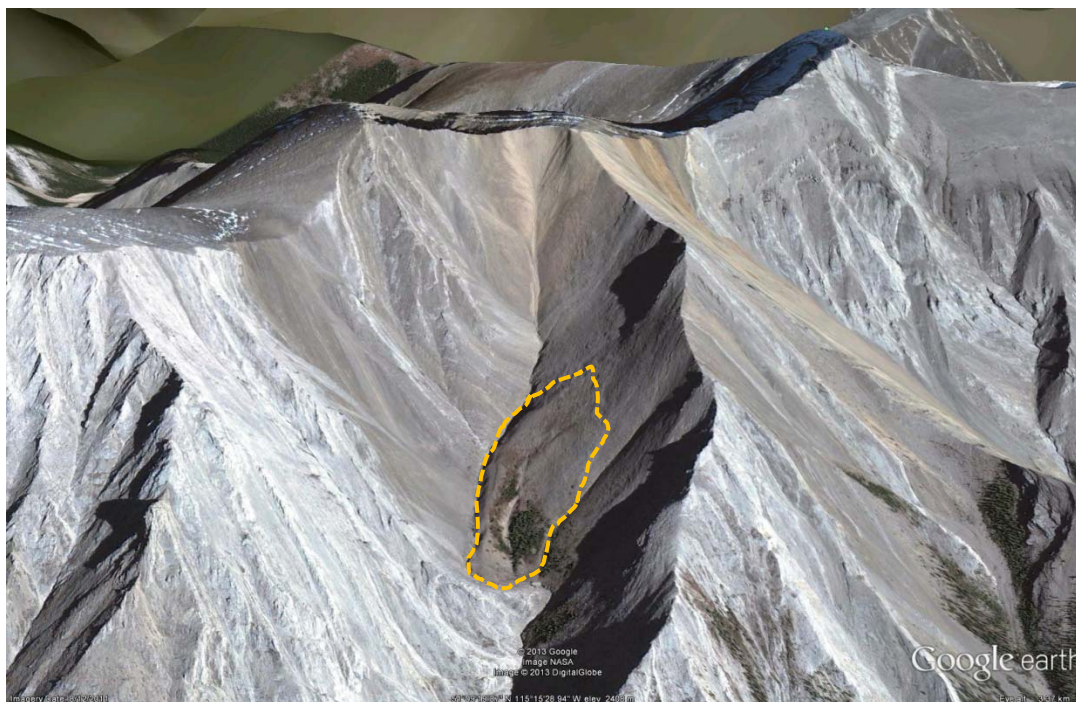
**Figure 2-5. Rockslide in the northernmost portion of the Cougar Creek watershed. The landslide is delineated in yellow. Mount Townsend (2820 m) is seen in the background. The lighter-coloured rocks in the foreground belong to the Palaeozoic Livingston Formation. Google Earth image.**

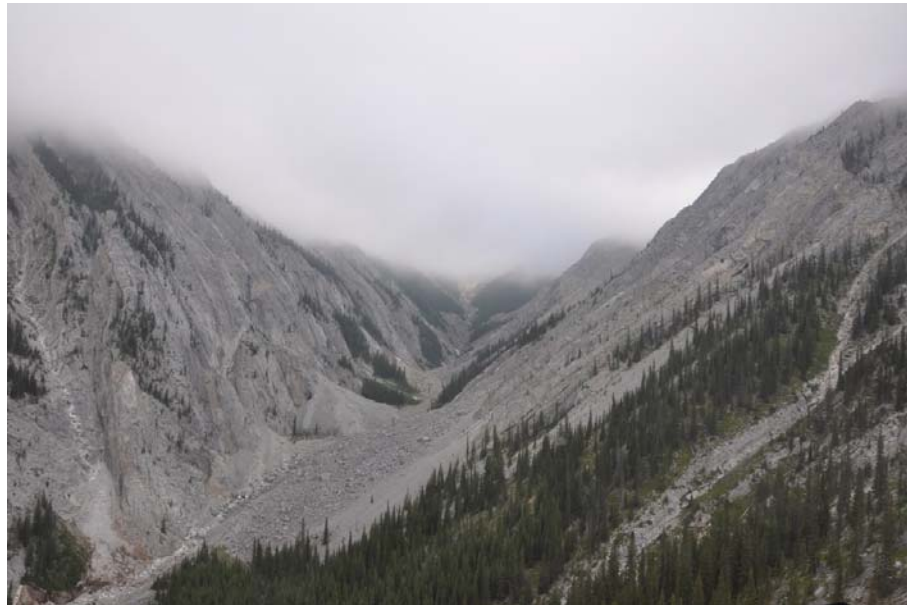
**Figure 2-6.** Rock slide deposits in the northernmost headwaters of Cougar Creek along a pronounced southeast-trending syncline that roughly defines the valley bottom. Note the steeply dipping and daylighting joint sets on both side of the valley. The slope of the limestone beds on the right (east) is approximately 40°, while on the left (west) it is approximately 35°. BGC photograph, Aug. 7, 2013, looking north.

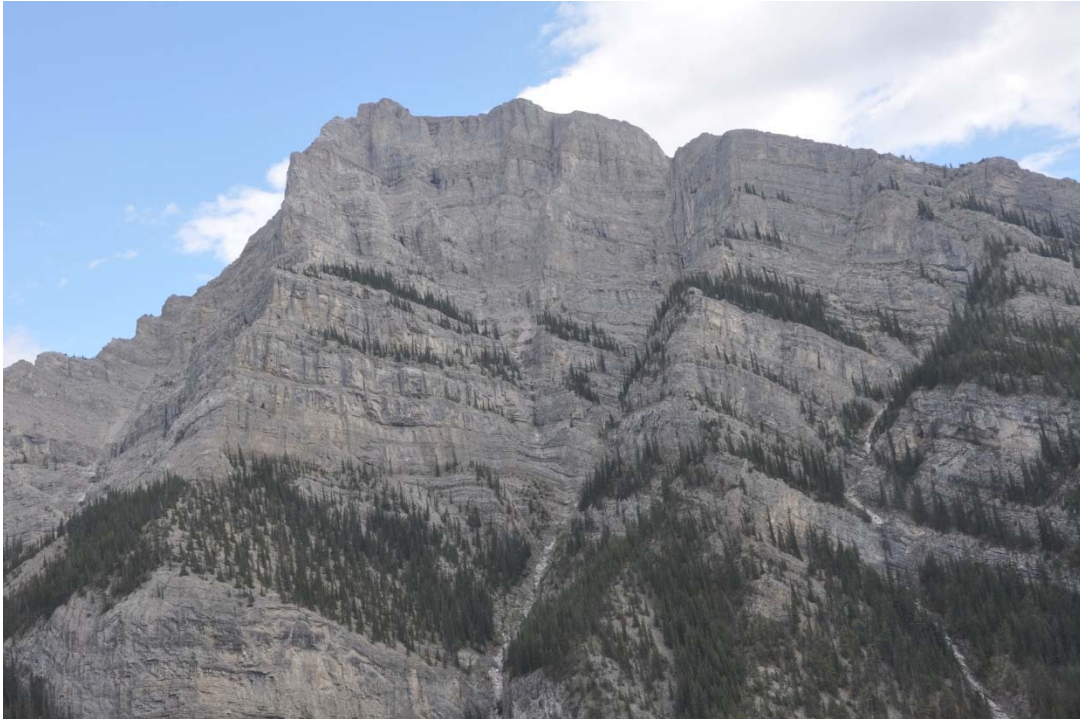
**Figure 2-10.** Rock fall producing cliffs on the strike slope of Grotto Mountain, primarily composed of the Mount Head and Livingstone Formation. BGC photograph of August 7, 2013, looking south.

The first two factors are the primary kinematic factors associated with larger scale instability, particularly where such failures would connect directly to the mainstem of Cougar Creek (Figure 2-10). Large scale failures of this type can and have travelled into the valley bottom

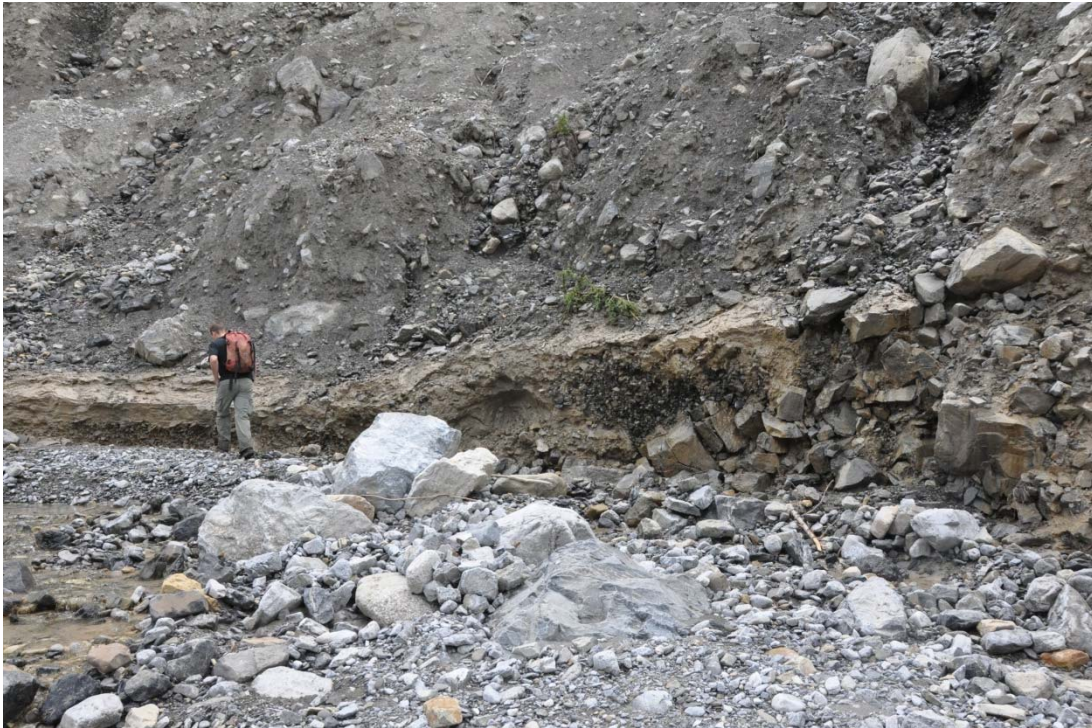
**Figure 2-13. Fine-grained (clayey silts) lacustrine beds outcropping along Cougar Creek channel and underlying debris flow deposits. Beds are 30 cm to 100 cm thick and thinly varved<sup>12</sup>. BGC photograph of August, 2013, looking downstream along west side of channel.**

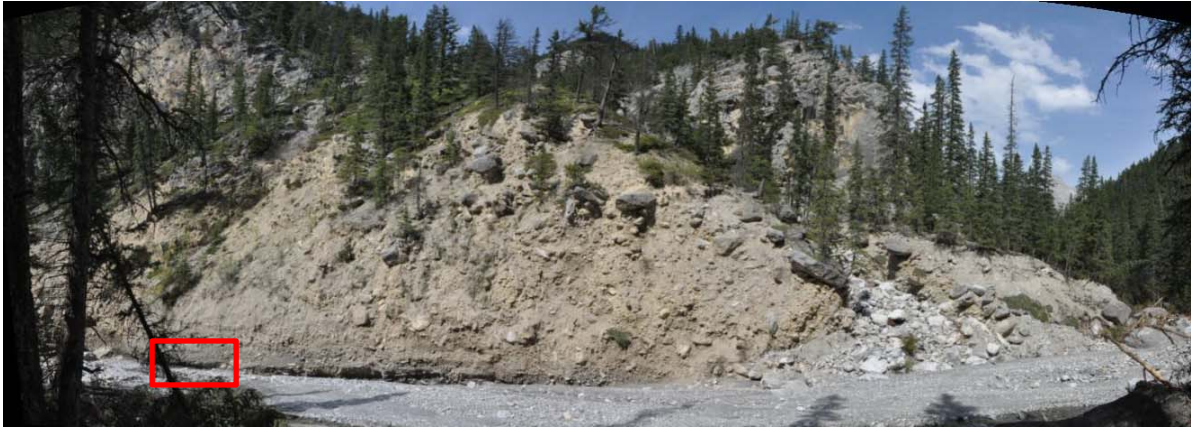
**Figure 3-1.** Large landslide deposit overlying fluvial sediments approximately 1.1 km upstream of the fan apex. Figure 3-2 shows the detail delineated here as a red box. The height of the landslide deposit above the current channel bed is approximately 25 m. BGC photograph of August 29, 2013, looking west.

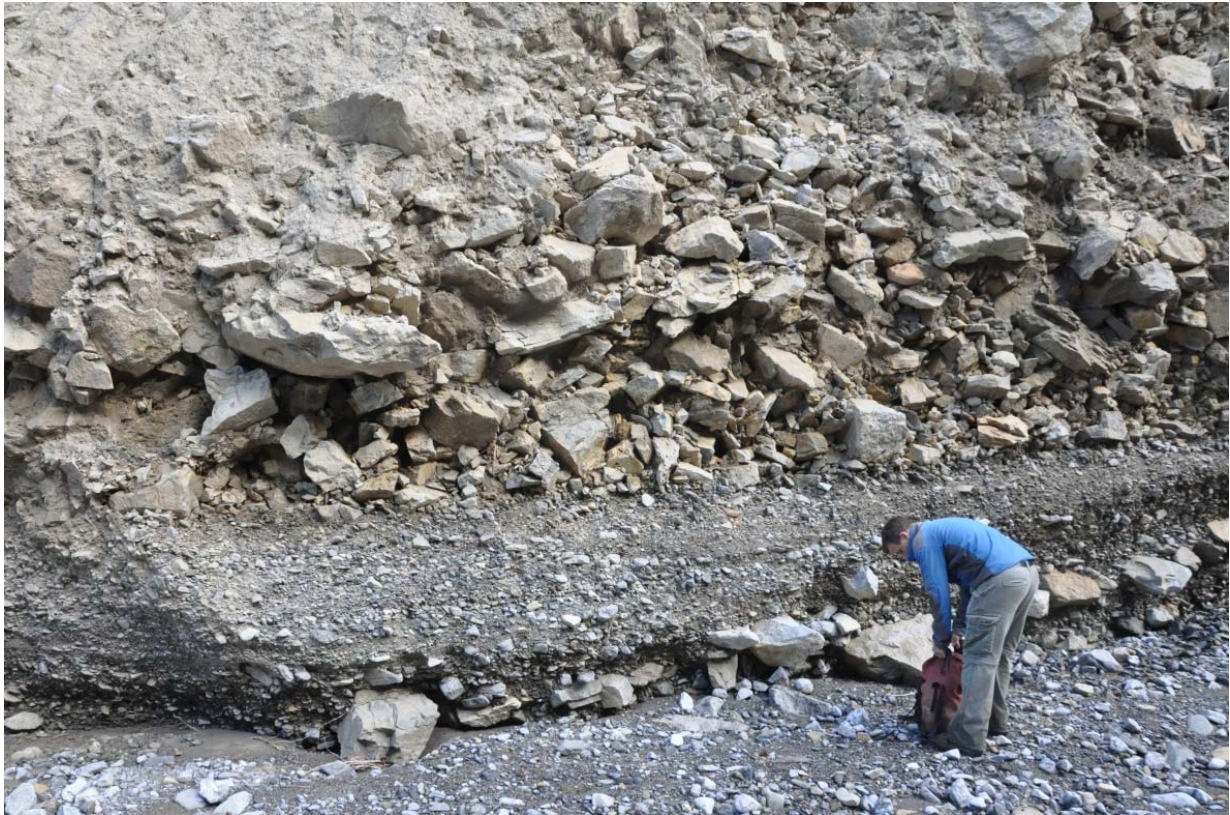
**Figure 3-2.** Fluvial sediments underlying coarse, angular matrix-supported landslide debris at the location of Figure . BGC photograph of August 29, 2013.

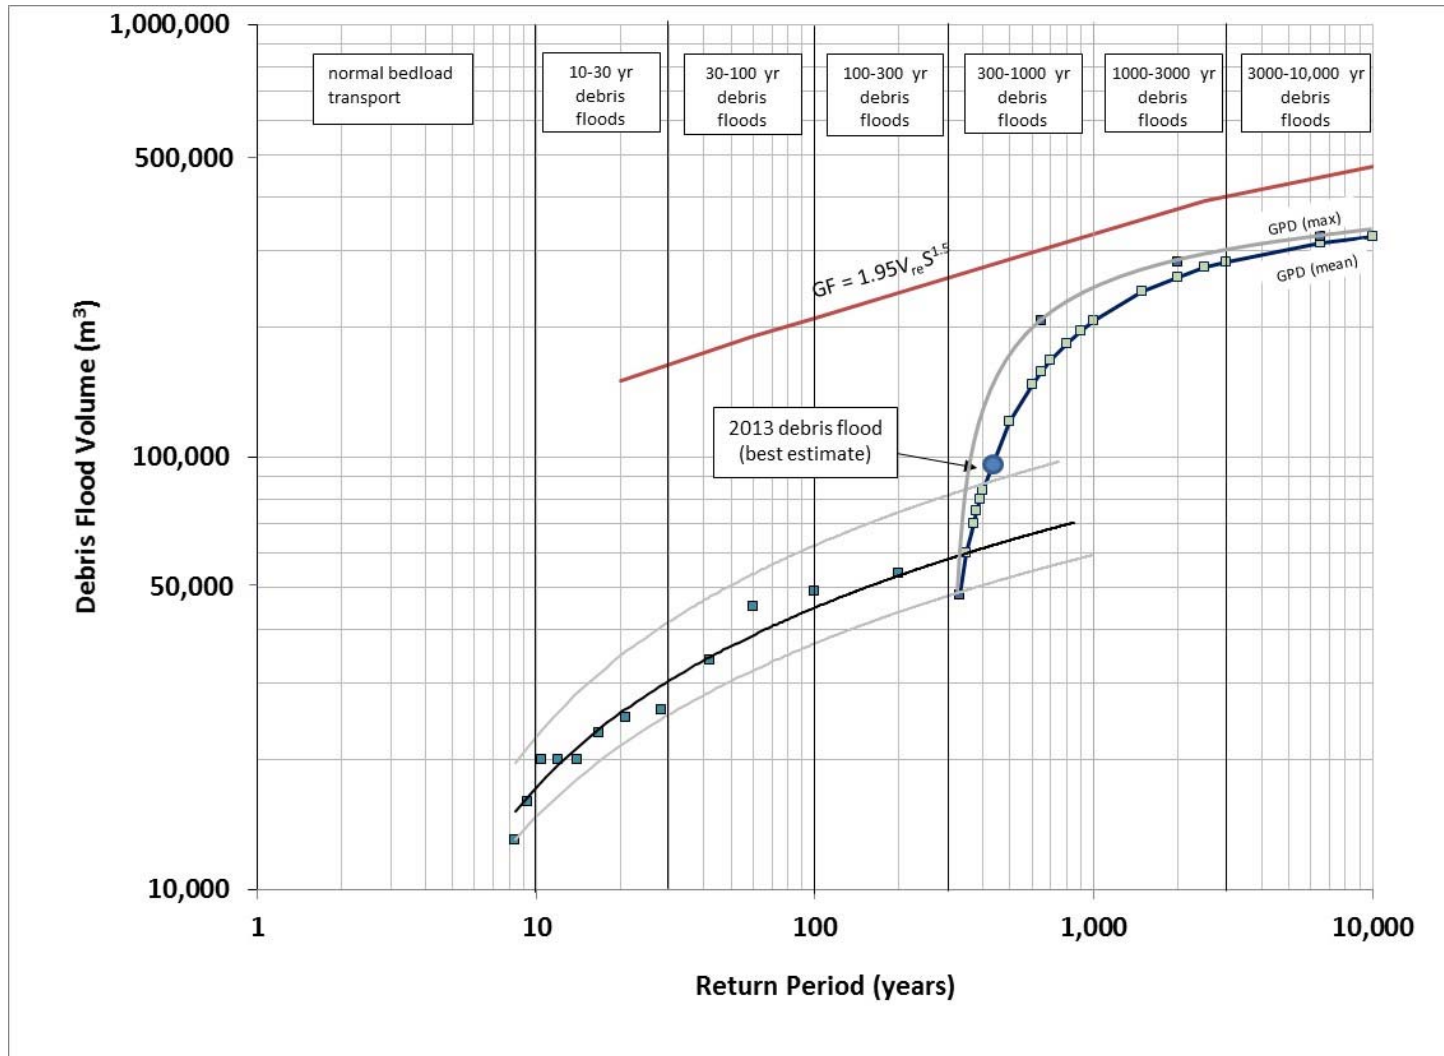
Figure 6-1. Return period – debris flood volume graph for all reconstructed debris floods including the Rickenmann and Koschni (2010) envelope (thick red line). The curved black and grey lines are based on the MCF analysis, while the curved lines indicates the mean (blue) and maximum (grey) volume estimate of the GPD distribution.

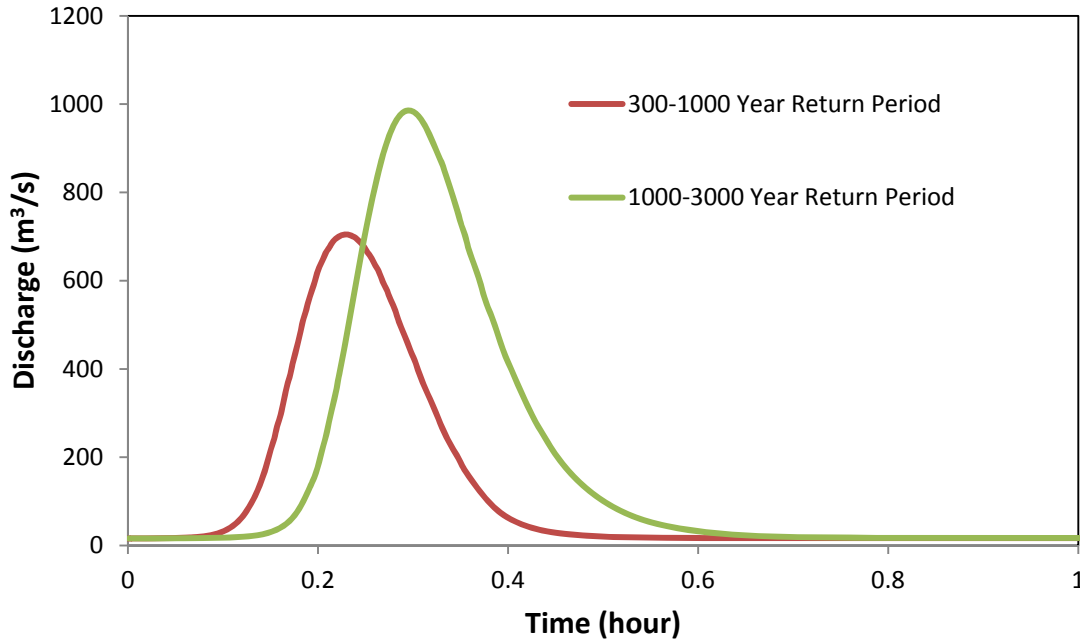
**Figure 7-2. Dam outbreak hydrographs from BREACH for 300-1000 and 1000-3000 year return period classes.**

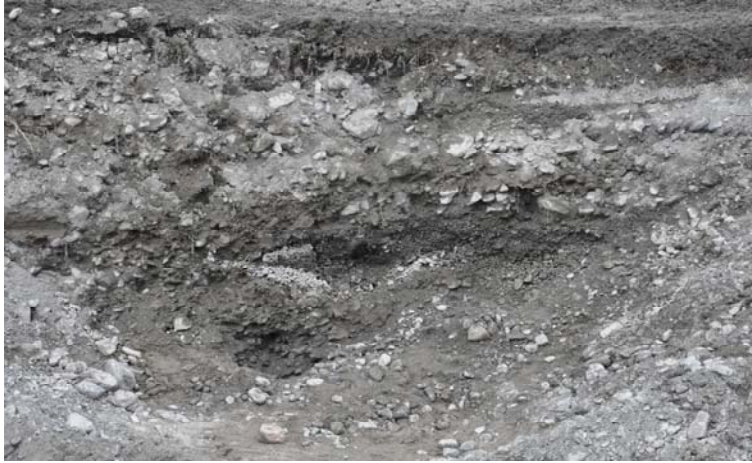
Sample	Depth (mbgs)	Date
◆ BGC-TP-18 Surface	0.0	-
◆ BGC-TP-18 Unit 4	3.6	2390 ± 30 BP
◆ BGC-TP-18 Unit 6	4.1	2440 ± 30 BP
◆ BGC-TP-18 Unit 8	4.85	2870 ± 30 BP

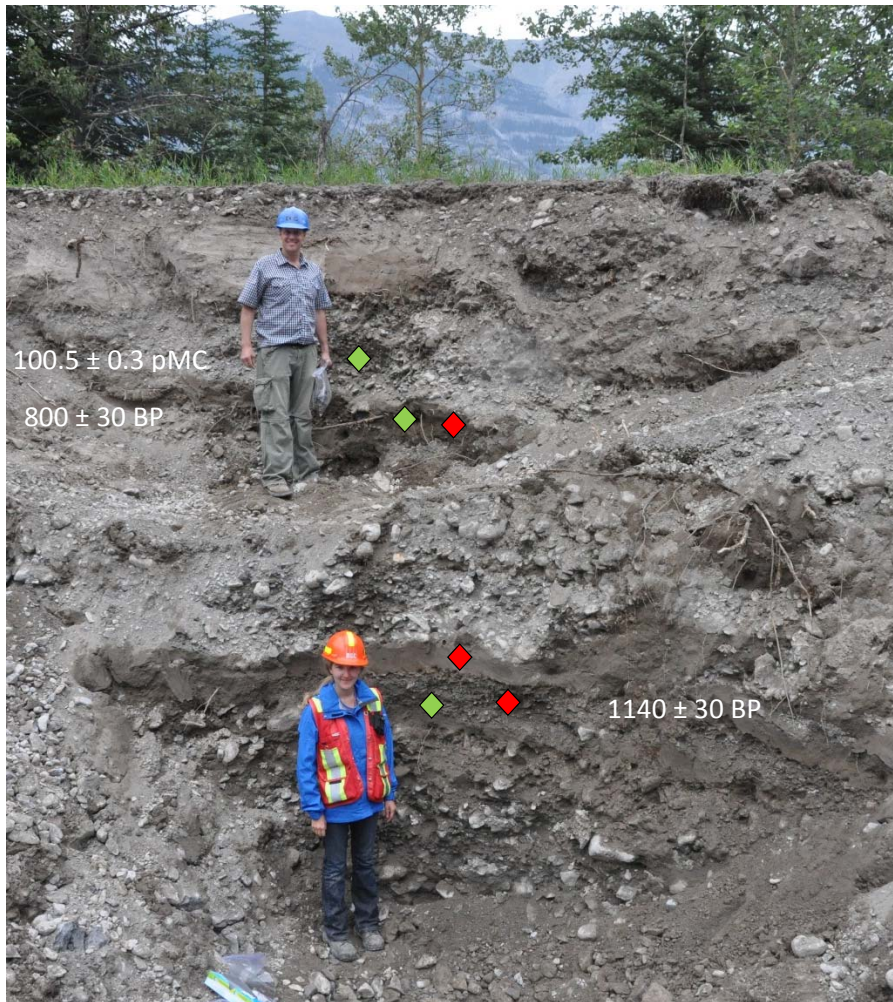
### TEST PIT # BGC-TP-19

Depth From (mbgs)	Depth To (mbgs)	Lithologic Description	Date
0	0.45	UNIT 1: FILL Possibly fill	-
0.45	0.9	UNIT 2: SAND Massive weakly stratified sands with numerous modern rootlets from poplar trees	-
0.9	1.6	UNIT 3: DEBRIS FLOOD Clast to matrix supported (mostly clast), subrounded to subangular sandy gravel, loose with modern rootlets, moist, Dmax=20cm	100.5 ± 0.3 pMC
1.6	2.9	UNIT 4: DEBRIS FLOOD <sup>1</sup> Massive gravel with sand layer, thin paleosol layer at 1.9 m	800 ± 30 BP
2.9	3.1	UNIT 5: SAND Massive unstratified sand with modern rootlets, weak bedding	-
3.1	3.3	UNIT 6: FLUVIAL <sup>2</sup> Clast supported and loose gravel, Dmax=10cm, fluvial gravel, silty sand at bottom, peat inclusion	1140 ± 30 BP
3.3	4.3	UNIT 7: DEBRIS FLOOD Silty sandy gravel, unsorted, unstratified subangular, Dmax=30cm, dense	-

Sample	Depth (mbgs)	Date
◆ BGC-TP-19 Unit 3	1.5	100.5 ± 0.3 pMC
◆ BGC-TP-19 Unit 4	1.9	800 ± 30 BP
◆ BGC-TP-19 Unit 4	1.9	-
◆ BGC-TP-19 Unit 5	3.0	-
◆ BGC-TP-19 Unit 6	3.2	-
◆ BGC-TP-19 Unit 6	3.2	1140 ± 30 BP

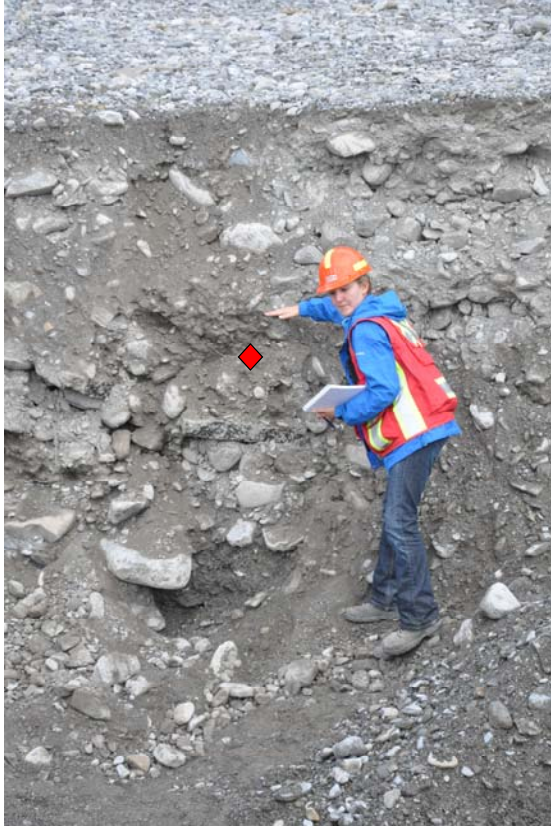
**TEST PIT # BGC-TP-45**

Depth From (mbgs)	Depth To (mbgs)	Lithologic Description
0	0.8	UNIT 1: FILL
0.8	2.2	UNIT 2: DEBRIS FLOOD Flood deposit to debris flood, clast supported (predominantly), Dmax=50cm, asphalt slab (slightly imbricated), sunangular to subrounded, predominantly unsorted, slight imbrication, some infill with medium coarse sand matrix, some woody/rooty material, moist down low
2.2	3	UNIT 3: FLOOD DEPOSIT Clast supported, sandy gravels, subrounded subangular, Dmax=20cm, slight imbrication, loose, interbedded sand lenses
3	3.7	UNIT 4: DEBRIS FLOOD Subrounded to subangular, upward coarsening, dense matrix supported debris flood, Dmax=40cm, unsorted, silt veneers on individual clasts, interbedded gravel lenses with downstream inclination at fan gradient
3.7	4.5	UNIT 5: DEBRIS FLOOD High apparent cohesion, massive unstratified matrix supported debris flood deposit, Dmax=40cm, subangular to angular

Sample	Depth (mbgs)
◆ BGC-TP-45 Unit 2	1.5
◆ BGC-TP-45 Unit 5	3.1

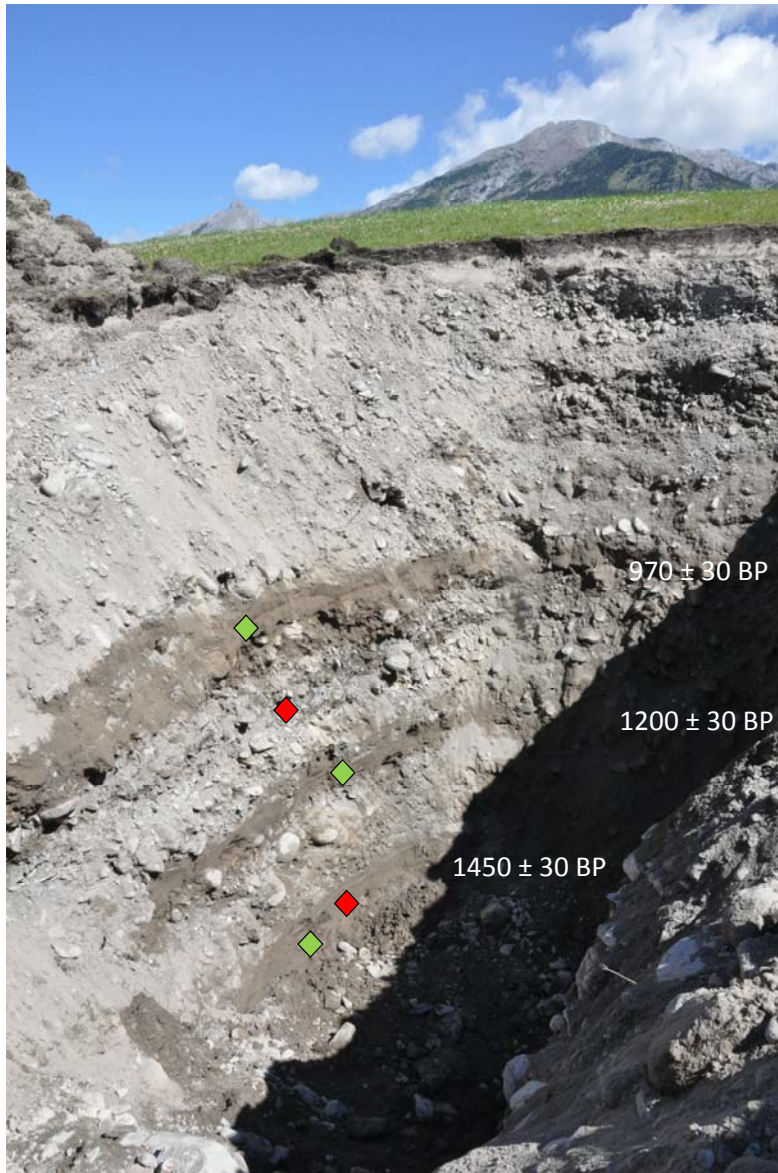
**TEST PIT # BGC-TP-41**

3.79	4.22	UNIT 8: DEBRIS FLOOD Same as Unit 4	-
4.22	4.42	UNIT 9: PALEOSOL Organic layer at 4.30 m, discontinuous dark brown to black in fine silty sands [Seen in west trench face only]	1450 ± 30 BP

Sample	Depth (mbgs)	Date
◆ BGC-TP-41 Unit 5	2.8	970 ± 30 BP
◆ BGC-TP-41 Unit 6	3.20	-
◆ BGC-TP-41 Unit 7	3.65	1200 ± 30 BP
◆ BGC-TP-41 Unit 9	4.3	-
◆ BGC-TP-41 Unit 9	4.3	1450 ± 30 BP

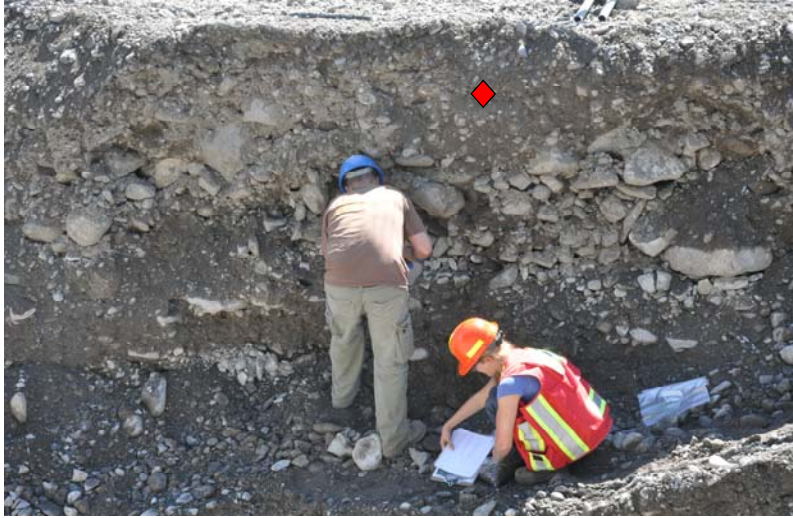
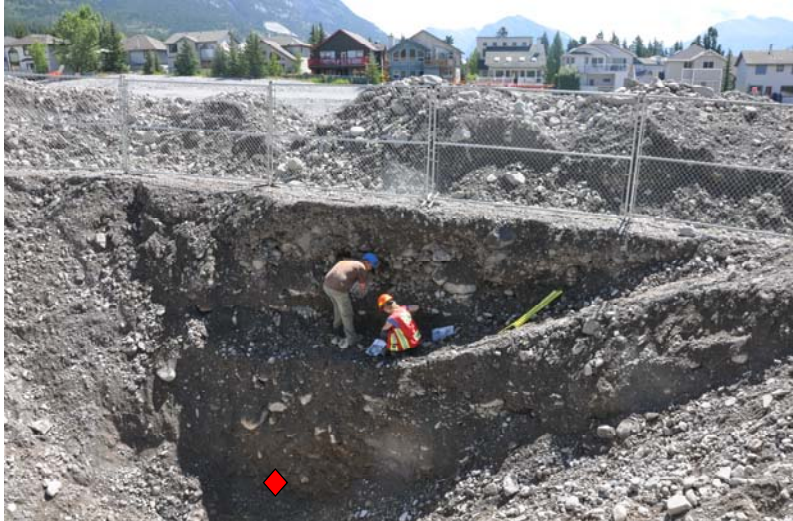
### TEST PIT # BGC-TP-46

Depth From (mbgs)	Depth To (mbgs)	Lithologic Description
0	1.3	UNIT 1: DEBRIS FLOOD June 2013 event, matrix supported debris flood, poorly graded, concrete slabs from pathway, Dmax=50cm
1.3	2.8	UNIT 2: DEBRIS FLOOD Matrix supported, sandy gravels, subangular to subrounded
2.8	2.9	UNIT 3: FLOOD Clast supported gravel, sunrounded to subangular, Dmax=10cm
2.9	4.3	UNIT 4: DEBRIS FLOOD Same as Unit 2, Dmax=50cm

Sample	Depth (mbgs)
◆ BGC-TP-46 Unit 1	0.65
◆ BGC-TP-46 Unit 4	3.6

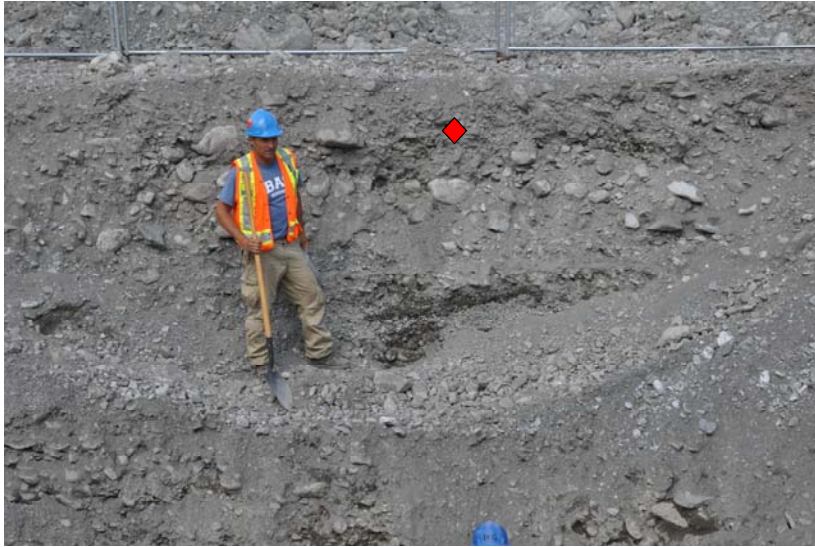
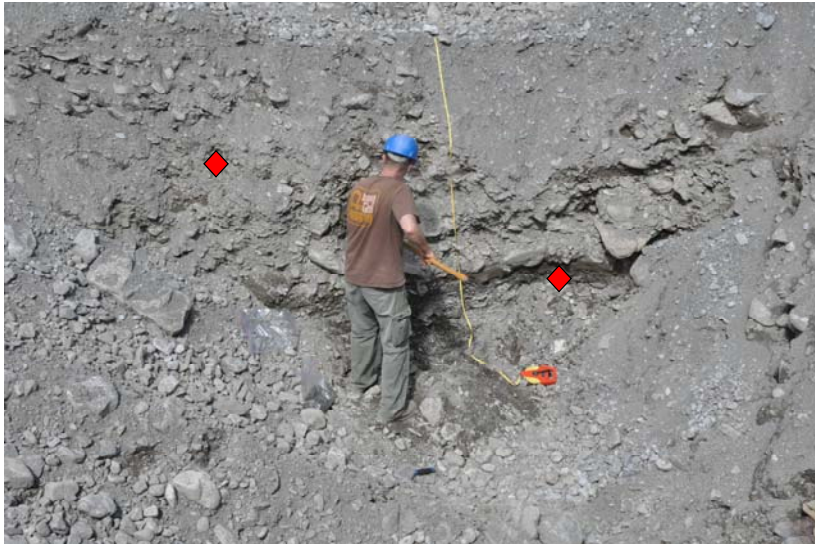
**TEST PIT # BGC-TP-47**

<b>Depth From (mbgs)</b>	<b>Depth To (mbgs)</b>	<b>Lithologic Description</b>
0	1.6	UNIT 1: DEBRIS FLOOD Dmax=40cm, June 2013 event, matrix supported, fine to medium sand matrix, no imbrication
1.6	2.3	UNIT 2: FLOOD Clast supported, flood event, pea to gravel size clast, Dmax=10cm
2.3	3.9	UNIT 3: DEBRIS FLOOD Matrix supported, fine to medium sands, massive with slight imbrication at bottom of deposit (flow in south west direction)), Dmax=50cm
3.9	4.35	UNIT 4: FLOOD Developing paleosol at top of unit, evidence of clast supported fluvial deposits beneath, Dmax=15cm, poorly developed pea to gravel sized lenses, some slight imbrication

Sample	Depth (mbgs)
◆ BGC-TP-47 Unit 1	0.8
◆ BGC-TP-47 Unit 3	3.1
◆ BGC-TP-47 Unit 4	3.95

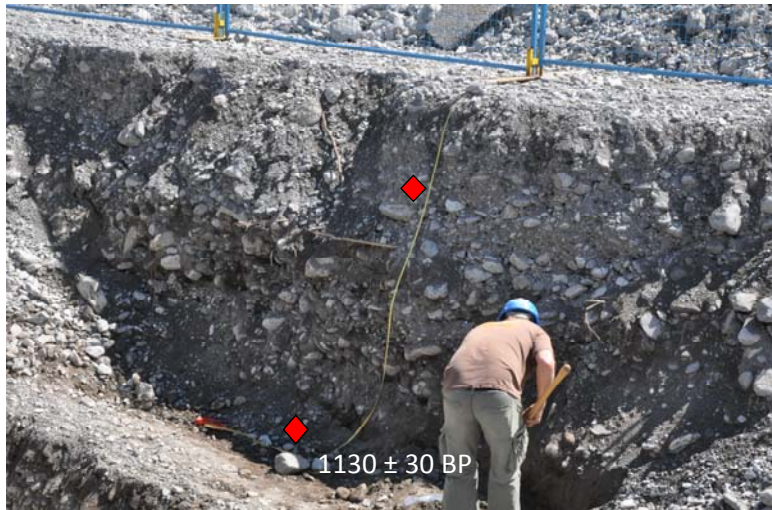
**TEST PIT # BGC-TP-48**

Depth From (mbgs)	Depth To (mbgs)	Lithologic Description	Date
0	1.1	UNIT 1: DEBRIS FLOOD June 2013 debris flood deposit, massive matrix supported, Dmax=40cm, subangular to subrounded, medium to coarse sand matrix (may be reintroduced material when backfilled)	-
1.1	2	UNIT 2: DEBRIS FLOOD Modern rootlets present, top of unit is pre 2013 flood surface, predominantly massive, some indication of slight imbrication, fine to medium sand matrix, Dmax=30cm	-
2	2.3	UNIT 3: PALEOSOL Silty sandy, inconsistent organic deposits, weakly developed horizons	1130 ± 30 BP
2.3	4.3	UNIT 4: DEBRIS FLOOD Matrix supported, subangular to subrounded, Dmax=40cm, gravel lenses, no imbrication	-
4.3	4.4	UNIT 5: PALEOSOL Fine sand with slight oxidation and organic matter	1770 ± 30 BP
4.4	4.6	UNIT 6: DEBRIS FLOOD	-

Sample	Depth (mbgs)	Date
◆ BGC-TP-48 Unit 1	0.5	-
◆ BGC-TP-48 Unit 3	2.15	-
◆ BGC-TP-48 Unit 3	2.15	1130 ± 30 BP
◆ BGC-TP-48 Unit 5	4.35	1770 ± 30 BP

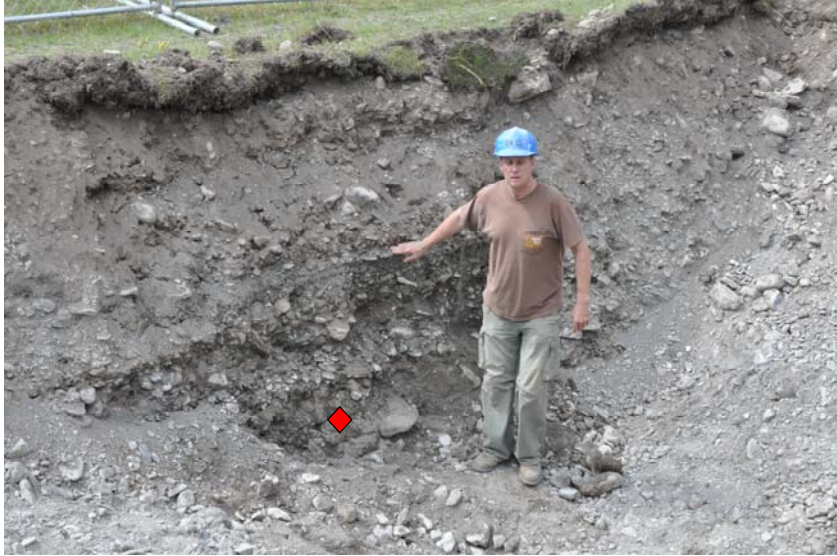
### TEST PIT # BGC-TP-9

Depth From (mbgs)	Depth To (mbgs)	Lithologic Description
0	1	UNIT 1: FILL Disturbed backfill material, lots of rootlets
1	1.3	UNIT 2: FLOOD Clast supported matrix, coarse sands to gravels, Dmax=15cm, may just be lens, subangular to subrounded
1.3	2.1	UNIT 3: DEBRIS FLOOD Massive, no imbrication, matrix supported medium to coarse grained sands, Dmax=30cm, finer sands approaching bottom
2.1	3.1	UNIT 4: FLOOD Loose, clast supported pockets within a predominantly matrix supported unit, Dmax=30cm, pea to gravel size, matrix is medium grained sand, subrounded
3.1	4	UNIT 5: DEBRIS FLOOD Dmax=40cm, matrix supported medium course sand matrix

Sample	Depth (mbgs)
◆ BGC-TP-9 Unit 3	1.7

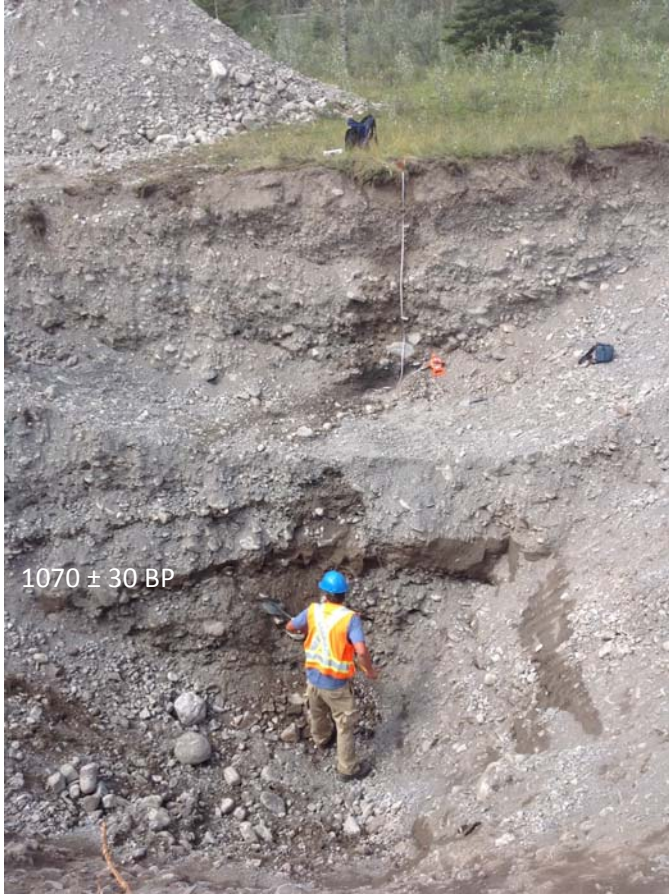
**TEST PIT # BGC-TP-20**

Depth From (mbgs)	Depth To (mbgs)	Lithologic Description	Date
0	0.4	UNIT 1 Overbank deposit, silty sand	-
0.4	1	UNIT 2: FLUVIAL Clast supported, Dmax=15cm, subangular, subrounded, rounded	-
1	1.65	UNIT 3: DEBRIS FLOOD Dmax=30cm, massive, matrix supported, medium to coarse sand matrix, rootlets	-
1.65	2.25	UNIT 4: DEBRIS FLOOD Same as Unit 3	-
2.25	2.65	UNIT 5: FLUVIAL Cleaner than Unit 2, coarser grained sands, clast supported, imbricated, Dmax=30cm	-
2.65	3.15	UNIT 6: DEBRIS FLOOD Matrix supported debris flow deposit, subangular to subrounded, Dmax=30cm	-
3.15	3.35	UNIT 7: PALEOSOL Peat lenses, contorted, continuous	1070 ± 30 BP
3.35	4.35	UNIT 8: DEBRIS FLOOD matrix supported debris flood deposit, Dmax=225cm, loose to compact, subrounded	-

Sample	Depth (mbgs)	Date
◆ BGC-TP-20 Unit 7	3.25	1070 ± 30 BP
◆ BGC-TP-20 8	3.85	-

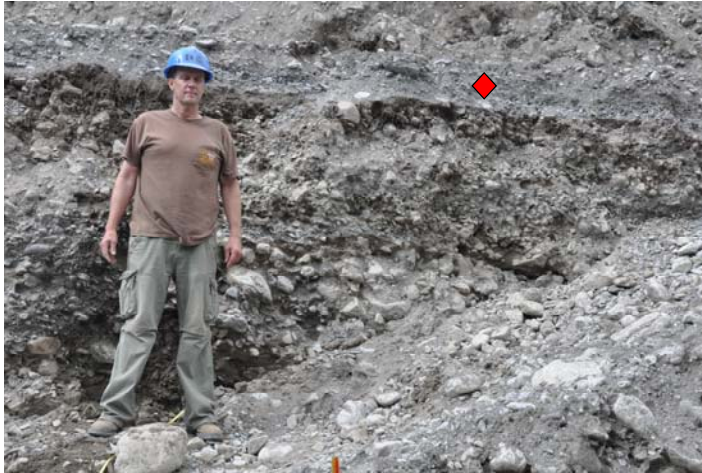
**TEST PIT # BGC-TP-30**

1.8	3.7	UNIT 6: DEBRIS FLOOD Transitional debris flood, loose sandy gravel with some boulders, matrix to clast supported, majority clast supported, distal debris flood deposit	1570 ± 30 BP

3.7	3.95	UNIT 7 Fine sand flood/ overbank deposit	-
3.95	4.15	UNIT 8 Fluvial gravel, Dmax=25cm	-
4.15	4.45	UNIT 9 Fluvial sands	1650 ± 30 BP
4.45	4.65	UNIT 10: DEBRIS FLOOD	-

Sample	Depth (mbgs)	Date
◆ BGC-TP-30 Unit 1	0.2	-
◆ BGC-TP-30 Unit 6	2.6	1570 ± 30 BP
◆ BGC-TP-30 Unit 9	4.3	-
◆ BGC-TP-30 Unit 9	4.15	1650 ± 30 BP

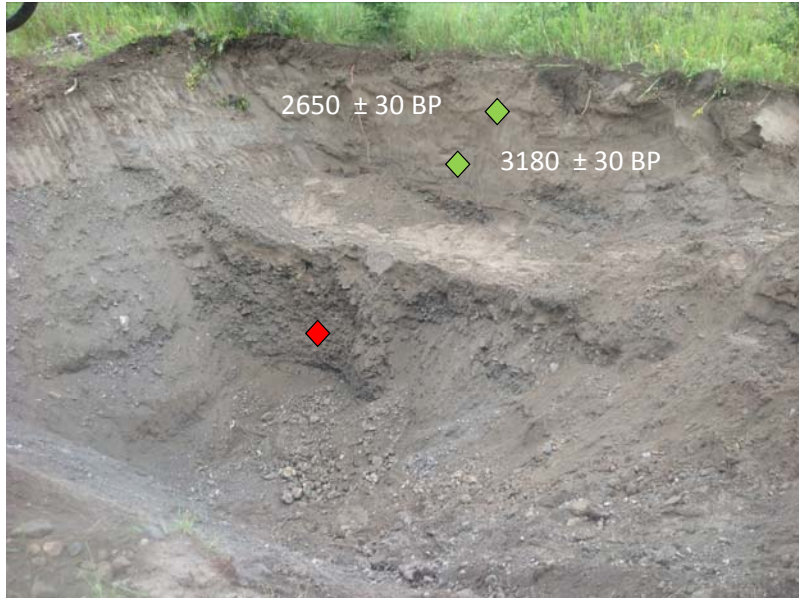
**TEST PIT # BGC-TP-13**

1.05	1.3	UNIT 5 Same medium grained lenses as Unit 2, wavy sand lenses	3180 ± 30 BP
1.3	1.5	UNIT 6 Predominantly sand and gravel with traces of silty sandy lenses, D <sub>max</sub> =5cm	-

1.5	1.55	UNIT 7: PALEOSOL Same as Unit 2	-
1.55	1.6	UNIT 8	-
1.6	2.5	UNIT 9: FLUVIAL Clast supported, sandy gravels, D <sub>max</sub> =10cm	-
2.5	3.5	UNIT 10: FLUVIAL Clast supported, fluvial gravel, less coarse than Unit 9, mild imbrication	-

Sample	Depth (mbgs)	Date
◆ BGC-TP-13 Unit 2	0.4	2650 ± 30 BP
◆ BGC-TP-13 Unit 5	1.15	3180 ± 30 BP
◆ BGC-TP-13 Unit 10	3.0	-

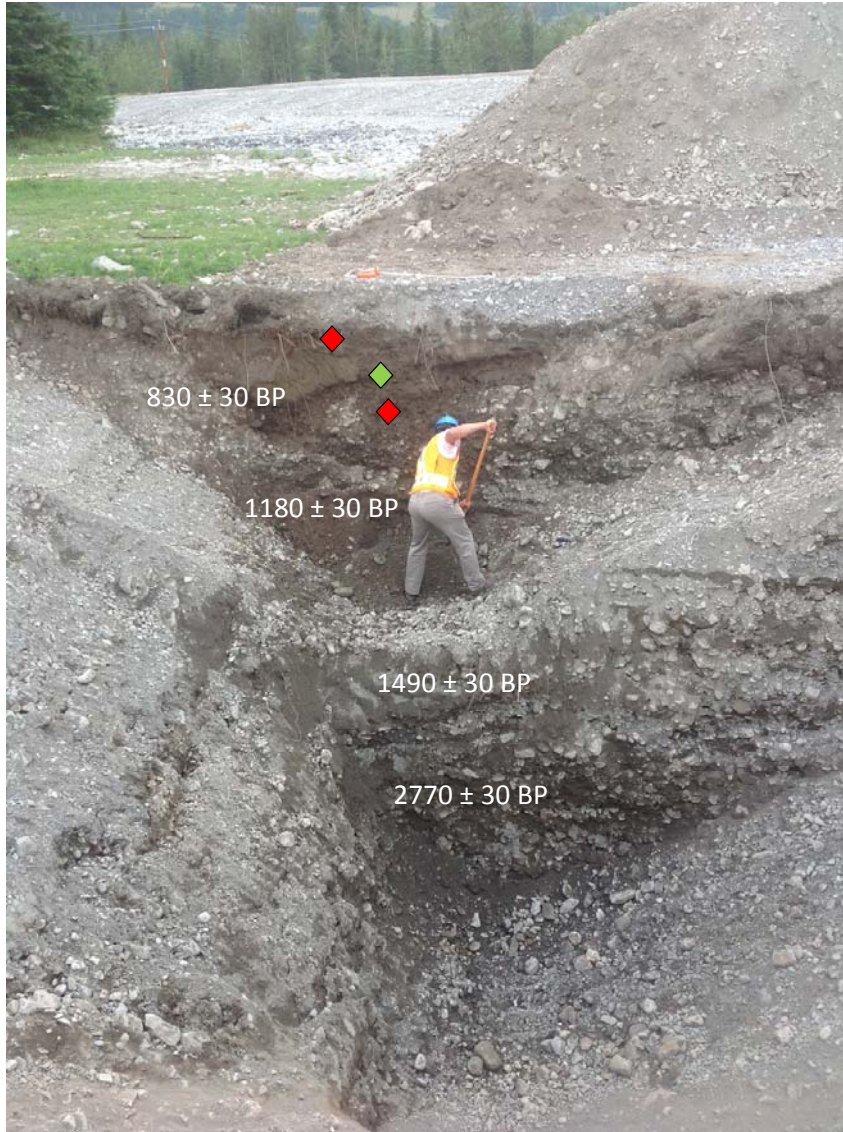
**TEST PIT # BGC-TP-21**

0.75	0.85	UNIT 3: PALEOSOL Silty sandy paleosol, lots of rootlets present, wavy contact	830 ± 30 BP
0.85	2	UNIT 4: DEBRIS FLOOD Debris flood and transitional debris flood zone, variable matrix, medium sand to granular matrix, Dmax=20cm	-
2	2.3	UNIT 5: PALEOSOL Weakly developed paleosol or oxidized overflow	1180 ± 30 BP

2.3	4	UNIT 6: DEBRIS FLOOD/ FLOOD Sandy gravels, interbedded units of matrix supported debris flood deposits and clast supported flood deposits, individual events cannot be distinguished, Dmax=20cm, abundant organics, weakly oxidized paleosol between fluvial gravels (weakly developed), east and west pit wall are different	1490 ± 30 BP 2770 ± 30 BP
4	4.7	UNIT 7: DEBRIS FLOOD Matrix supported debris flood deposit, subangular rocks, no imbrication, Dmax=10-15cm	-

Sample	Depth (mbgs)	Date
◆ BGC-TP-21 Unit 2	0.6	-
◆ BGC-TP-21 Unit 3	0.8	830 ± 30 BP
◆ BGC-TP-21 Unit 4	1.75	-
◆ BGC-TP-21 Unit 5	2.05	1180 ± 30 BP
◆ BGC-TP-21 Unit 6	2.7	1490 ± 30 BP
◆ BGC-TP-21 Unit 6	3.8	2770 ± 30 BP

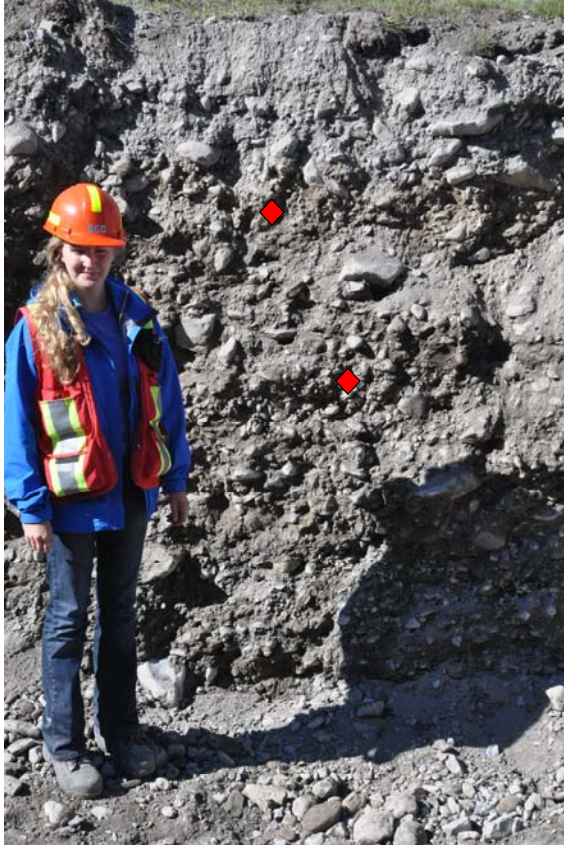
**TEST PIT # BGC-TP-38**

1.6	3	UNIT 4: DEBRIS FLOOD Generally unsorted with gravel sized lenses (poorly developed 40 cm across by 4 cm thick), Dmax=19cm, subangular to subrounded, matrix supported	-
3	3.2	UNIT 5: FLOOD Clast supported subrounded gravel, slight imbrication, loose, Dmax=15cm	-

3.2	3.75	DEBRIS FLOOD Same as Unit 4	-
3.75	3.8	UNIT 6: PALEOSOL Organic rich silty sands overplayed by fine sands, dark brown to black, overlying reddish ochre coloured silty sands	570 ± 30 BP

3.8	4	UNIT 7: DEBRIS FLOOD Same as Unit 4	-

Sample	Depth (mbgs)	Date
◆ BGC-TP-38 Unit 2	0.7	-
◆ BGC-TP-38 Unit 2	0.95	0 ± 30 BP
◆ BGC-TP-38 Unit 3	1.3	-
◆ BGC-TP-38 Unit 6	3.8	570 ± 30 BP
