BGC Project Memorandum

To:	Town of Canmore	Doc. No.:	TC14-006
Attention:	Felix Camire	cc:	Andy Esarte
From:	Matthias Jakob	Date:	October 14, 2014
Subject:	Bow River – Cougar Creek Sedimentation Considerations		
Project No.:	1261-012

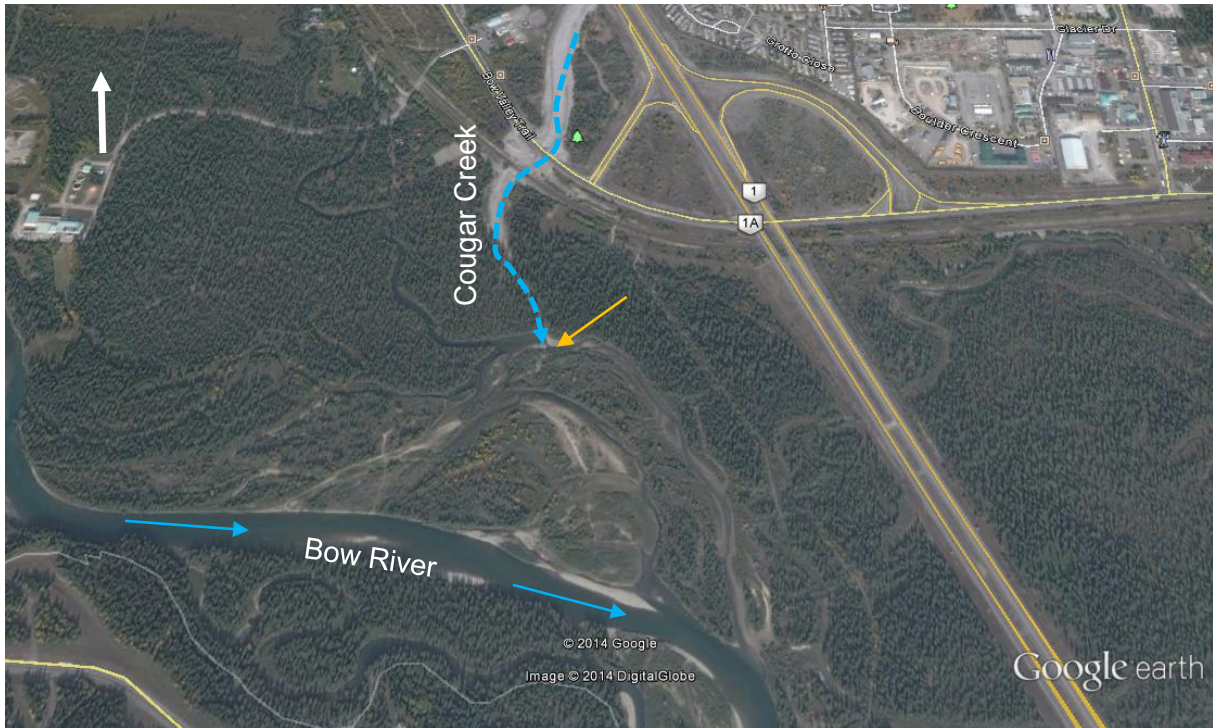
Figure 2-1. Confluence of Cougar Creek with Bow River floodplain. The orange arrow shows the point of confluence. Image Google Earth.

The confluence of Cougar Creek with the Bow River occurs on an almost 1 km wide portion of the Bow River floodplain. Cougar Creek does not directly discharge into the main channel Bow River, but instead connects via side channels approximately 340 m north of the main river, and immediately downstream of the confluence with Policeman Creek (Figure 2-1). At this confluence, a small gravel bar has developed that demonstrates occasional gravel transport into this side channel.

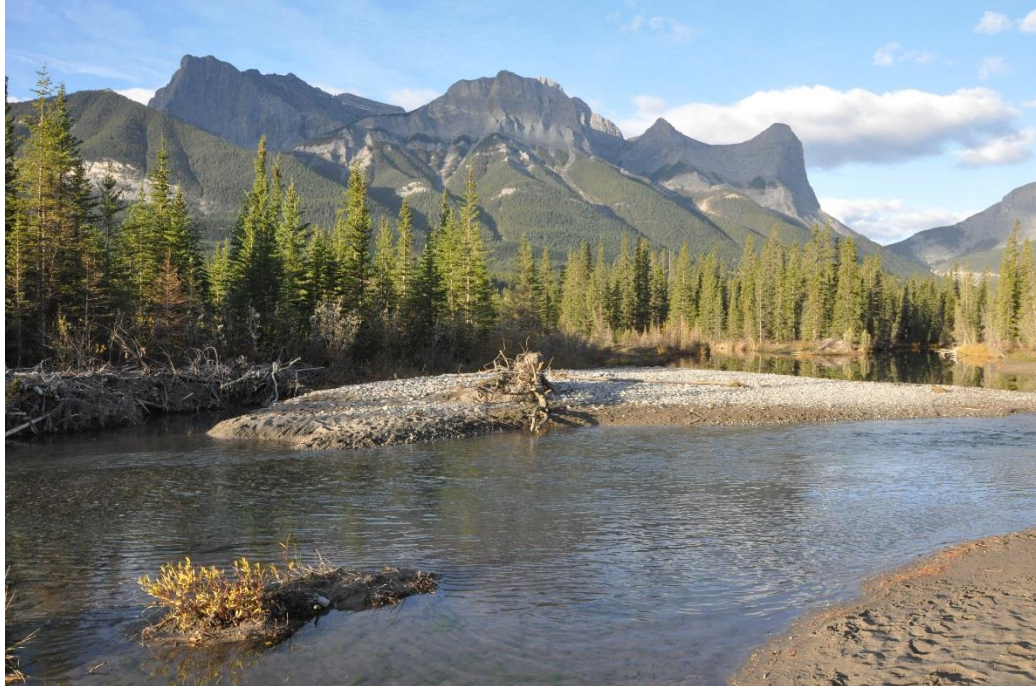
Figure 2-2. Gravel bar on the south side of Policeman Creek at the confluence with Cougar Creek which was likely deposited during the June 2013 debris flood. Photo looking west. BGC photograph of October 7, 2014.

A field visit was conducted on October 7, 2014 by Dr. Matthias Jakob of BGC to view the confluence. Figure 2-2 shows a medial gravel bar on the south side of the side channel (continuation of Policeman Creek) that was deposited during the 2013 event (not visible on the 2008 orthophotos). This gravel bar has persisted to today. It is expected, however, that over time this gravel bar will be eroded during periods of high flow from Bow River and Policeman Creek.

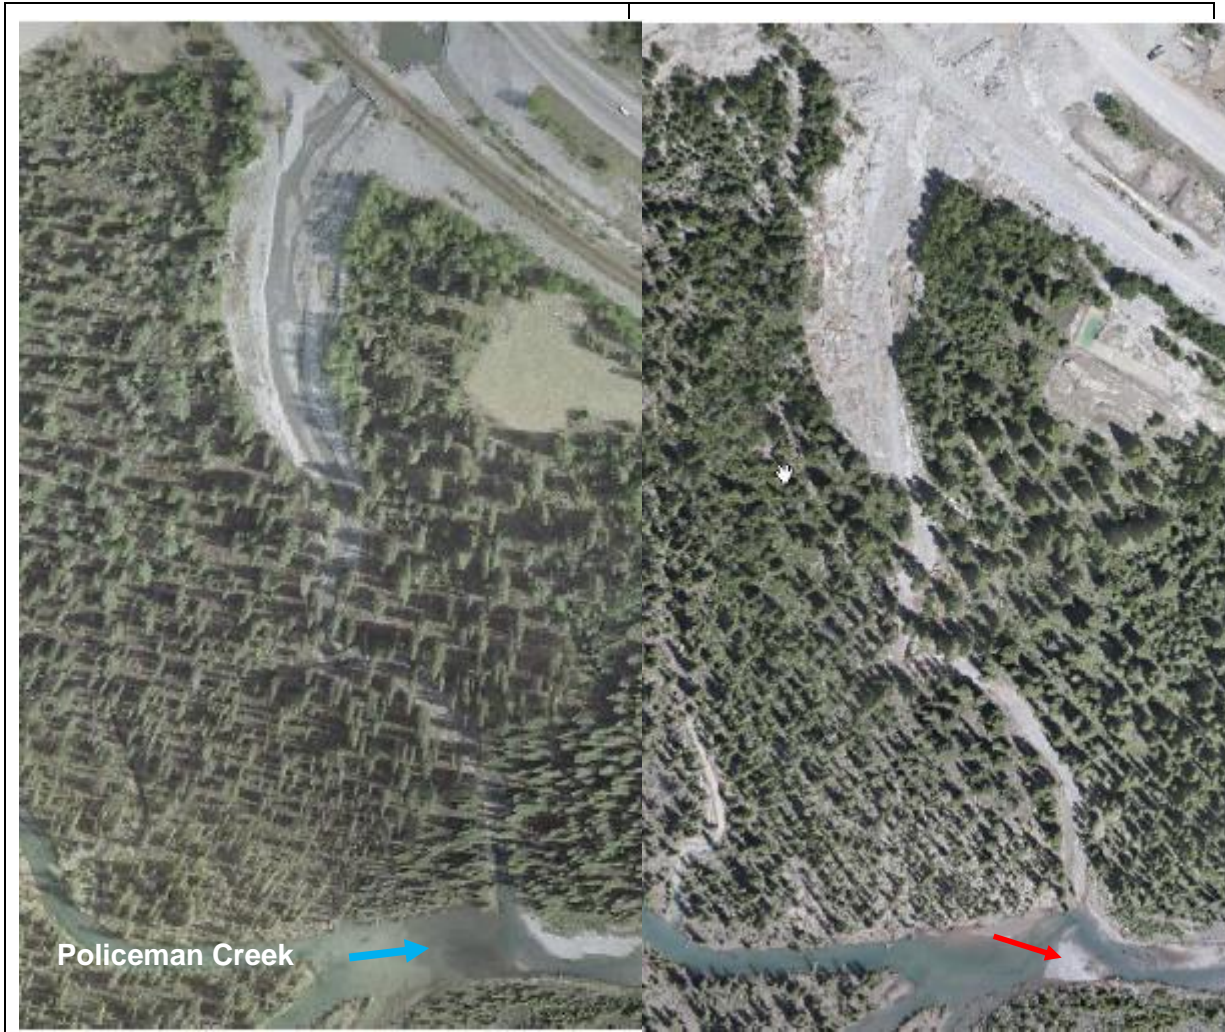
Figure 2-3. Comparison of 2008 (left) and 2013 (right) orthophotos for the area near the confluence of Cougar Creek (coming in from the north) and Policeman Creek. The new gravel bar is shown by a red arrow.

Upstream of the confluence, the channel of Cougar Creek still shows significantly more sediment than visible on 2008 air photographs (Figure 2-3). This material, which is largely between 11 mm to 64 mm in diameter will be transported over time to Policeman Creek. However, upstream between the confluence and the CP Railway (CPR) tracks abundant loose sediment is still present in Cougar Creek, which would also be mobilized during high flows leading to further sedimentation.
