**SPRINGBANK OFF-STREAM RESERVOIR PROJECT
ELBOW RIVER AQUATIC HABITAT ASSESSMENT: REDWOOD MEADOWS TO DISCOVERY RIDGE
(FALL 2019) TECHNICAL DATA REPORT**

Attachment A Elbow River Aquatic Macrohabitat Distribution (Fall 2019)
June 2020

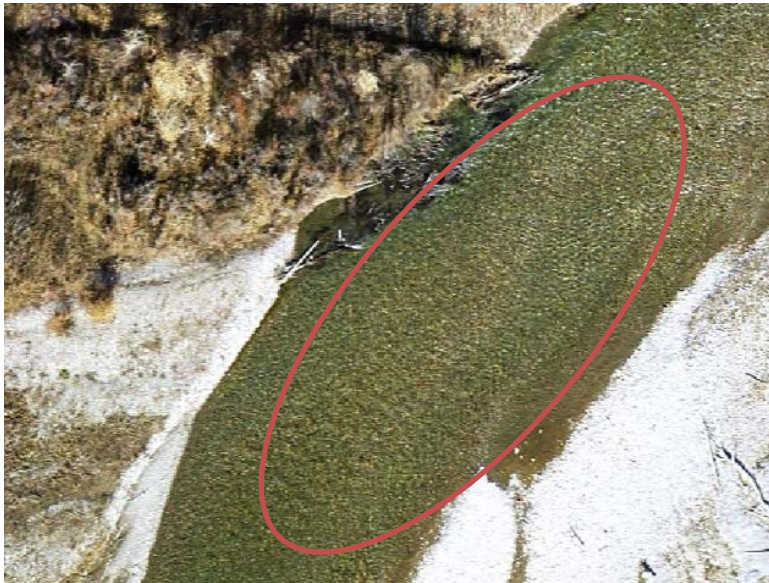
Figure A-1 Fall 2019 Orthoimagery Snapshot of Elbow River Riffle Macrohabitat Unit

Shallow reaches with swiftly flowing, turbulent water sometimes contain partially exposed substrate. Substrates are typically cobble-dominant in the main channel or are smaller substrates (i.e., gravels) within side channels or inactive channels. All riffles identified in the survey are low gradient (less than 4%).

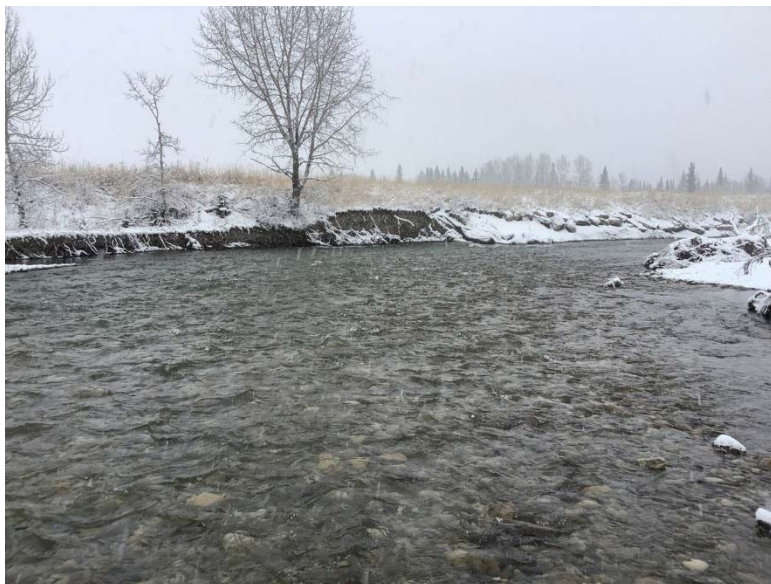
Photo A-1 Fall 2019 photo of Elbow River Riffle Macrohabitat Unit

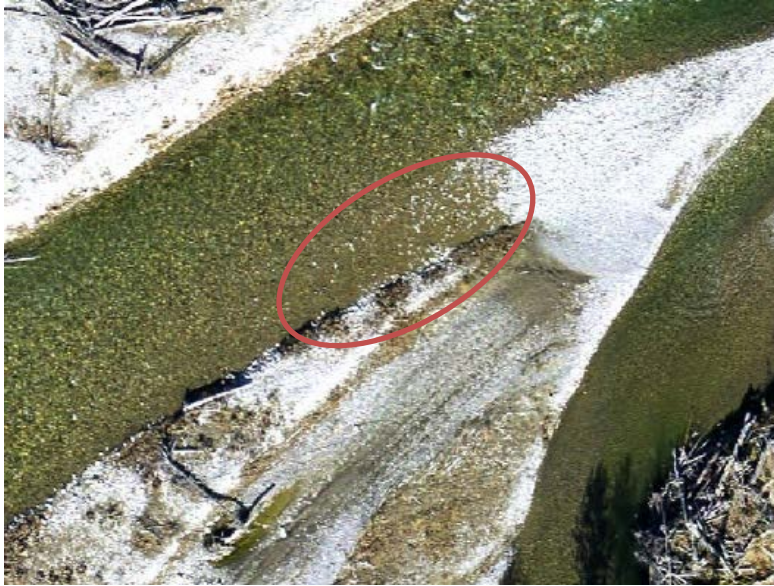
Figure A-2 Fall 2019 Orthoimagery Snapshot of Elbow River Edgewater Macrohabitat Unit

Shallow and still-water habitat are found at the margins of riffles or runs in active channels. Edgewater comprise part of a riffle or run at higher flows, and the presence of coarse substrates (e.g., cobble, gravel) are reflective of seasonal flow dynamics in these macrohabitat areas.

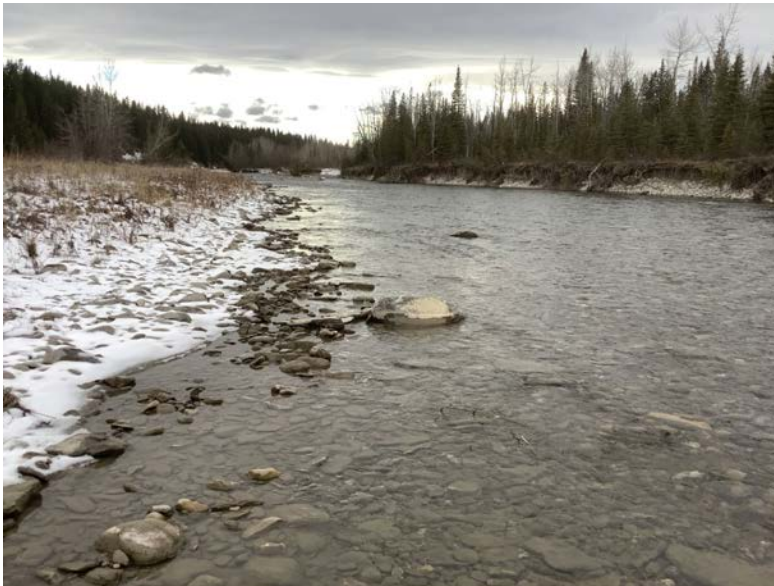
Photo A-2 Fall 2019 photo of Elbow River Edgewater Macrohabitat Unit

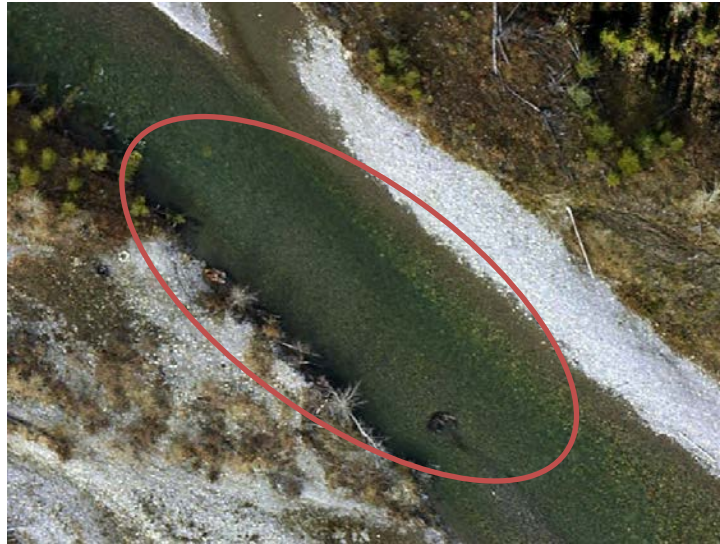
Figure A-3 Fall 2019 Orthoimagery Snapshot of Elbow River Run Macrohabitat Unit

Runs are deep and relatively swift-flowing reaches with little surface agitation compared to riffles and have no major flow obstructions. They can appear as flooded riffles or elongated laterally scoured areas with water considered too swift to be described as pool habitat.

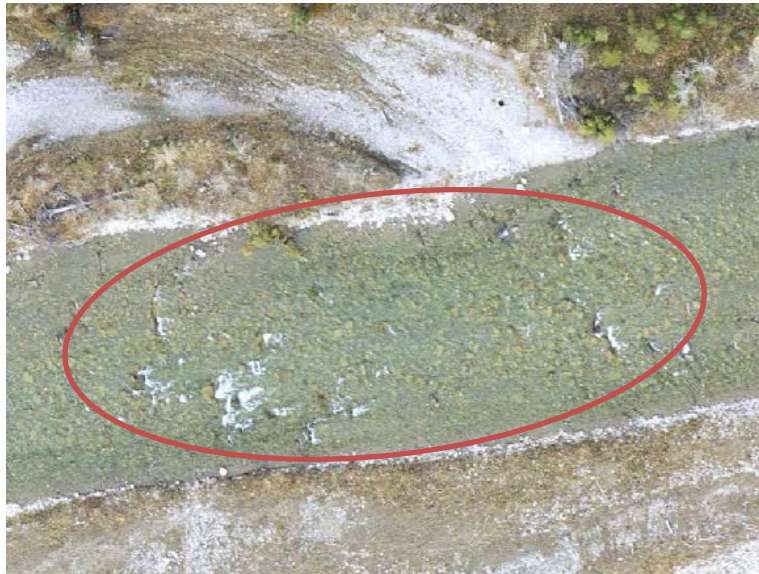
Figure A-4 Fall 2019 Orthoimagery Snapshot of Elbow River Pocket Water Macrohabitat Unit

This is a run habitat containing numerous boulders or other large obstructions that create eddies or scour holes (pockets) behind the obstructions.

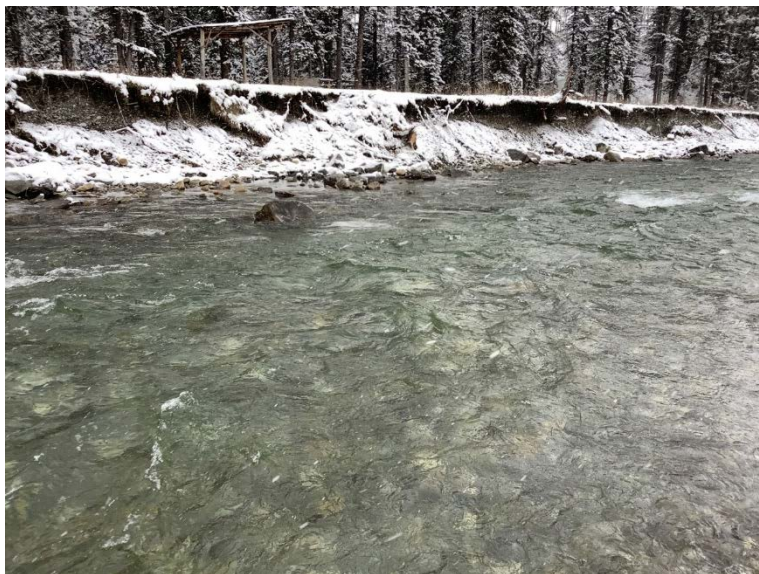
Photo A-4 Fall 2019 Photo of Elbow River Pocket Water Macrohabitat Unit

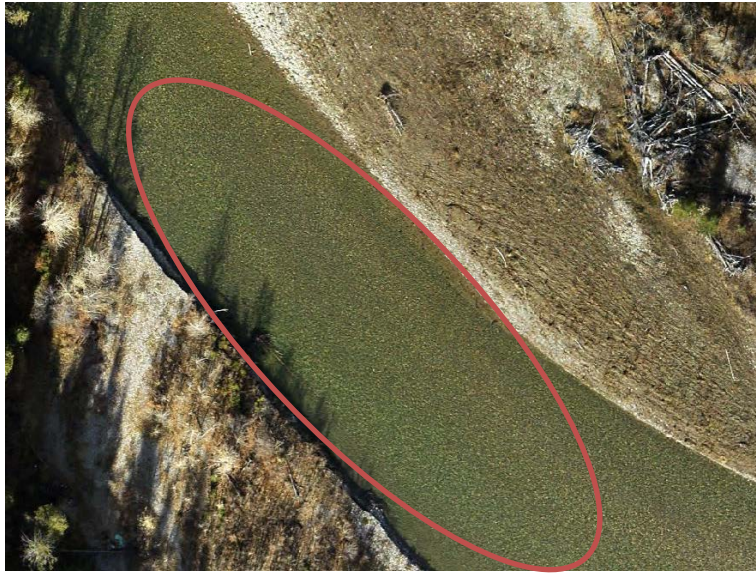
Figure A-5 Fall 2019 Orthoimagery Snapshot of Elbow River Fast Glide Macrohabitat Unit

This refers to a wide and uniform reach with a poorly defined thalweg, usually located downstream of a scoured pool or run macrohabitat unit. Fast glides are associated with high velocities in the main channel, and they are typically characterized as having low or nil embeddedness with significant contributions of coarse substrates, such as cobble or large gravel.

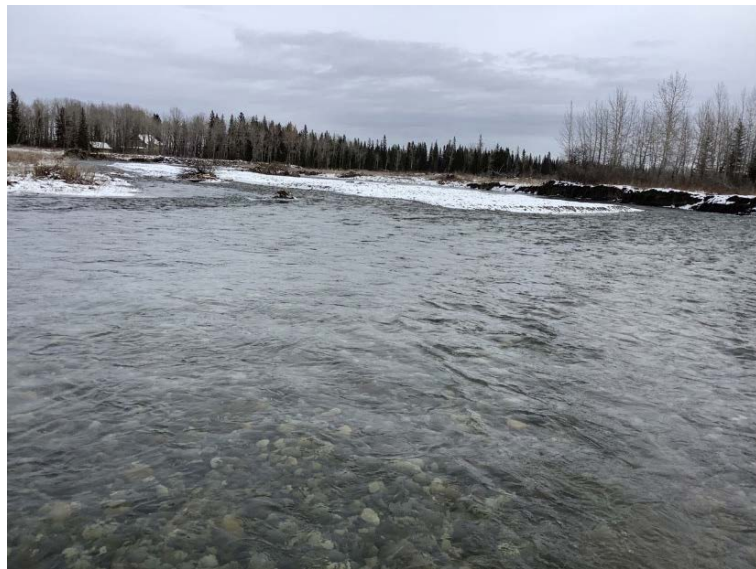
Photo A-5 Fall 2019 Photo of Elbow River Fast Glide Macrohabitat Unit

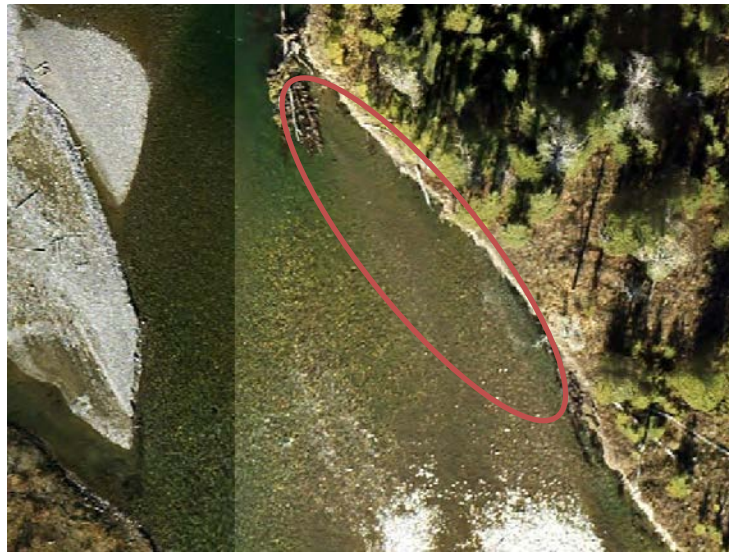
Figure A-6 Fall 2019 Orthoimagery Snapshot of Elbow River Slow Glide Macrohabitat Unit

These are glide sections with lower velocities than fast glides, which is reflected in substrate composition, including a low to medium embeddedness with significant contributions of smaller substrates such as small gravel, sand, or silt. They are distinguished from fast glides based on importance of habitat attributes to redd-constructing salmonids.

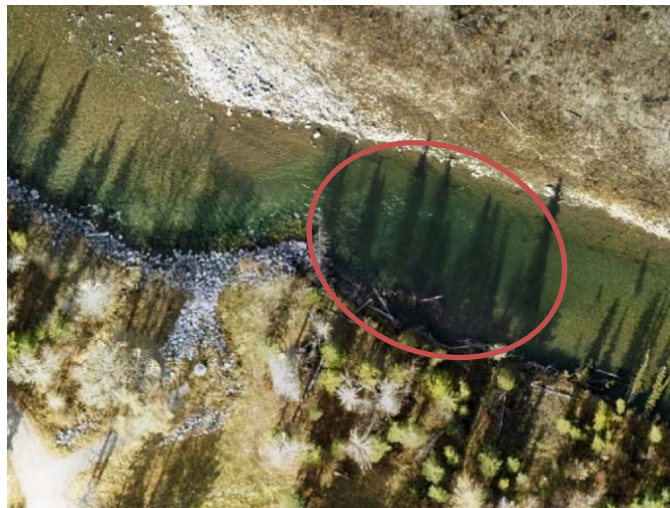
Figure A-7 Fall 2019 Orthoimagery Snapshot of Elbow River Mid-Channel Pool Macrohabitat Unit

These are pools formed by mid-channel scouring of surface water. The scour hole typically encompasses more than 60% of the wetted channel. Water velocity is low, and the substrate is highly variable for mid-channel pools. They often occur immediately downstream of, or within, channel confinements (e.g., debris, bedrock, armouring).

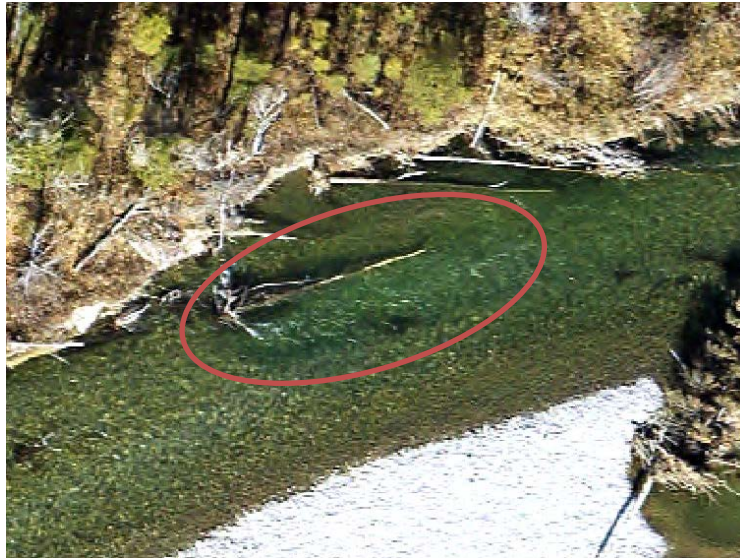
Figure A-8 Fall 2019 Orthoimagery Snapshot of Elbow River Mid-Channel Root-Wad Formed Pool Macrohabitat Unit

These are small mid-channel pools formed through scouring of large woody debris or root wads.

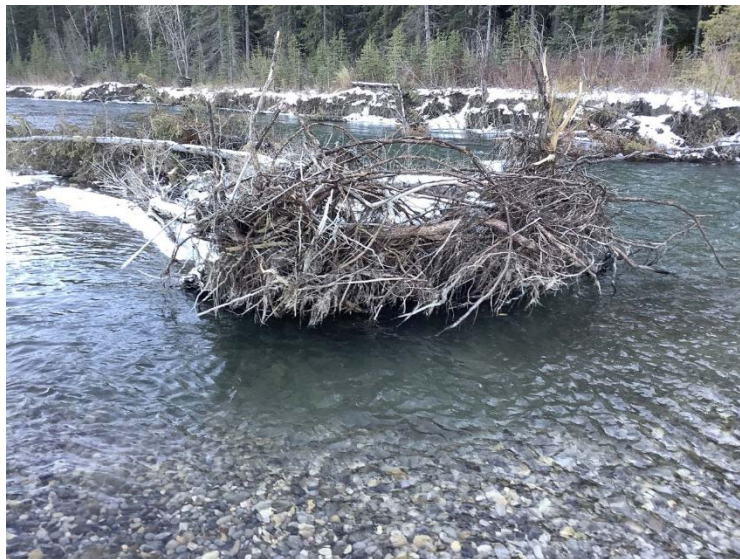
Photo A-8 Fall 2019 Photo of Elbow River Mid-Channel Root-Wad Formed Pool Macrohabitat Unit

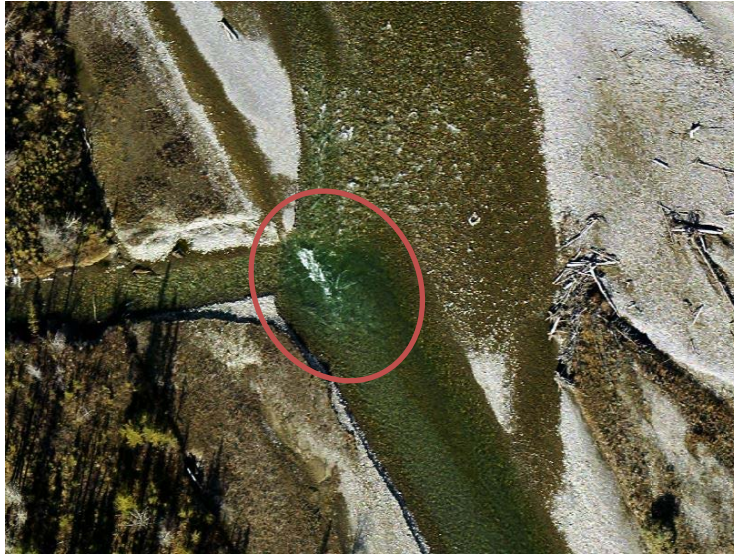
Figure A-9 Fall 2019 Orthoimagery Snapshot of Elbow River Channel Confluence Pool Macrohabitat Unit

These pools formed at the confluence of two or more channels. Scour can be due to plunges, lateral obstructions or scour at the channel intersections. Velocity and turbulence are usually greater than those in other pool types.

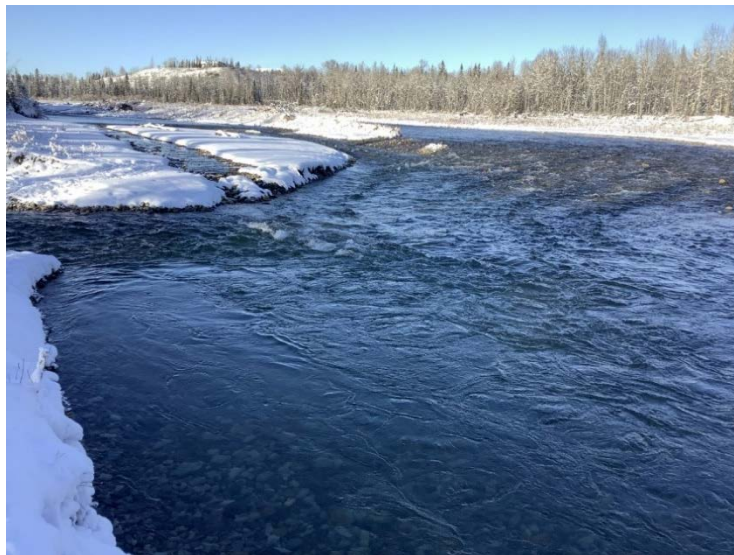
Photo A-9 Fall 2019 Photo of Elbow River Mid-Channel Channel Confluence Pool Macrohabitat Unit

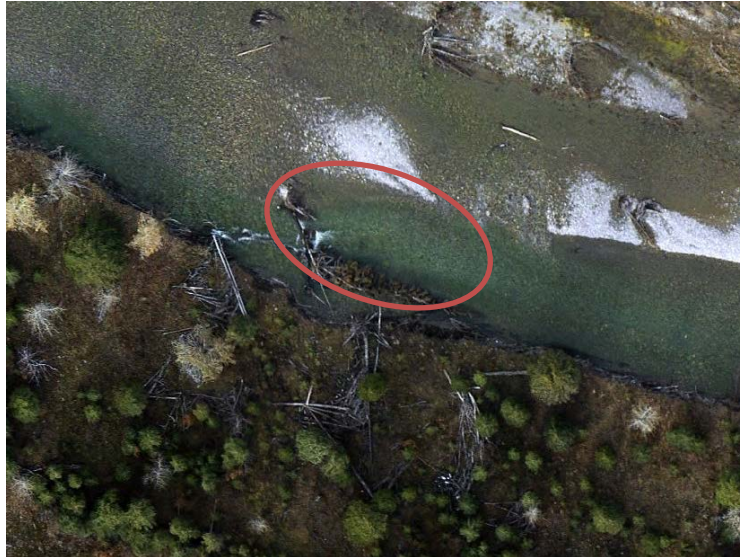
Figure A-10 Fall 2019 Orthoimagery Snapshot of Elbow River Channel Confluence Pool Macrohabitat Unit

These are found where surface water plunges over a channel obstruction (e.g., bedrock ledge, log jam) into the streambed below, scouring a depression. They are often large and deep. In disconnected channels, plunge pools are present at the upstream end of the channel where flood waters have plunged from the surrounding flood plain into the channel.

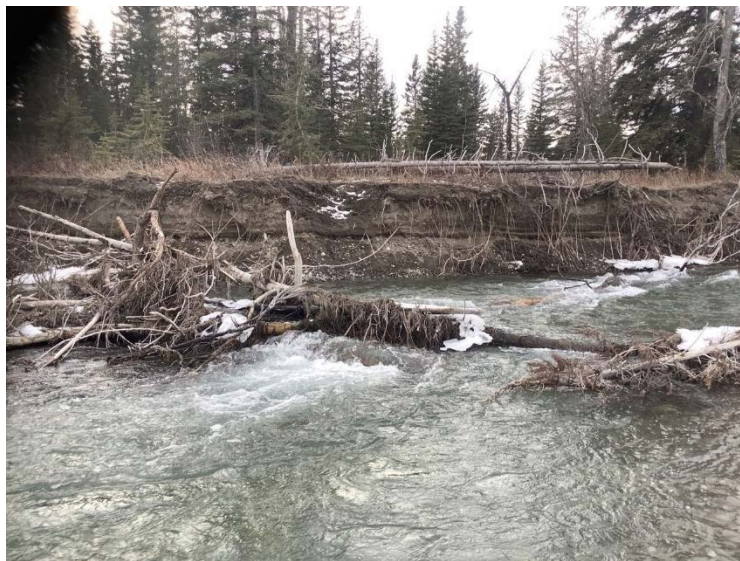
Photo A-10 Fall 2019 Photo of Elbow River Mid-Channel Channel Confluence Pool Macrohabitat Unit

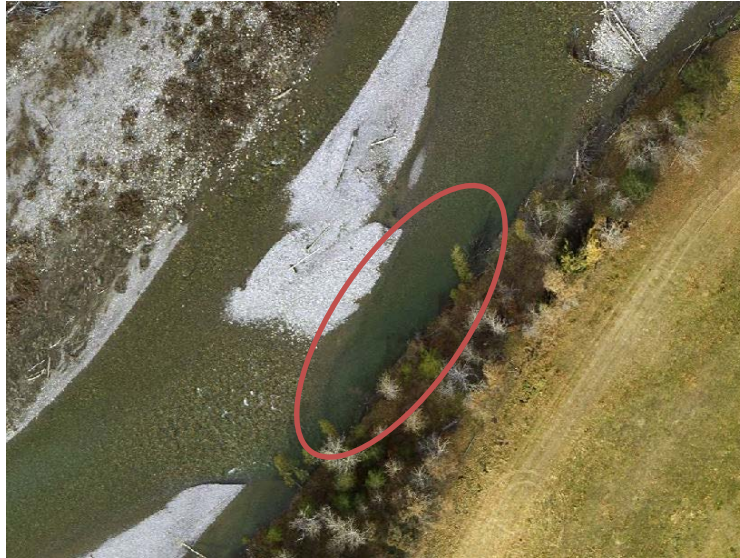
Figure A-11 Fall 2019 Orthoimagery Snapshot of Elbow River Lateral Scour Pool Macrohabitat Unit

These are formed at the outside meander bend of a channel, and they are formed in alluvial banks and lack woody debris enhancement.

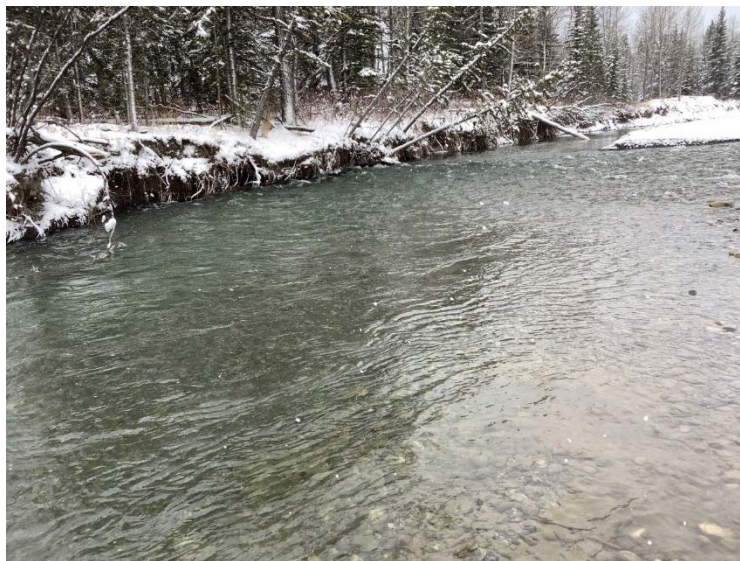
Photo A-11 Fall 2019 Photo of Elbow River Lateral Scour Pool Macrohabitat Unit

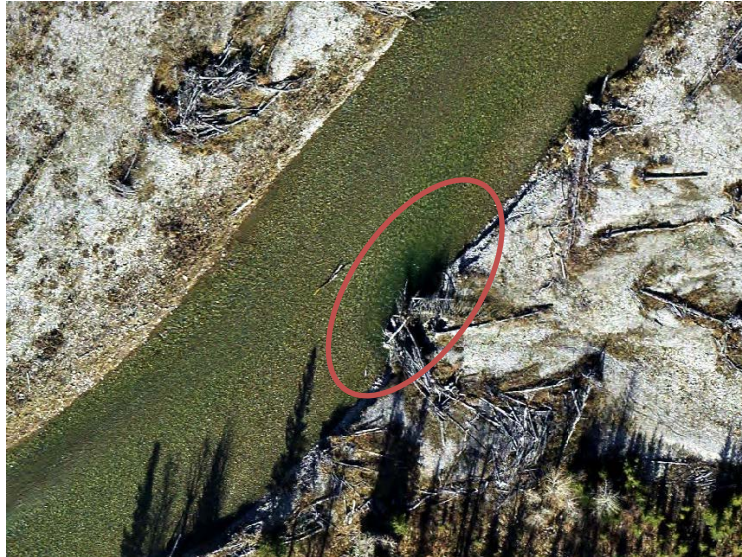
Figure A-12 Fall 2019 Orthoimagery Snapshot of Elbow River Log-Enhanced Lateral Scour Pool Macrohabitat Unit

These are formed by surface waters impinging against a partial channel obstruction consisting of large woody debris. The associated scour is generally confined to less than 60% of the wetted channel width.

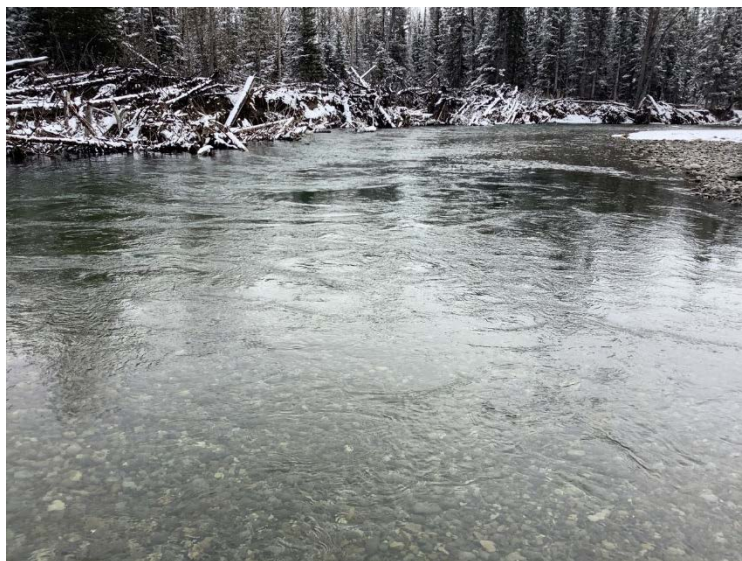
Photo A-12 Fall 2019 Photo of Elbow River Log-Enhanced Lateral Scour Pool Macrohabitat Unit.

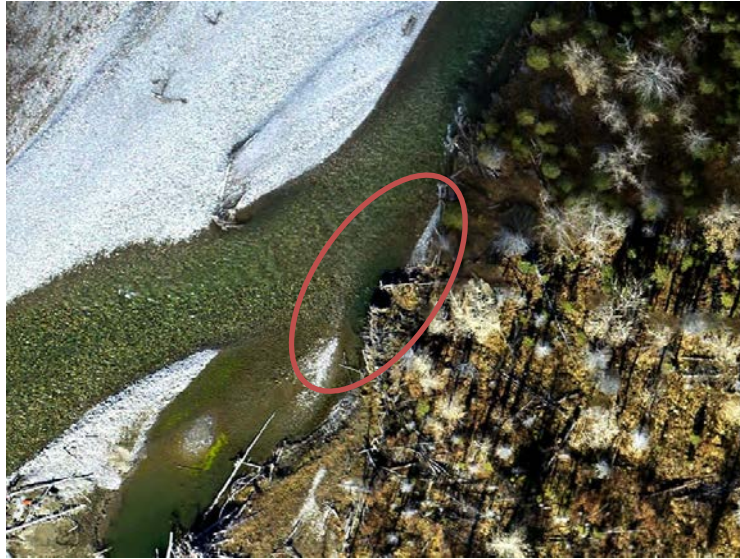
Figure A-13 Fall 2019 Orthoimagery Snapshot of Elbow River Root-Wad Enhanced Lateral Scour Pool Macrohabitat Unit

These are lateral scour pools formed by surface waters impinging against a partial channel obstruction consisting of a root wad. The associated scour is generally confined to less than 60% of the wetted channel width.

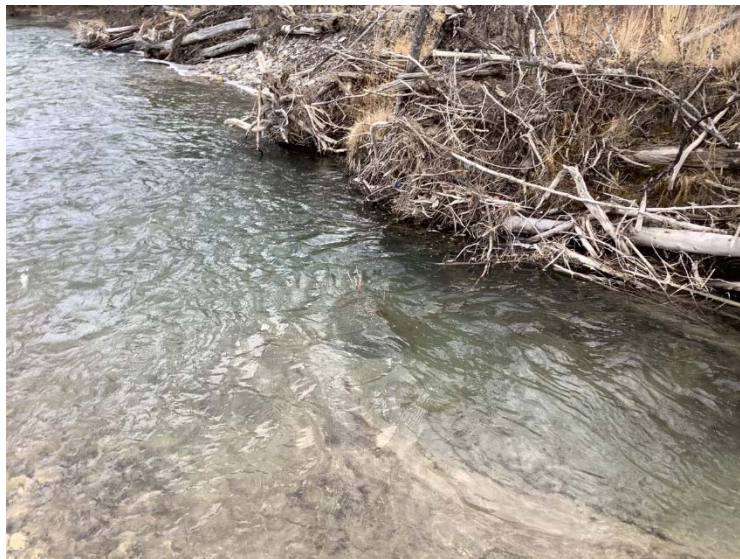
Photo A-13 Fall 2019 Photo of Elbow River Root-Wad Enhanced Lateral Scour Pool Macrohabitat Unit

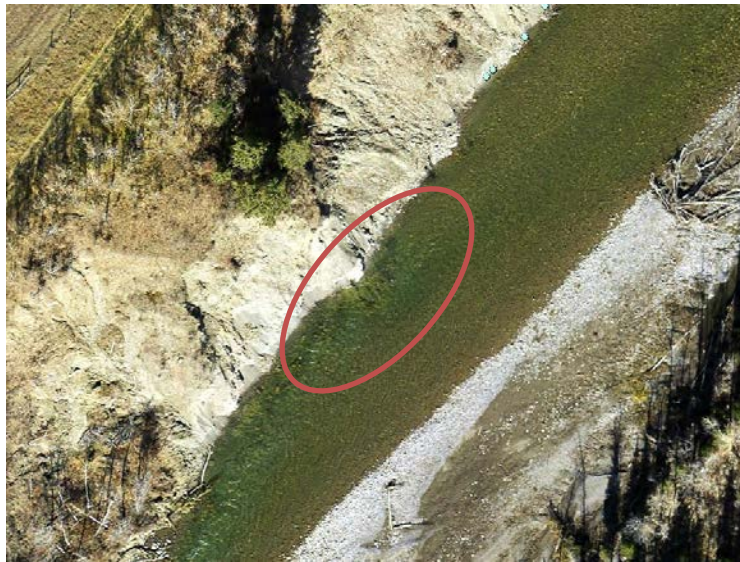
Figure A-14 Fall 2019 Orthoimagery Snapshot of Elbow River Bedrock-Formed Lateral Scour Pool Macrohabitat Unit

These are lateral scour pools formed by surface waters impinging against a bedrock stream bank. The associated scour is generally confined to less than 60% of the wetted channel width.

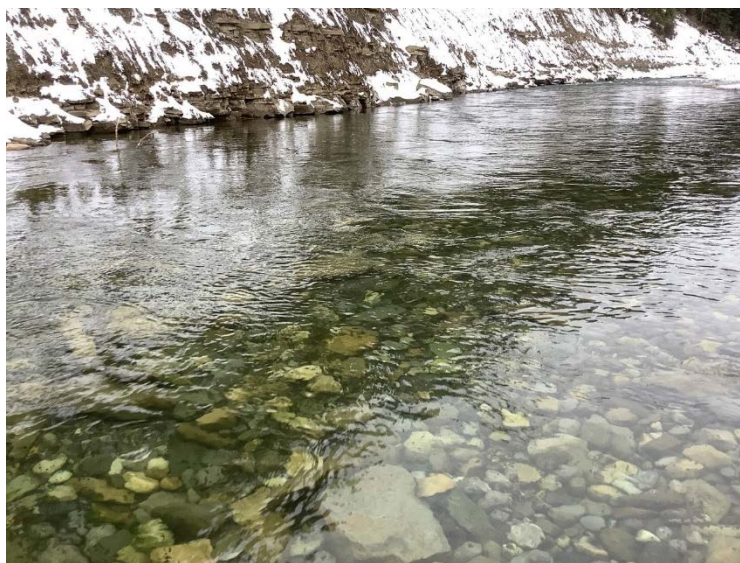
Photo A-14 Fall 2019 Photo of Elbow River Bedrock-Formed Lateral Scour Pool Macrohabitat Unit

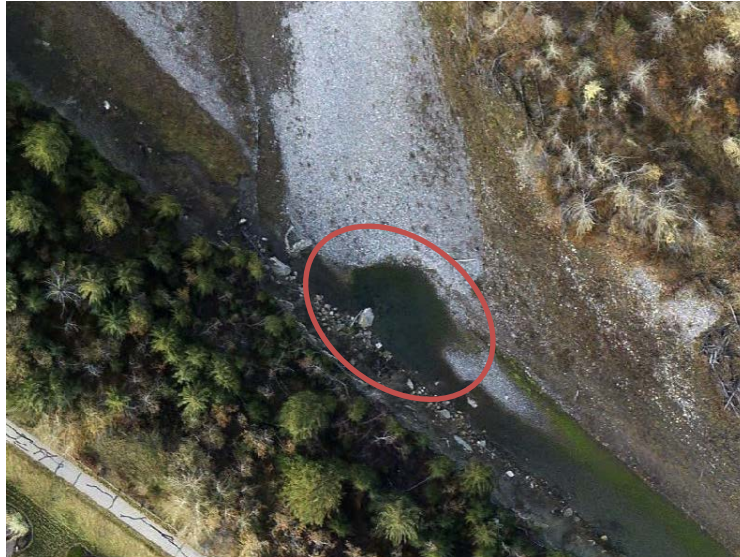
Figure A-15 Fall 2019 Orthoimagery Snapshot of Elbow River Boulder-Formed Lateral Scour Pool Macrohabitat Unit

These are lateral scour pools formed by surface waters impinging against partial channel obstructions consisting of a boulder or boulders. The associated scour is generally confined to less than 60% of the wetted channel width.

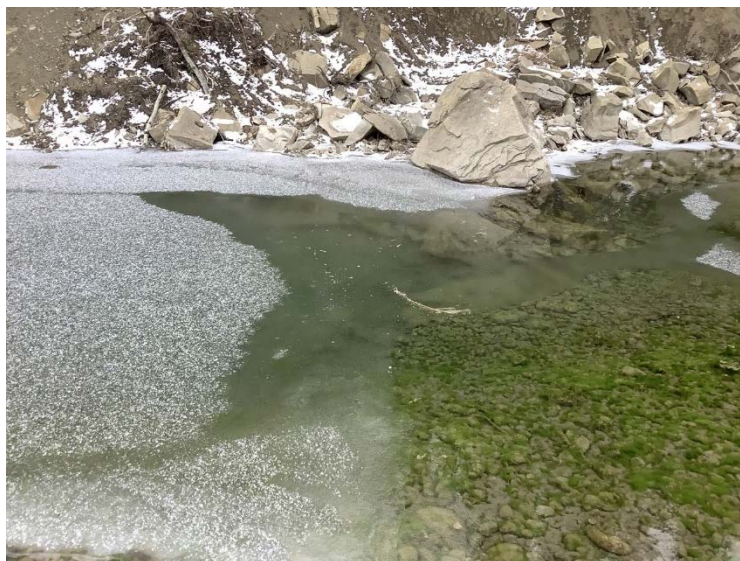
Photo A-15 Fall 2019 Photo of Elbow River Boulder-Formed Lateral Scour Pool Macrohabitat Unit

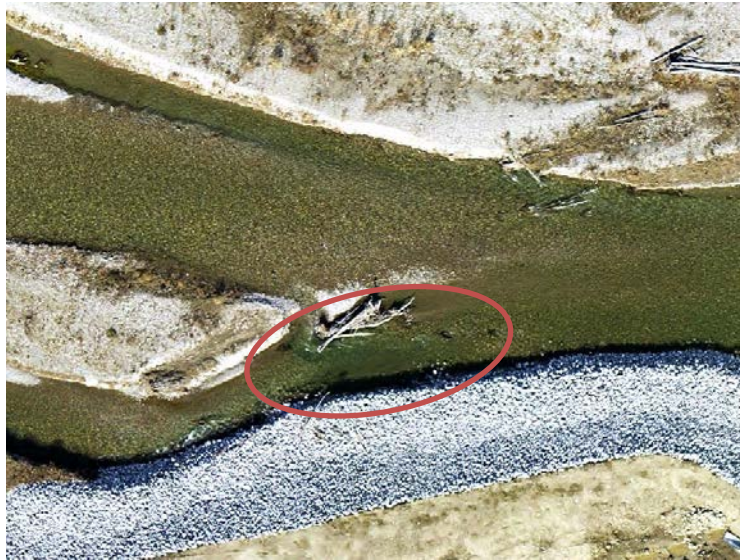
Figure A-16 Fall 2019 Orthoimagery Snapshot of Elbow River Armoured Bank Lateral Scour Pool Macrohabitat Unit

These are lateral scour pools formed by surface waters impinging against an artificial armoured bank or spur.

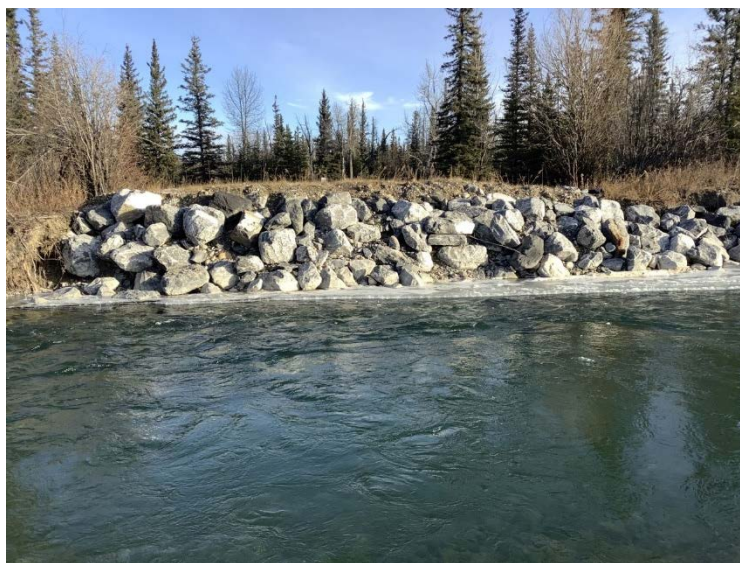
Photo A-16 Fall 2019 Photo of Elbow River Armoured Bank Lateral Scour Pool Macrohabitat Unit

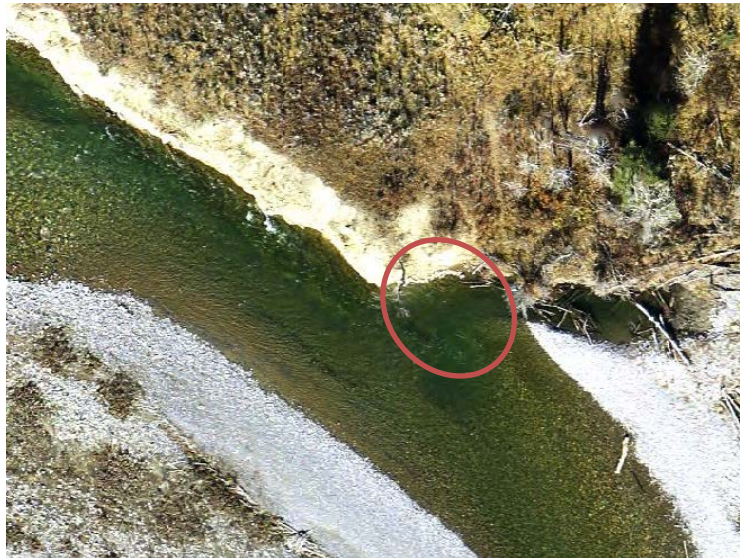
Figure A-17 Fall 2019 Orthoimagery Snapshot of Elbow River Bedrock-Formed Backwater Pool Macrohabitat Unit

These are found along channel margins and caused by eddies around a bedrock obstruction. These pools are usually shallow and are dominated by fine-grained substrate. Water velocities are quite low.

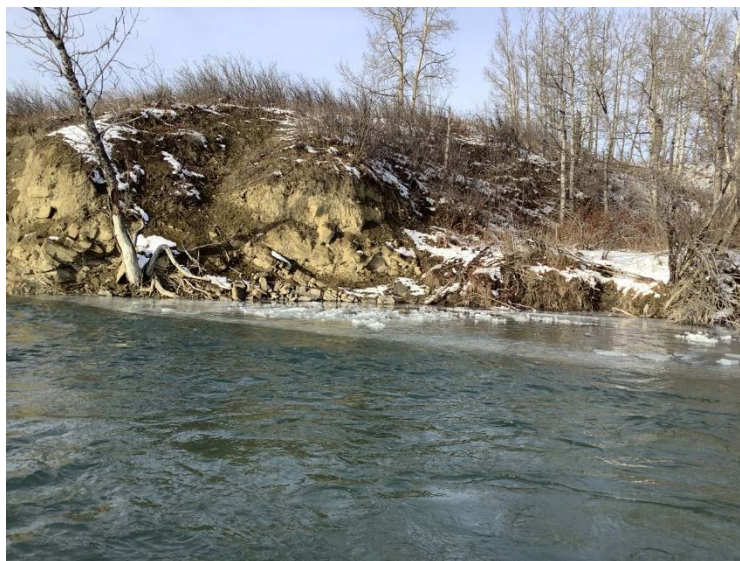
Photo A-17 Fall 2019 Photo of Elbow River Bedrock-Formed Backwater Pool Macrohabitat Unit

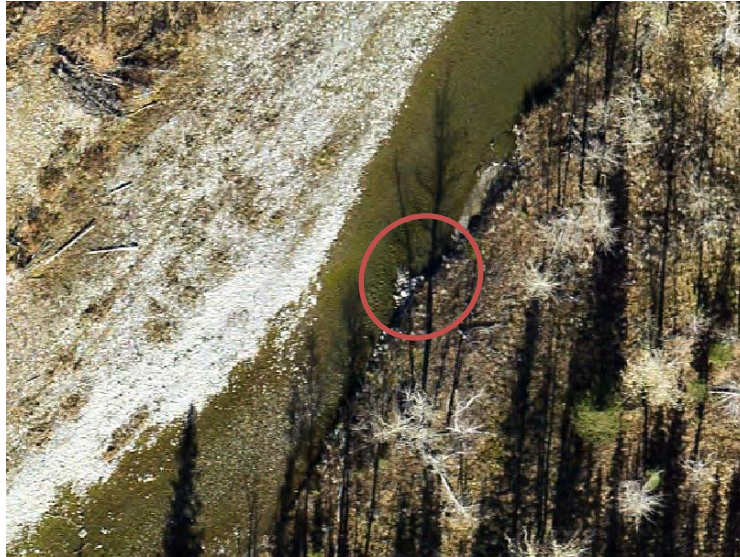
Figure A-18 Fall 2019 Orthoimagery Snapshot of Elbow River Boulder-Formed Backwater Pool Macrohabitat Unit

These are found along channel margins and are caused by eddies around a boulder obstruction. These pools are usually shallow and are dominated by fine-grained substrate. Water velocities are quite low.

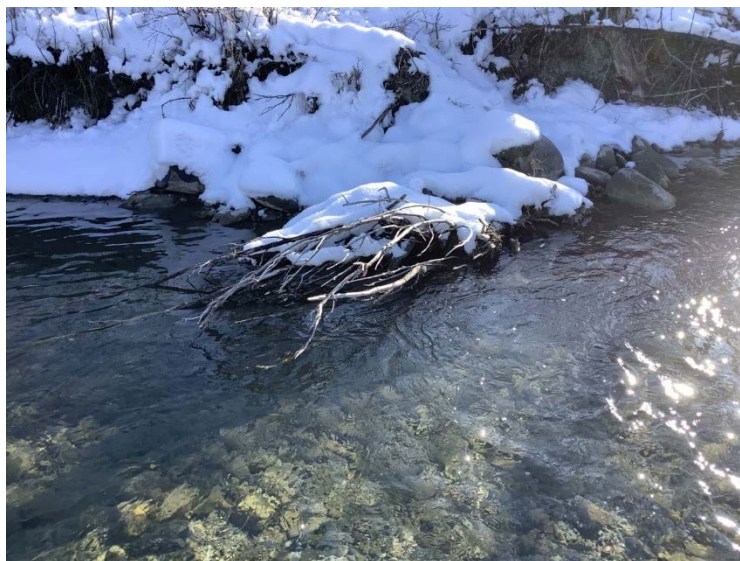
Photo A-18 Fall 2019 Photo of Elbow River Boulder-Formed Backwater Pool Macrohabitat Unit

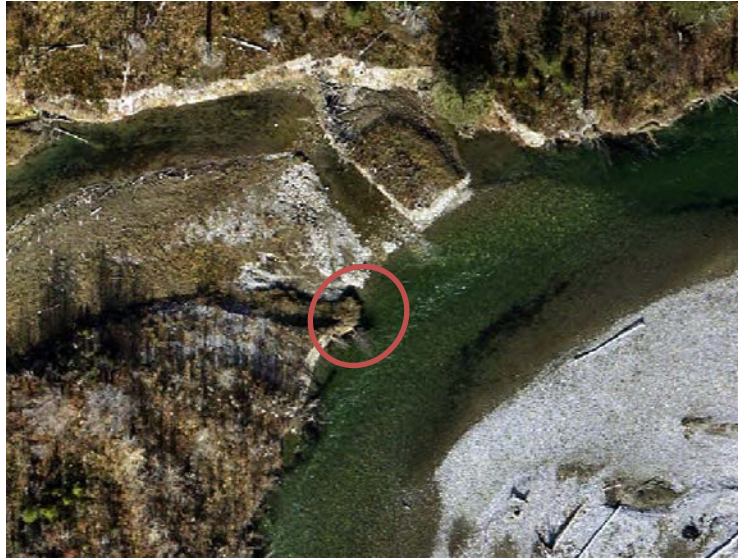
Figure A-19 Fall 2019 Orthoimagery Snapshot of Elbow River Root-Wad Formed Backwater Pool Macrohabitat Unit

These are found along channel margins and caused by eddies around a root wad obstruction. These pools are usually shallow and are dominated by fine-grained substrate. Water velocities are quite low.

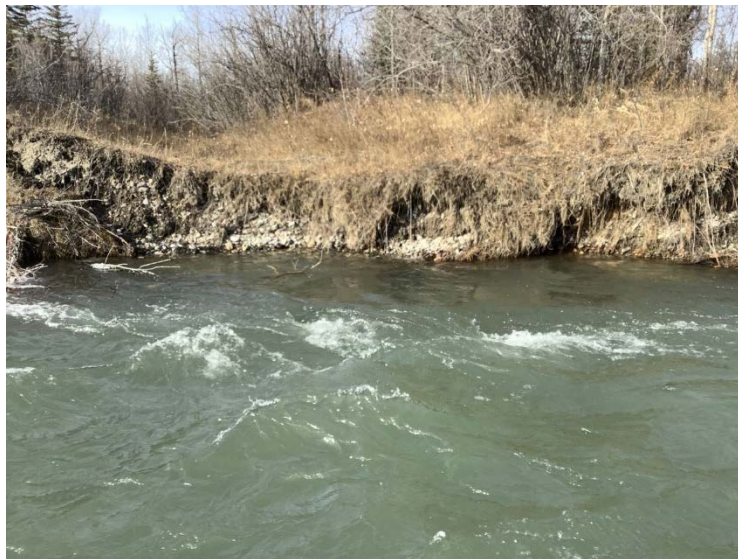
Photo A-19 Fall 2019 Photo of Elbow River Root-Wad Formed Backwater Pool Macrohabitat Unit

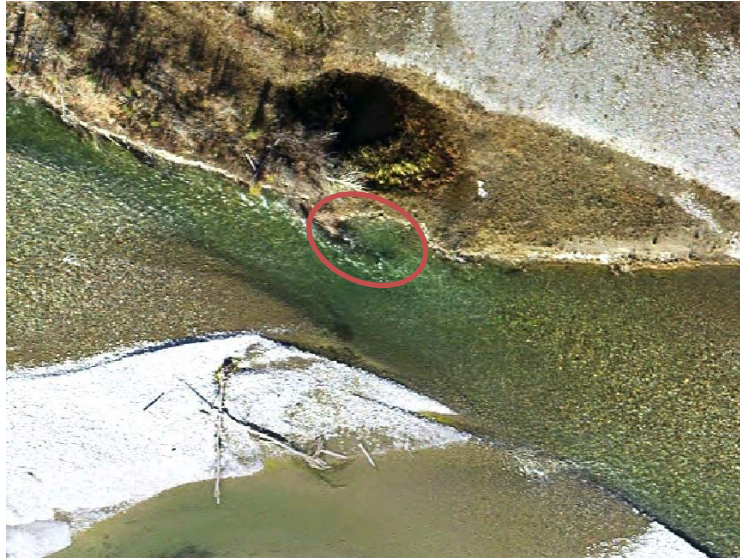
Figure A-20 Fall 2019 Orthoimagery Snapshot of Elbow River Log-Formed Backwater Pool Macrohabitat Unit

These are found along channel margins and are caused by eddies around large woody debris obstruction. These pools are usually shallow and are dominated by fine-grained substrate. Water velocities are quite low.

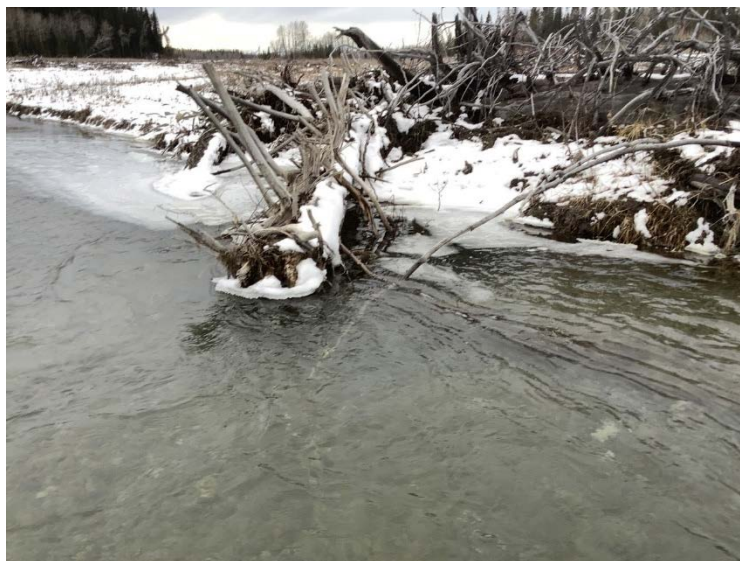
Photo A-20 Fall 2019 Photo of Elbow River Log-Formed Backwater Pool Macrohabitat Unit

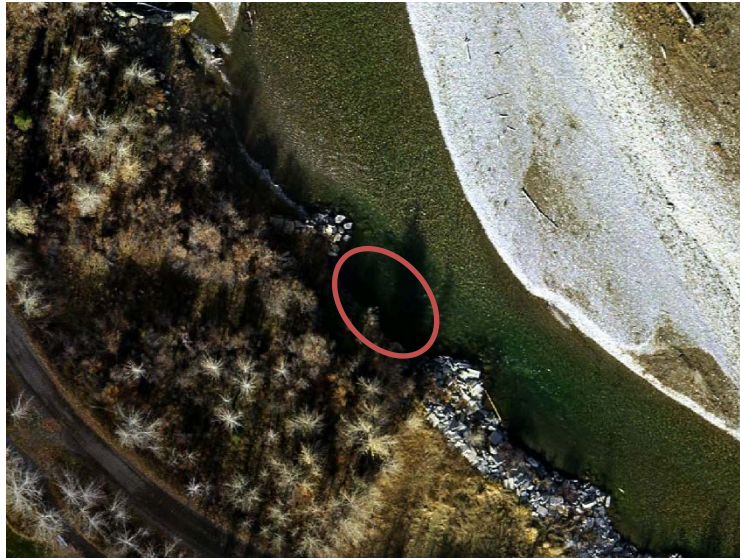
Figure A-21 Fall 2019 Orthoimagery Snapshot of Elbow River Armoured Bank Backwater Pool Macrohabitat Unit

These are backwater pools formed downstream of rock-armoured banks or river-training spurs.

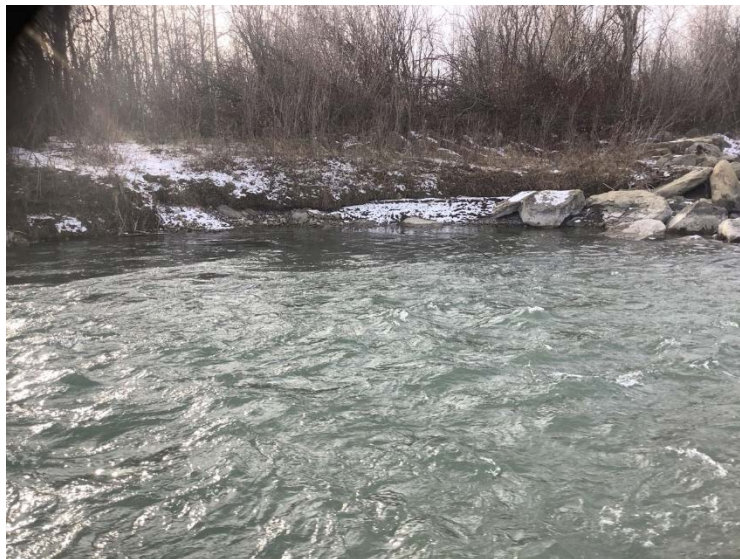
Photo A-21 Fall 2019 Photo of Elbow River Armoured Bank Backwater Pool Macrohabitat Unit.

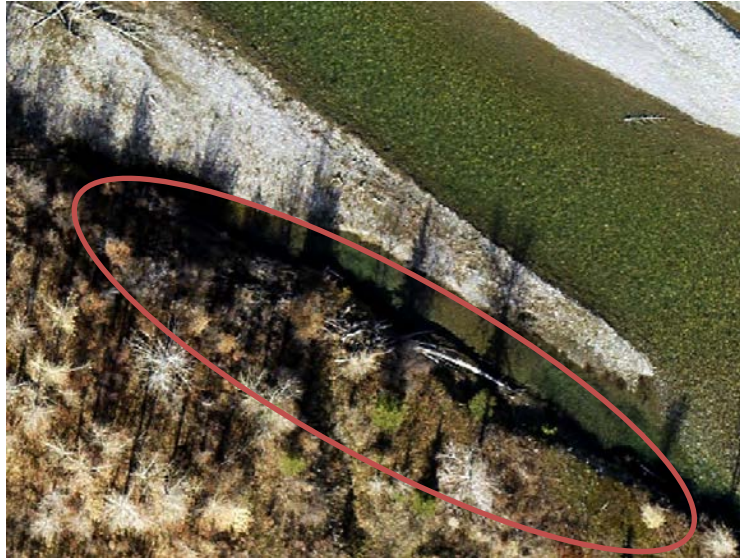
Figure A-22 Fall 2019 Orthoimagery Snapshot of Elbow River Backwatered Channel Confluence Macrohabitat Unit

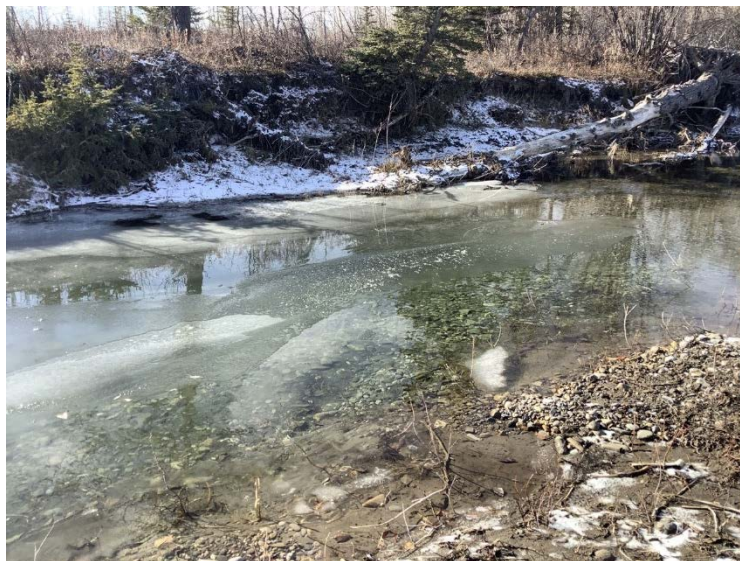
Photo A-22 Fall 2019 Photo of Elbow River Backwatered Channel Confluence Macrohabitat Unit

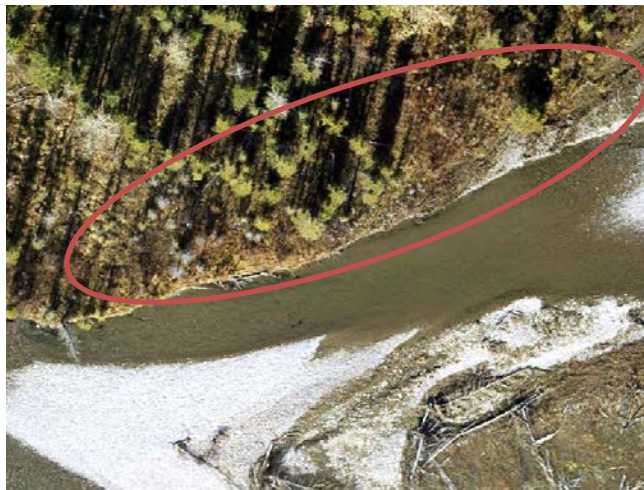
Figure A-23 Fall 2019 Orthoimagery Snapshot of Elbow River Flat Macrohabitat Unit in an Active Side Channel.

This is a collective term for uniform sections of stream connecting riffle and pool habitat in secondary or inactive channels that are not flowing at the time of the field survey or exhibit low rates of flow that are not characteristic of run or glide macrohabitat definitions. Low flows in these areas have resulted in the deposition of fine materials that have embedded underlying coarse substrates. Flow is distributed across a wide area, resulting in sediment deposition.

Connected channels are maintained by higher flows seasonally (e.g., freshet) and fine materials are flushed from these areas periodically throughout the year. Flats in disconnected channels are maintained by flood flows only and sustain longer periods of baseline flows. As a result, flats in disconnected channels are typically more highly embedded and are more likely to support aquatic macrophytes.

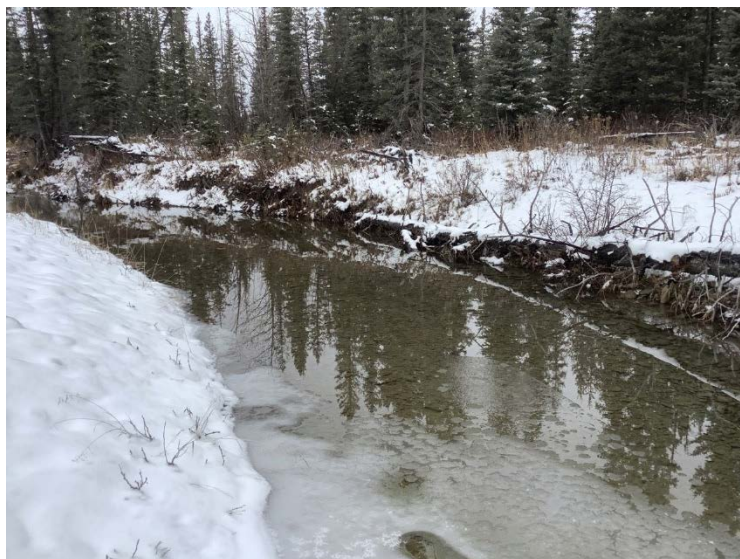
Photo A-24 Fall 2019 Photo of Elbow River Flat Macrohabitat Unit in an Inactive Connected Channel.

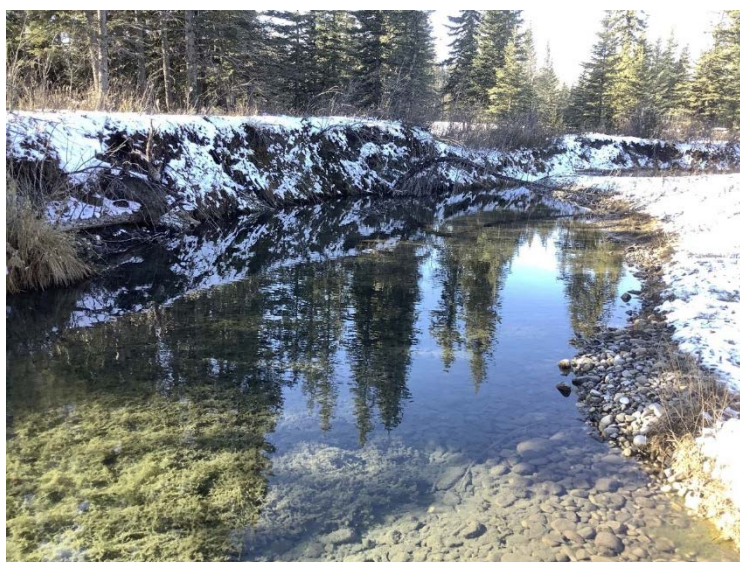
Photo A-25 Fall 2019 Photo of Elbow River Flat Macrohabitat Unit in an Inactive Disconnected Channel (Maintained By Flood Flows Only).
