**ALBERTA TRANSPORTATION SPRINGBANK OFF-STREAM RESERVOIR PROJECT
RESPONSE TO NRCB AND AEP SUPPLEMENTAL INFORMATION REQUEST 2,
DATED NOVEMBER 18, 2019**

Appendix 3-1 Provincial Flood Damage Assessment Study (2015), Environment and Sustainable Resource Development. Prepared by IBI Group.
June 2020

Provincial Flood Damage Assessment Study

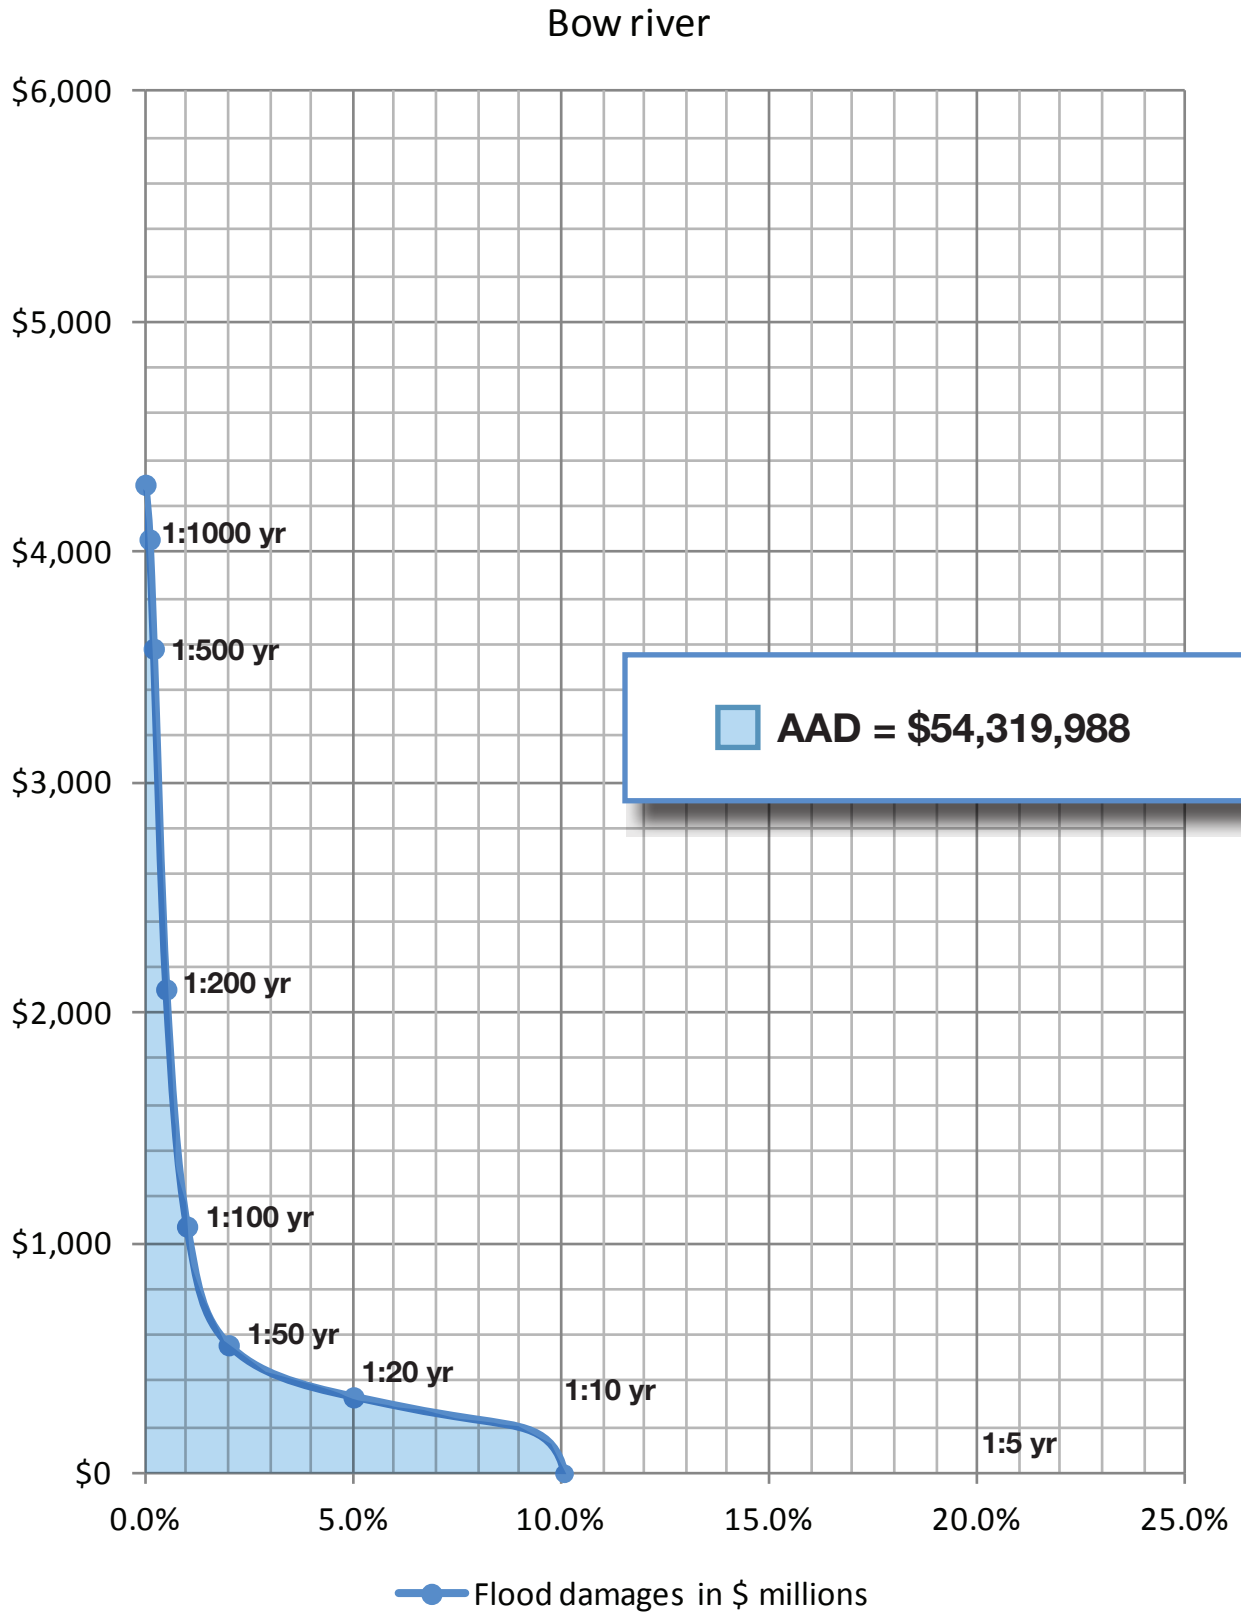
Flood Damages Probability Distribution, Bow River
