Erosion and Riverbed integrity at the Low-Level Outlet for the Springbank Off-Stream Reservoir Project

SR1 Concerned Landowners Group (“SCLG”)

February 2021

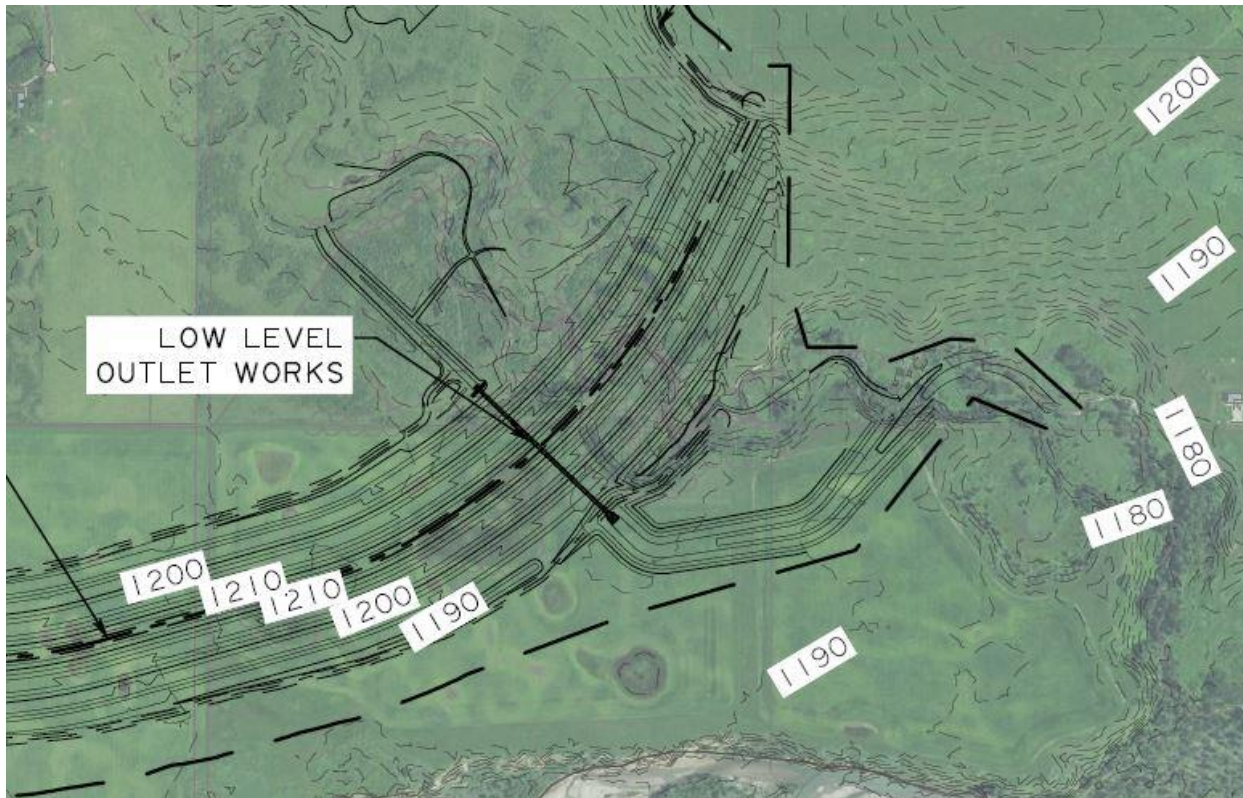
Detail of Low Level Outlet works from drawing 73396A-111, Stantec General Reservoir Overview, Springbank Off-Stream Storage Project Preliminary Design Report, December 2020

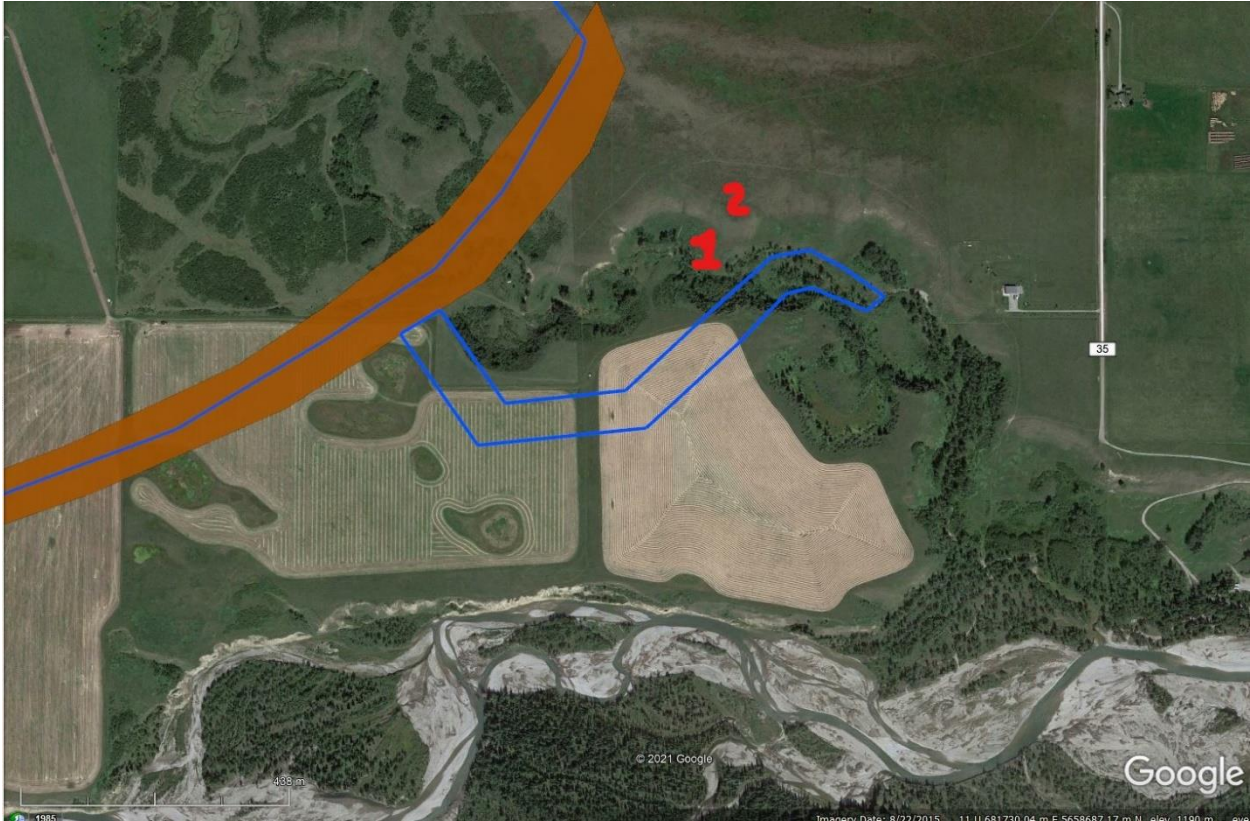
Google Earth image of area of Low Level Outlet Works showing locations of Photograph 1 and 2 shown below.

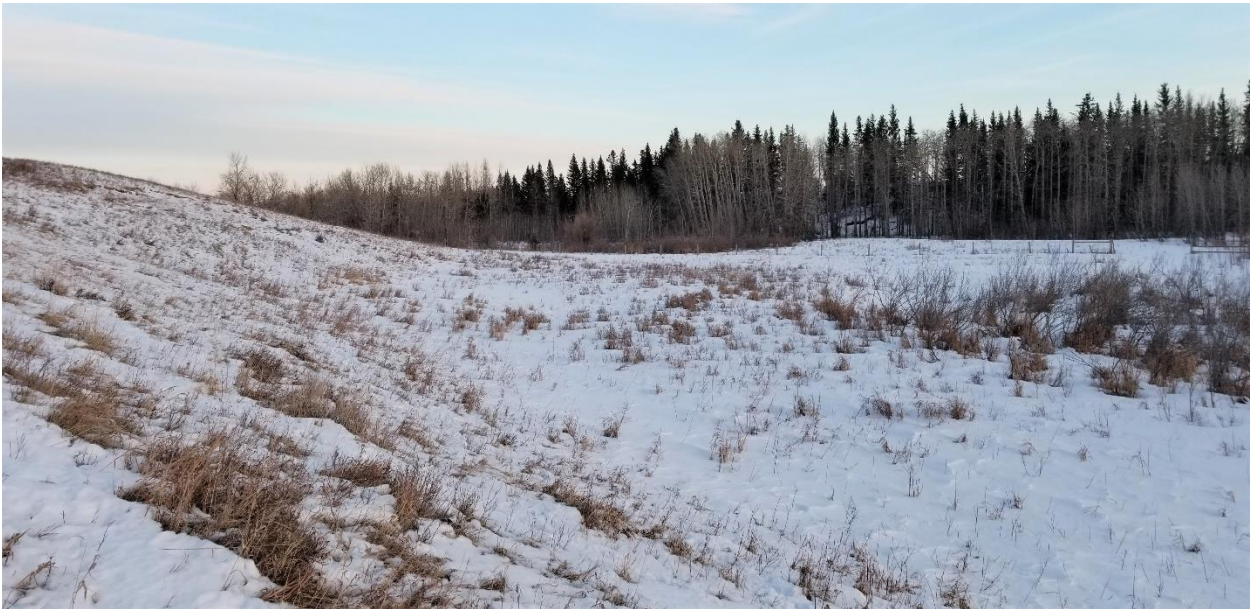
Photograph 1 View southeast along unnamed creek showing wooded area along creek bottom

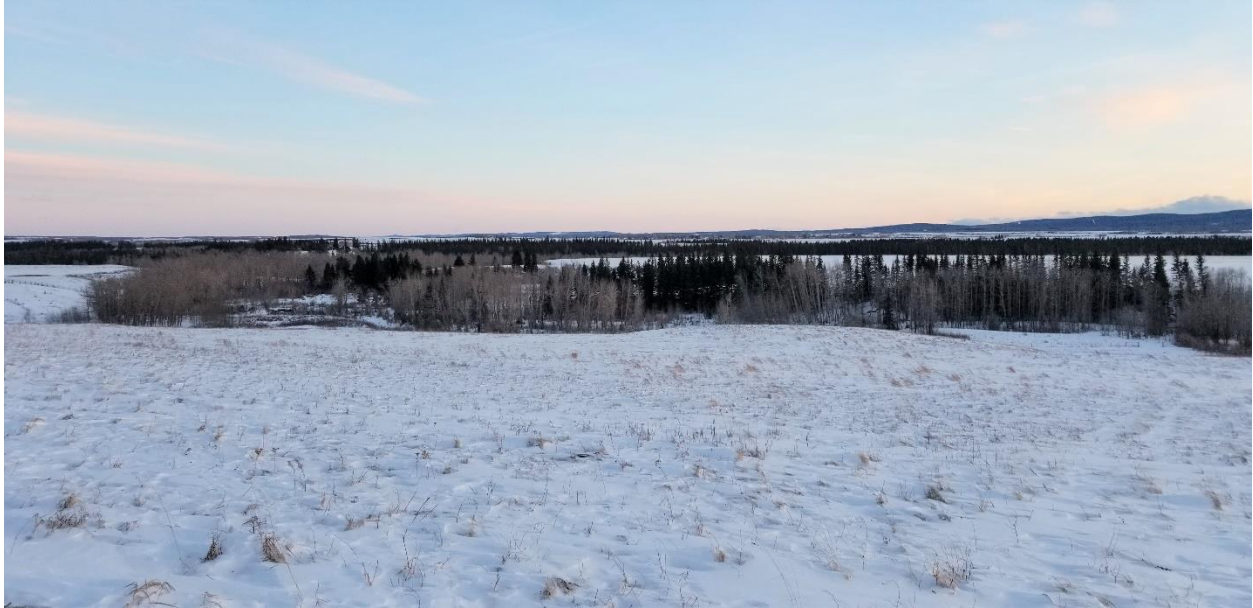
Photograph 2 from benchland east of unnamed creek looking south along the stretch of the creek below the outlet of the low level diversion. This area will be turned into a “new” Elbow River at the flow rates for drainage of the reservoir. No rip-rap is scheduled for the creek bed at the outlet.

The Springbank SR1 Concerned Landowners Group seeks mitigation from erosion within the unnamed stream and Elbow River floodplain at the high flow rates for draining the reservoir after a flood event which fills the reservoir. We anticipate that this will require additional rip-rap within the unnamed stream bed on both west and east banks, and along the south side of the Elbow River floodplain opposite the confluence with the unnamed creek.

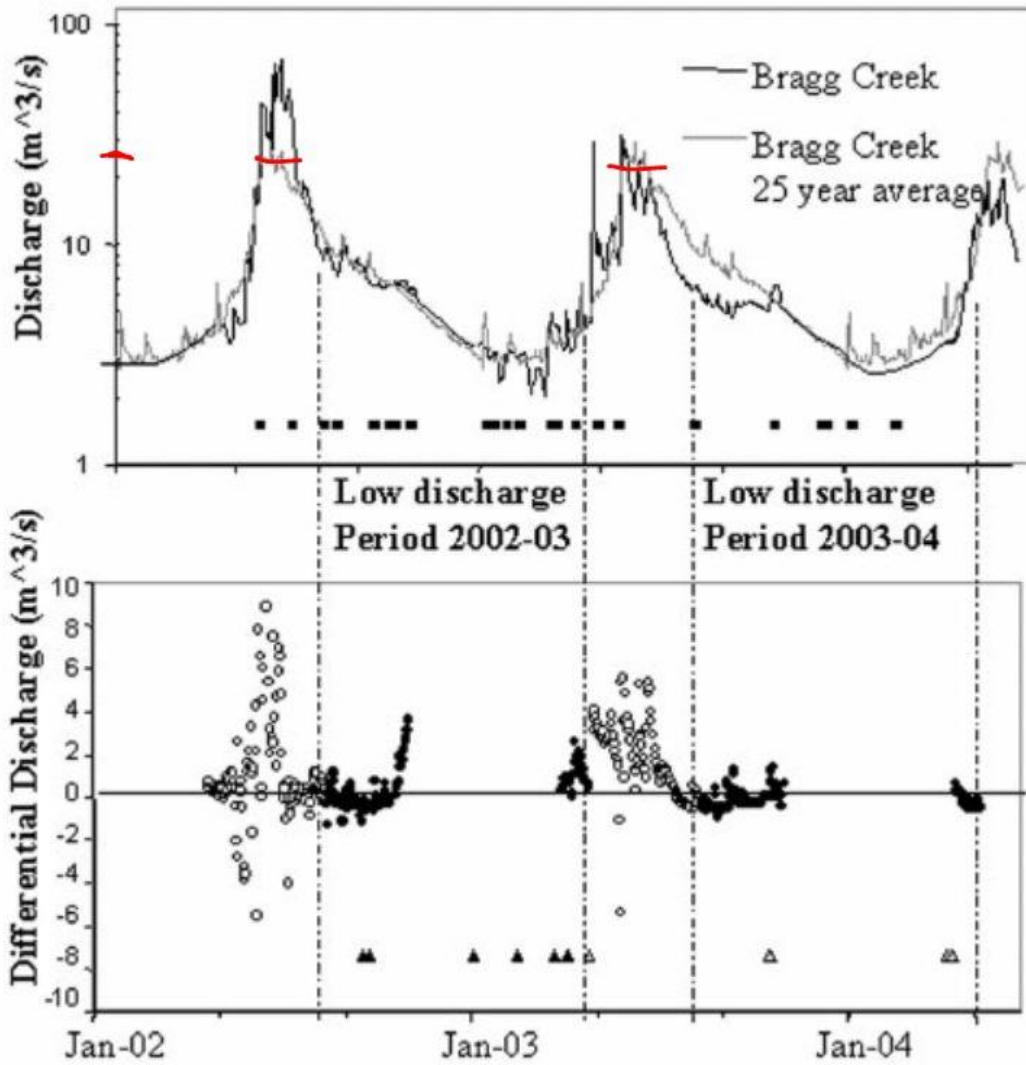
Hydrographs for the Elbow River at Bragg Creek and downstream for the years 2002 to 2004 from Manwell (2006). 27m³/s is marked on the vertical (log scale) upper graph. Note that for these years that value is about a third of the flood maximum (about 75m³/s).
