SPRINGBANK OFF-STREAM RESERVOIR PROJECT
ENVIRONMENTAL IMPACT ASSESSMENT
VOLUME 4: APPENDICES
APPENDIX M: AQUATIC ECOLOGY

Attachment 8A Fish Passage Analysis
March 2018

Attachment 8A **FISH PASSAGE ANALYSIS**

Reference: Springbank Off-stream Storage Project (SR1) – Hydraulic Modeling to Support Fish Passage Assessment

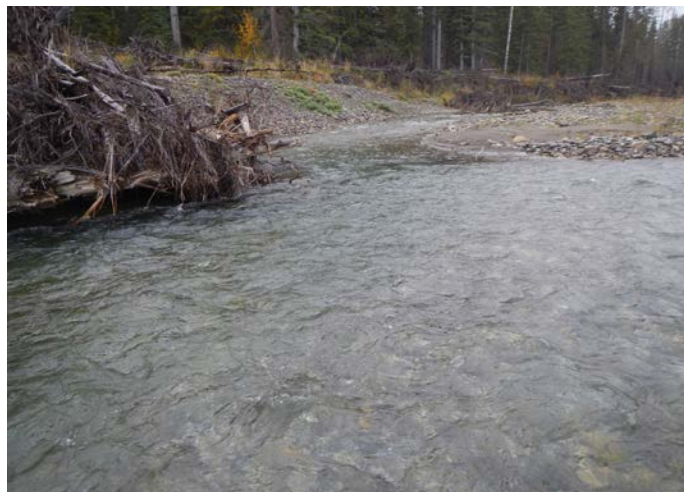
Photo 1: Looking upstream from T1 at woody debris and depth cover.

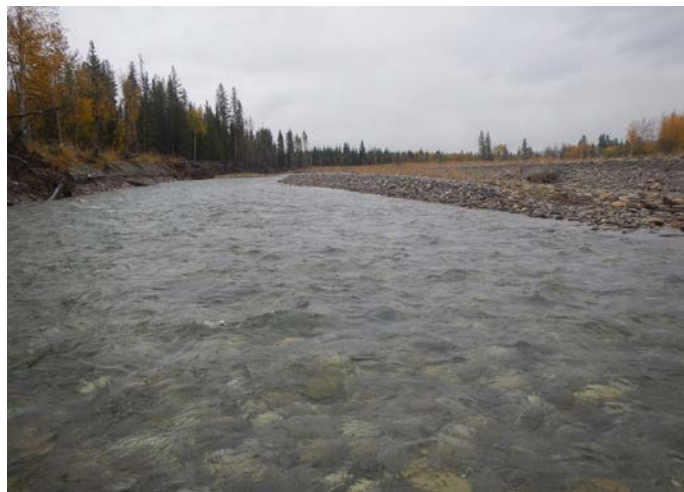
Photo 2: Upstream view from T3 at run habitat found throughout the reach.

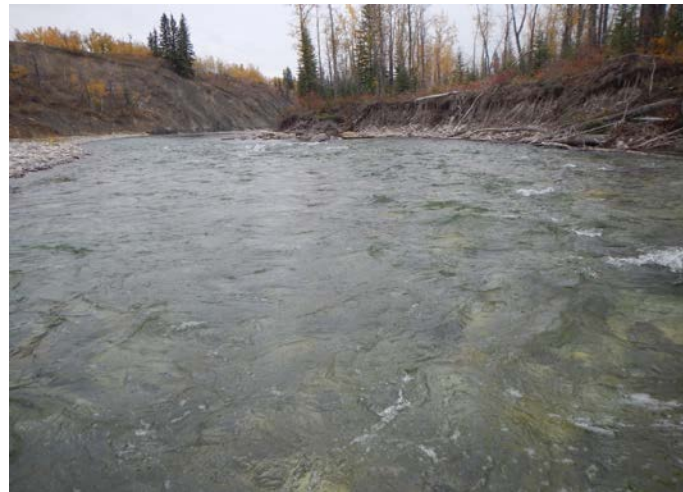
Photo 1: Looking downstream from T2 at run/riffle habitat and woody debris.
