Appendix IR454-1 Physical Model Study of the Springbank Off-stream Storage Project Diversion Structure
on the Elbow River Report
May 2019

Physical Model Study of the Springbank Off-stream Storage Project Diversion Structure on the Elbow River

Paul Knox, Andrew Cornett, Mitchel Provan
Ocean, Coastal and River Engineering
NRC Technical Report: OCRE-TR-2016-028

December 2016

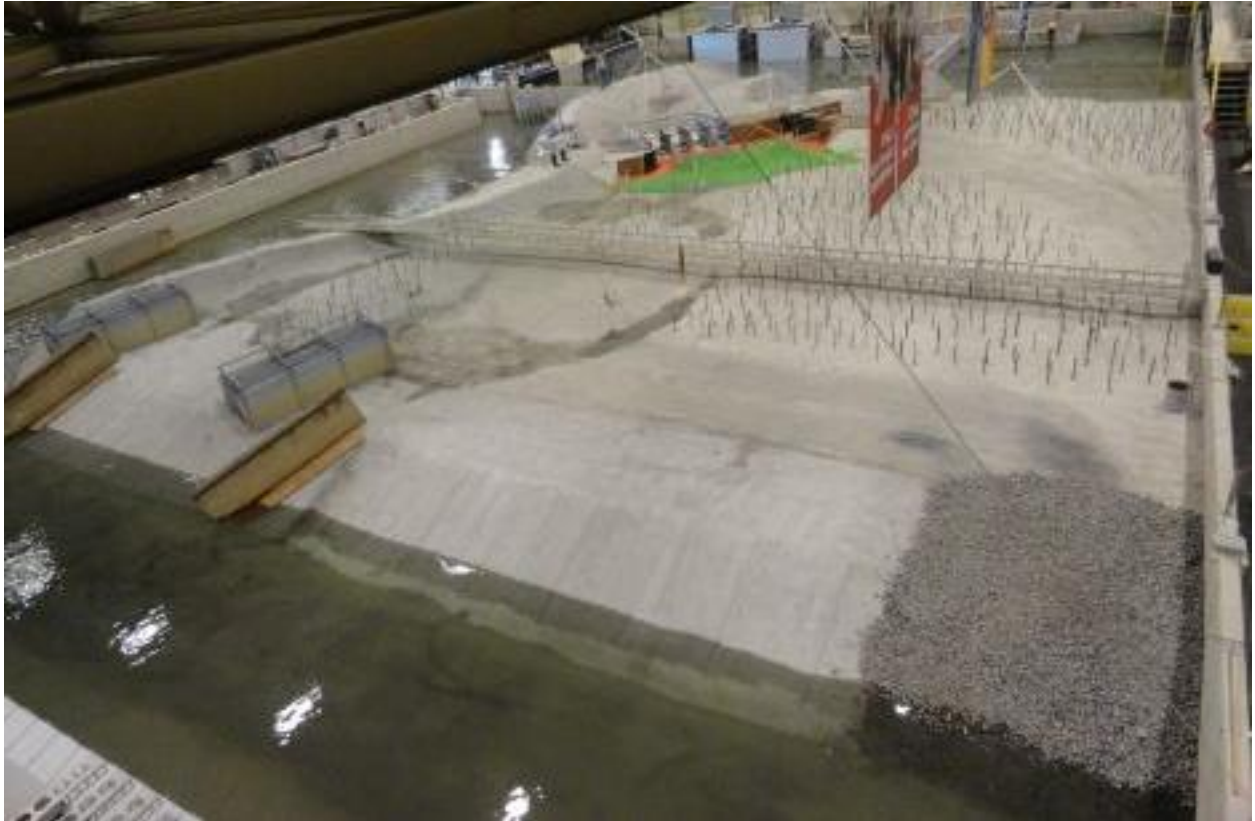
Figure 22. Photograph of the physical model after construction – looking downstream.

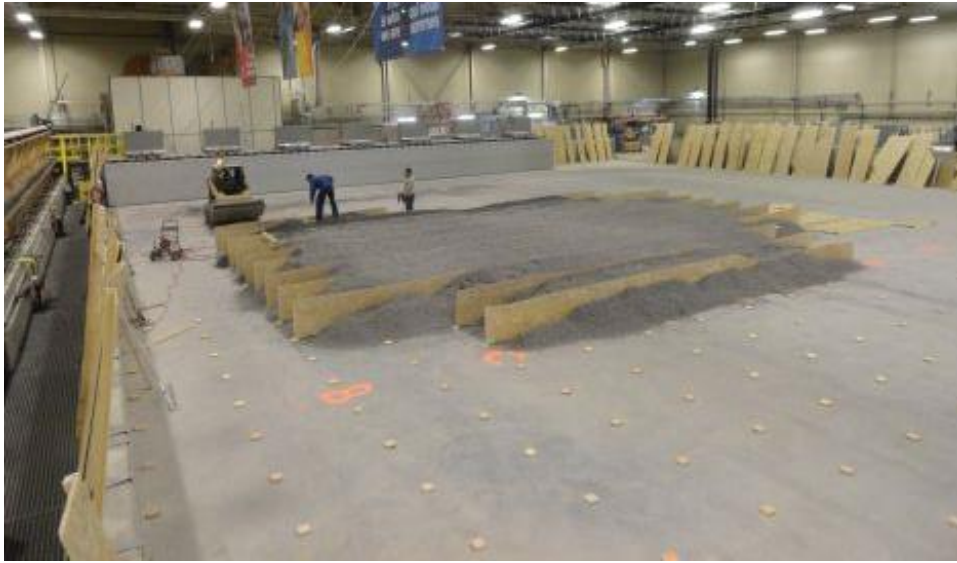
Figure 27. Fibreglass templates were erected and backfilled with fine gravel.

The concrete bathymetry was constructed using a series of fibreboard templates erected at 1m intervals (model scale, or MS) throughout the model domain. The templates, used to represent cross-sections of the riverbed, were cut to an accuracy of $\pm 2\text{mm MS}$ and were supported on the basin floor by a grid of pads leveled to within $\pm 1\text{mm MS}$. Heavy construction equipment was used to fill the templates with clear gravel once secured on top of the leveled pads. The clear gravel was then compacted with a plate tamper such that the final surface rested approximately 5cm MS below the top edge of the templates. Fine aggregate concrete was then placed on top of the gravel base and power screeded to match the elevations of the templates. Once cured, a smooth finish was achieved using a combination of hand- and mechanical-trowelling, and a roughened finish (where applicable) was achieved using a stiff broom finish on the curing concrete. Photographs showing some of the stages of the bathymetry construction are shown in Figure 27 to Figure 32.

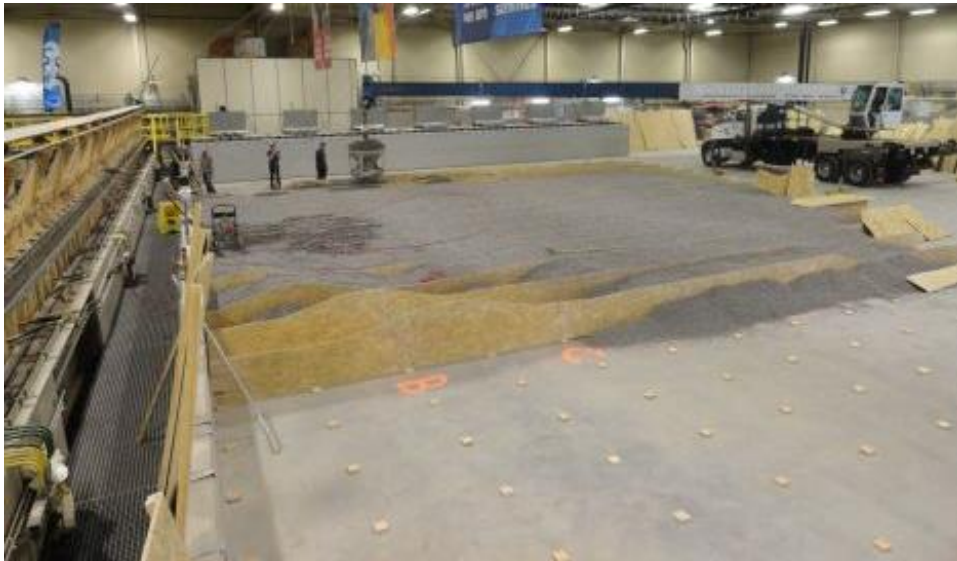
Figure 28. Heavy construction equipment was used to fill templates.

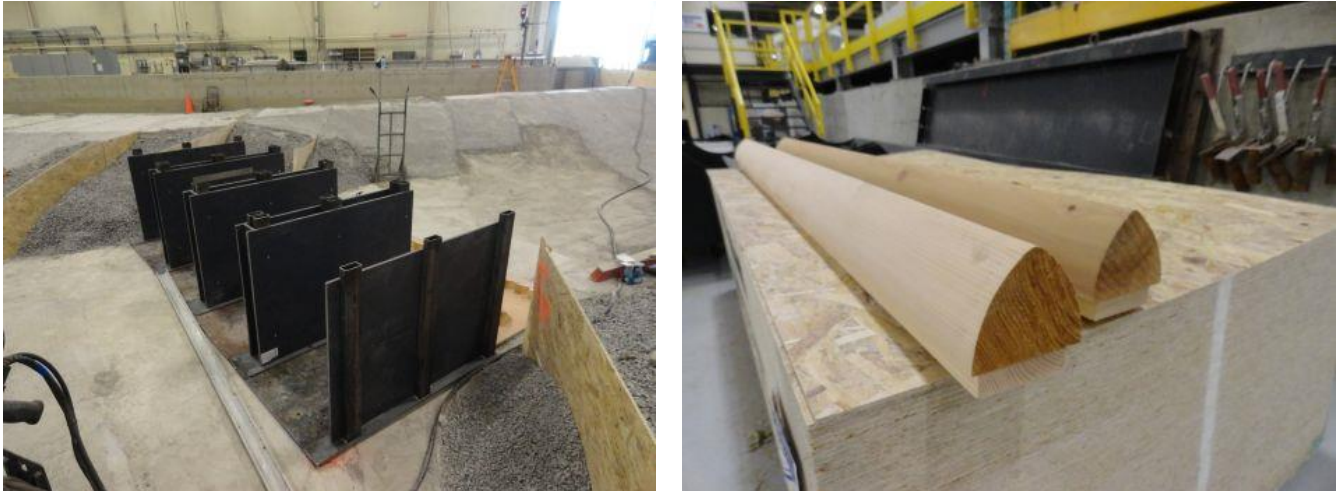
Figure 38. Left: diversion inlet pier struts and base plates installed in the basin. Right: precision milled hardwood pier noses after manufacture.

The diversion inlet structure was constructed on a $\frac{1}{2}$ " steel baseplate, and the central piers were made from hollow structural steel that was welded to the baseplate, and the piers were clad with PVC. The pier noses were precision milled from hardwood to match the prototype designs. The concrete apron of the diversion inlet was made from concrete grout, and its construction was guided by the use of a template to precisely match the profile curves. Wooden chute blocks were cut and fastened to the concrete apron of the diversion inlet apron and stilling basin. The gates for the diversion inlet were not modelled in the original design - if the model diversion inlet was to be closed, marine plywood was fastened to the back of the pier to stop the flow through the diversion inlet bays. Photographs showing some of the stages of construction for the original diversion inlet structure are shown in Figure 38 to Figure 42.

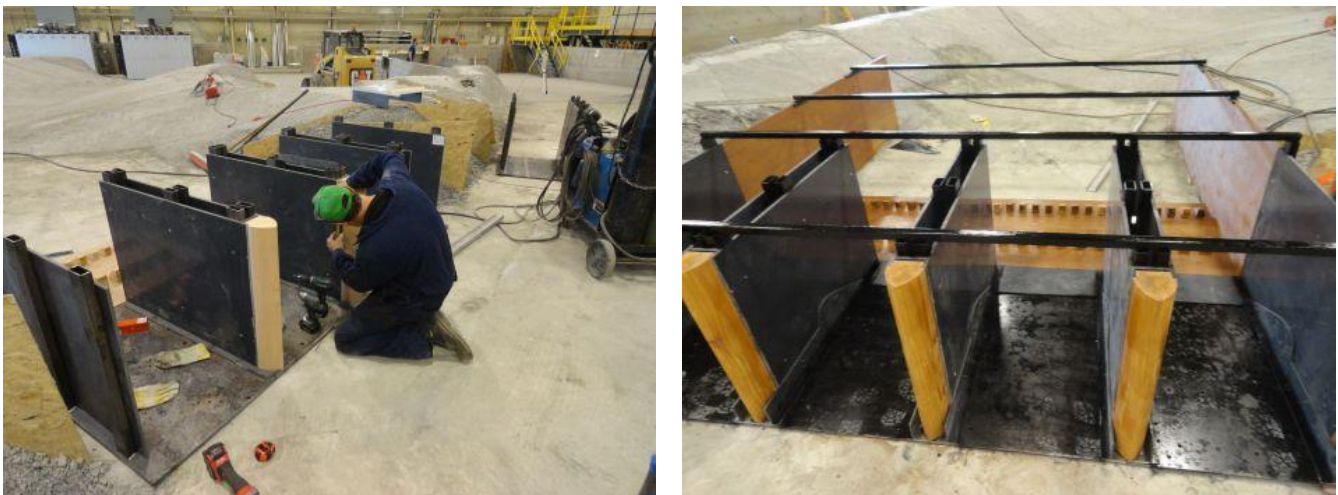
Figure 39. Left: installing the pier noses. Right: installing the support struts, rear retaining walls and rear stilling basin chute blocks.

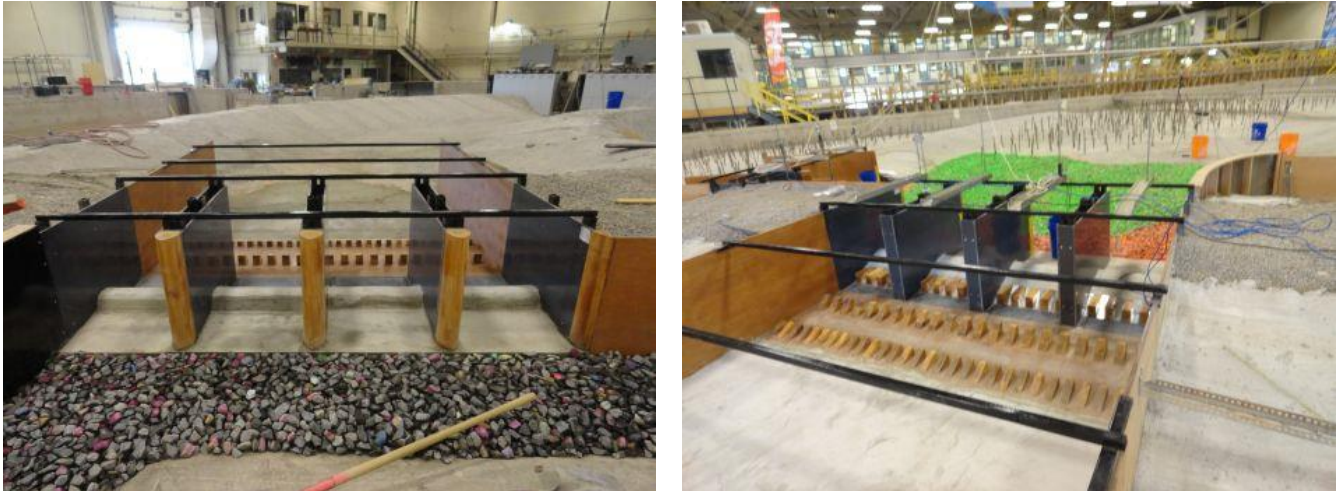
Figure 42. Left: diversion inlet looking downstream. Right: diversion inlet looking upstream (the 440kg riprap and 210kg riprap used in the mobile bed portion of the model was painted to aid in movement detection).

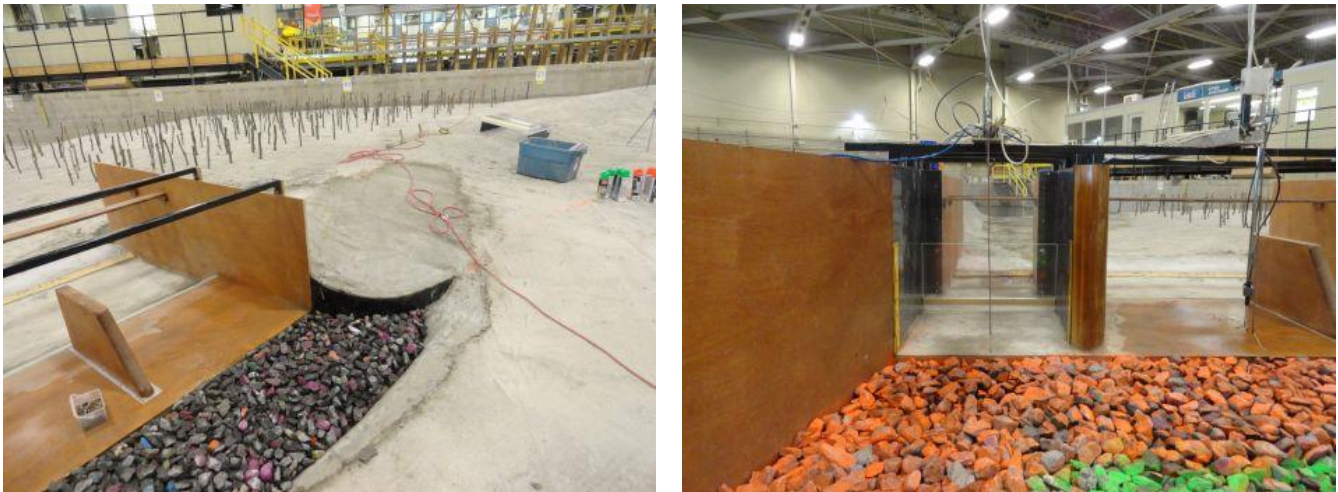
Figure 44. Left: the riprap apron was installed, and the (black) curved retaining wall on the RHS of the service spillway was tapered to match the profile of the floodplain berm. Right: view of the finished sluiceway with the clear plastic gate lowered and riprap painted orange.

The sluiceway and service spillway were constructed similarly to the diversion. The sluiceway section was built on a steel baseplate with hollow structural steel members clad with PVC sheet to form the interior pier. The sluiceway concrete apron was cast in concrete to match the curved profile of the design. The radial sluiceway gate was modelled with a lift gate made from clear acrylic plastic. The bottom 1m of the lift gate was cut to match the curved radial gate profile to give the flow through the opening the proper character. The base of the service spillway was made from plywood, as was the angled central pier that divided the Obermeyer crest gates. The sluiceway pier was constructed on a ½" steel baseplate, clad with PVC, and fitted with the precision milled hardwood pier nose. The concrete apron of the diversion inlet was made from concrete grout, and its construction was guided by the use of a template to precisely match the profile. Obermeyer gates set to specific elevations were pre-constructed from sheet metal facing supported by wooden ribs, and the gates were screwed to the service spillway base to allow rapid installation and removal in the model. A wooden end sill was fastened to the concrete apron of the sluiceway/service spillway stilling basin. Photographs showing some of the stages of construction for the original diversion inlet structure are shown in Figure 43 to Figure 45.

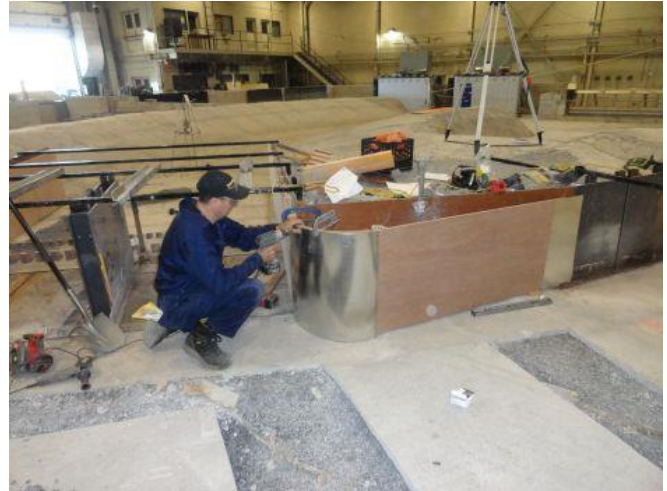
Figure 51. Installing the modified central retaining wall between the diversion inlet and service spillway.

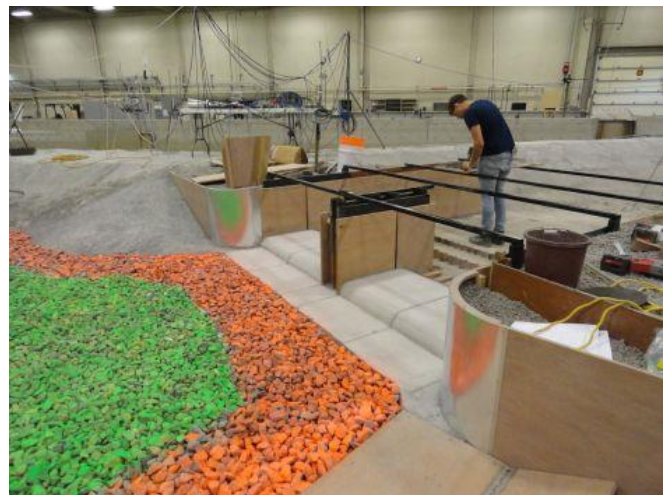
Figure 52. Left: diversion inlet concrete apron and breast wall (the lift gate is closed). Right: installation of the 440kg riprap (orange) and the 210kg riprap stone used to model the mobile-bed portion of the model (green).

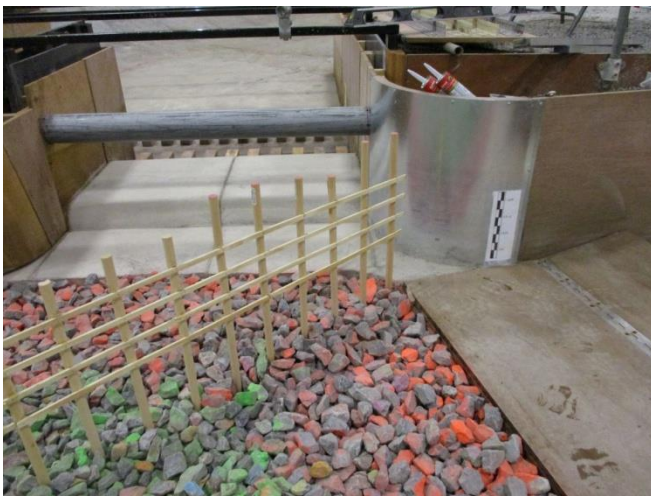
Figure 65. Debris Barrier E implementation in the model.

Debris barrier E (see Figure 63) featured three straight legs: moving from upstream, leg AB was 46m long, leg BC was 41m, and leg CD was 90m. The profile designs for the barrier are shown in Figure 64. The wall was to be made from pipe piles 300mm in diameter and spaced on 2m centers, and guide rails made from timber were to be set at elevations of 1216m, 1215m, 1214m and 1213m. These designs were replicated to scale in the model, and Figure 65 shows the barrier being constructed.

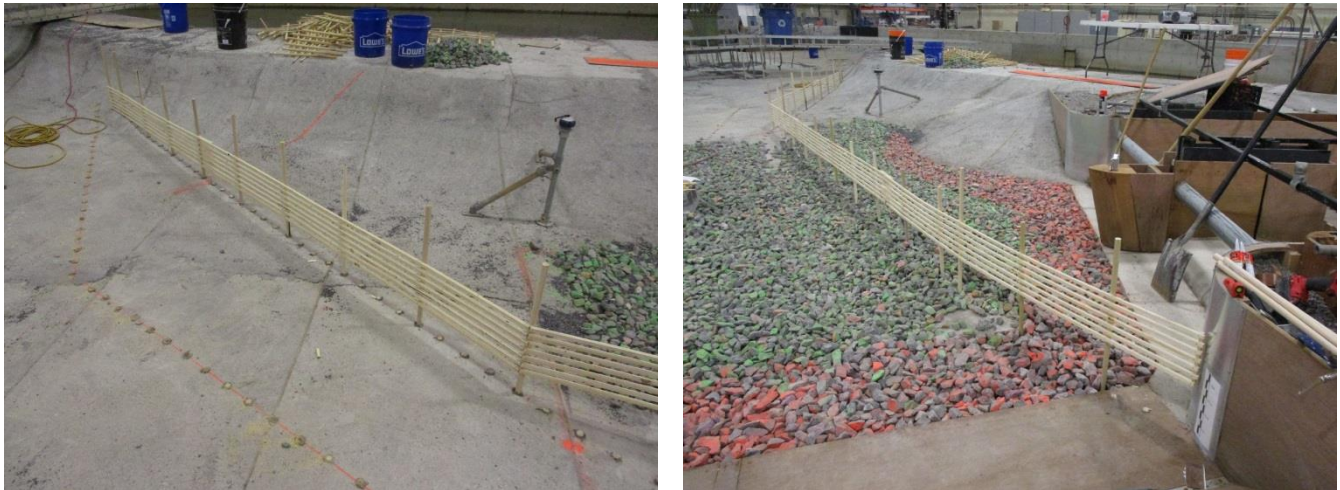
Figure 67. Debris Barrier F construction in the model.

Debris barrier F was similar to E, with guide rails between elevations of 1213m and 1216m, however the guide rails were set on a tighter spacing (0.5m) and the alignment stayed closer to the left bank of the river channel to provide less obstruction (refer to Figure 66 and Figure 67).

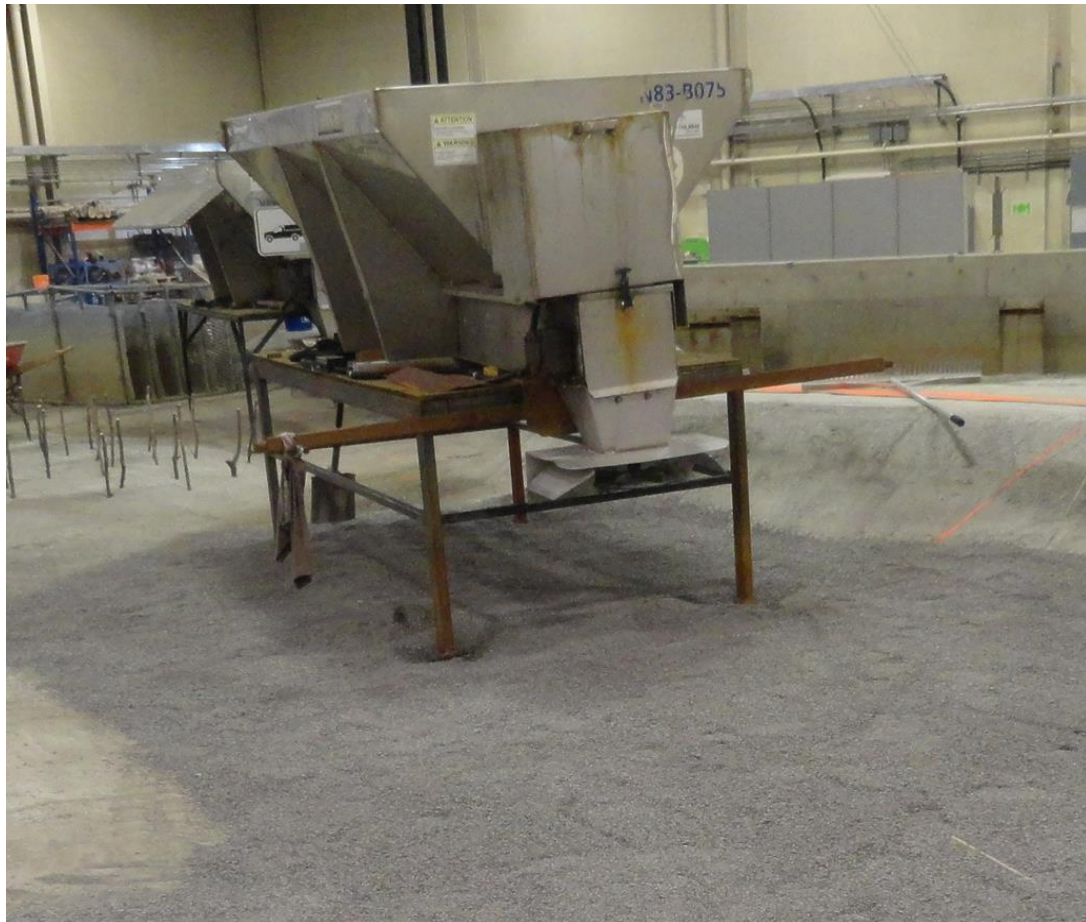
Figure 71. Rock Spreader B075.

In order to match the very high sediment loads in the river, motorized spreaders were used to seed the flow with the model sediment (refer to Section 3.2.3 for the model sediment scaling). The spreaders were borrowed from the City of Ottawa (they are normally used to spread road salt) and mounted on steel support frames. Three different spreaders were used for this study and were given the following names: battery spreader, 3360 spreader and B750 spreader (shown in Figure 71). The loading rate of each spreader was calibrated prior to testing to match the sediment loading rates provided by Stantec. The calibration process included filling a spreader with a known quantity of sediment and running the spreaders until they were empty. The spreader motor and conveyor belt did not have a throttle, so the delivery rate was adjusted via the gate opening (small, medium or large) at the end of the conveyor. The delivery rates for all three spreaders for the various gate openings are shown in Table 2. Based on the calibration results the spreaders had loading rates ranging from 280 kg/s to 1800 kg/s (full scale).

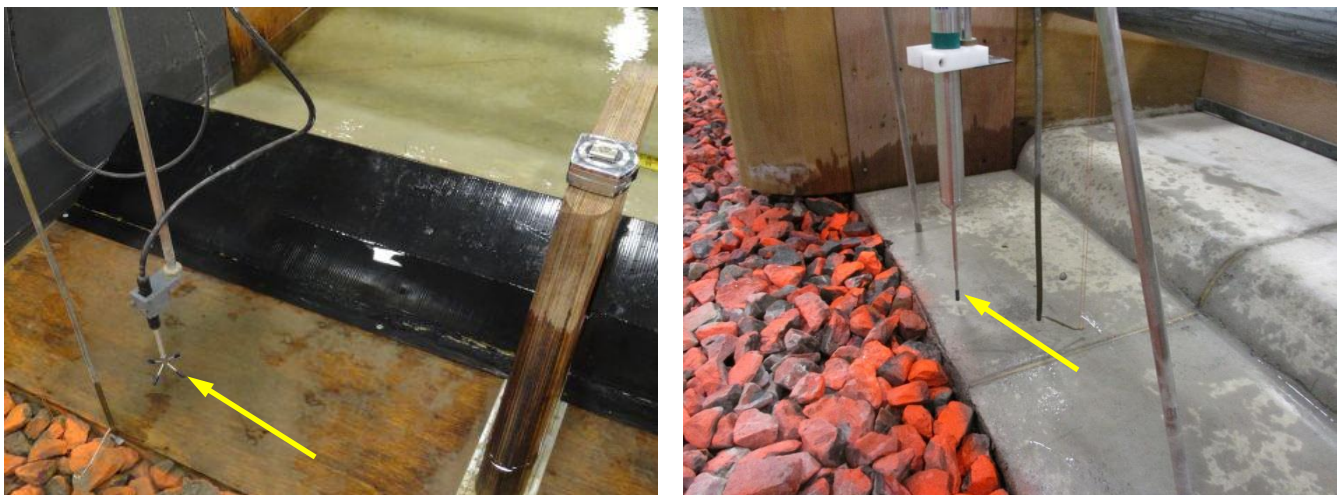
Figure 79. Three-axis acoustic Doppler velocimeter (left) two-axis electromagnetic current meter (right).

Two different types of instruments were used to measure velocities within the model, four 2-axis electromagnetic current meters developed by Alec Technologies and two 3-axis acoustic Doppler velocimeters made by Vectrino (ADV's) were utilized (see Figure 79). The height of the current meters above the river bottom was adjusted to be mid-depth for each flow condition. However the ADV sensors require 5cm (model scale) depth below the sensor for accurate readings, therefore they were not used during some of the lower flows since the depths were insufficient.

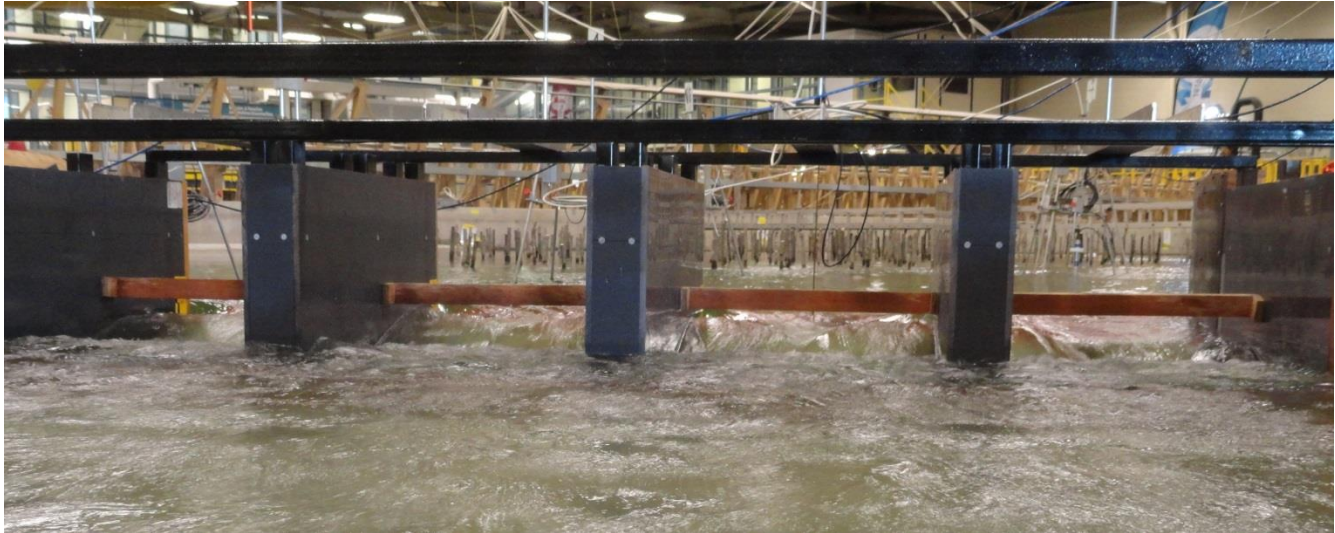
Figure 90. Turbulent flows downstream of diversion inlet gates.

The flow through the four diversion inlet bays was more evenly distributed for this condition compared to the 320 m³/s flow scenario. The hydraulic jumps downstream of the diversion inlet gates all appeared relatively uniform in strength and location, as shown in Figure 90.

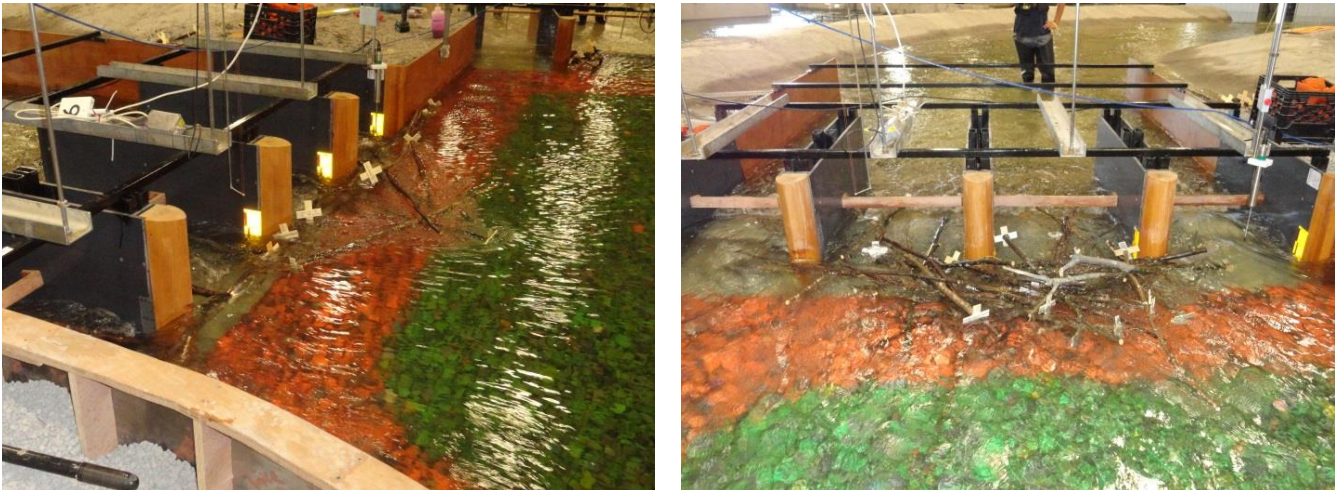
Figure 95. Single trees (left) and a 40-tree raft (right) caught on the diversion inlet piers.

The debris generally followed the streamlines that had been mapped out using drogues and dye during test series A. Single trees were able to pass through the diversion inlet bays as long as they were oriented with the flow. Since the width of each diversion inlet bay was less than the length of the trees, the trees tended to catch on the piers whenever they approached a diversion inlet bay sideways. Trees with a root ball were more frequently caught than trees without root balls. Individual trees would sometimes rotate around the point of contact and then pass safely through the diversion. In other cases, the trees would end up spanning the width of the bay between two adjacent piers. Once one tree was caught on the piers it caused a snowball effect and the single tree would catch multiple trees regardless of their orientation (see Figure 95). Most of the trees in the larger rafts were caught on the piers with only a few individual trees passing through the diversion inlet bays.

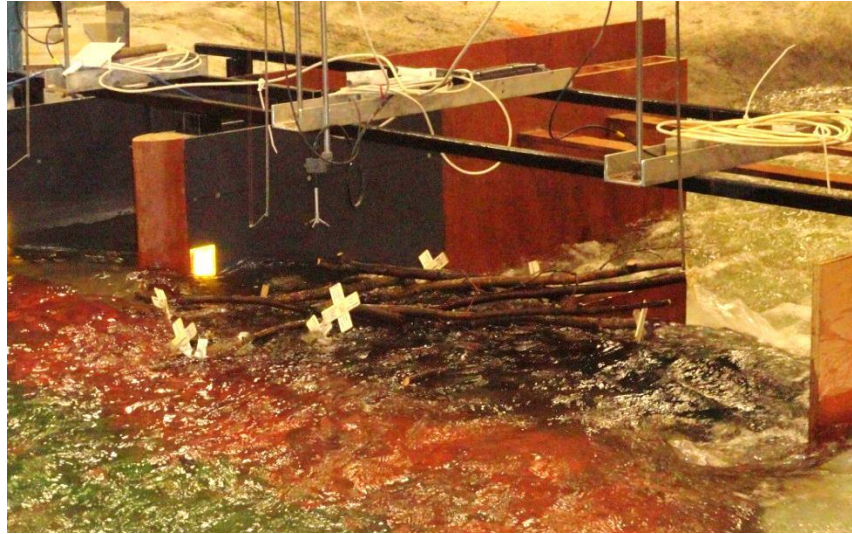
Figure 100. Tree raft snagged on piers in the service spillway.

trees that made it over the Obermeyer gates became trapped in the downstream roller. The rafts of trees that were released into the upstream flow were not able to orient themselves with the flow direction and therefore got caught in the service spillway, particularly between the two piers (see Figure 100).

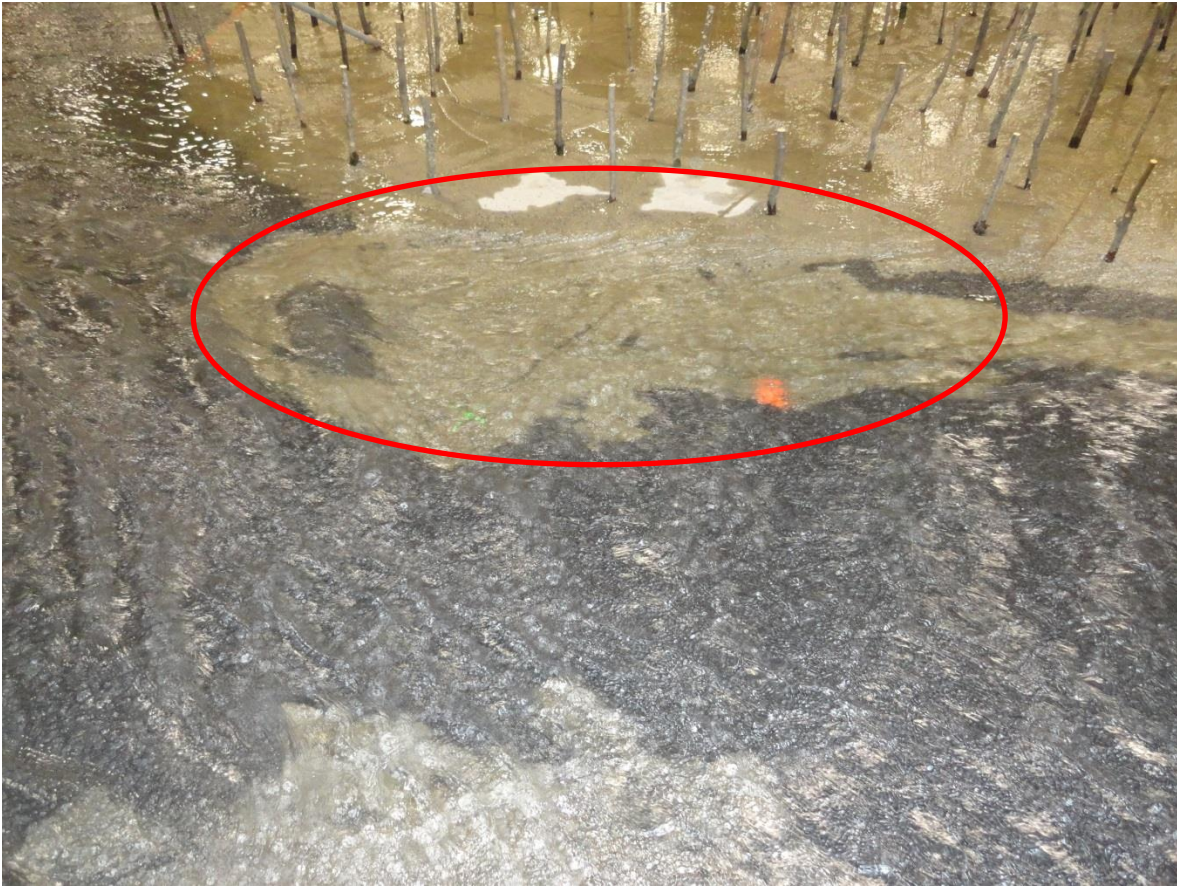
Figure 104. Erosion of sediment in secondary upstream flow channel (circled)

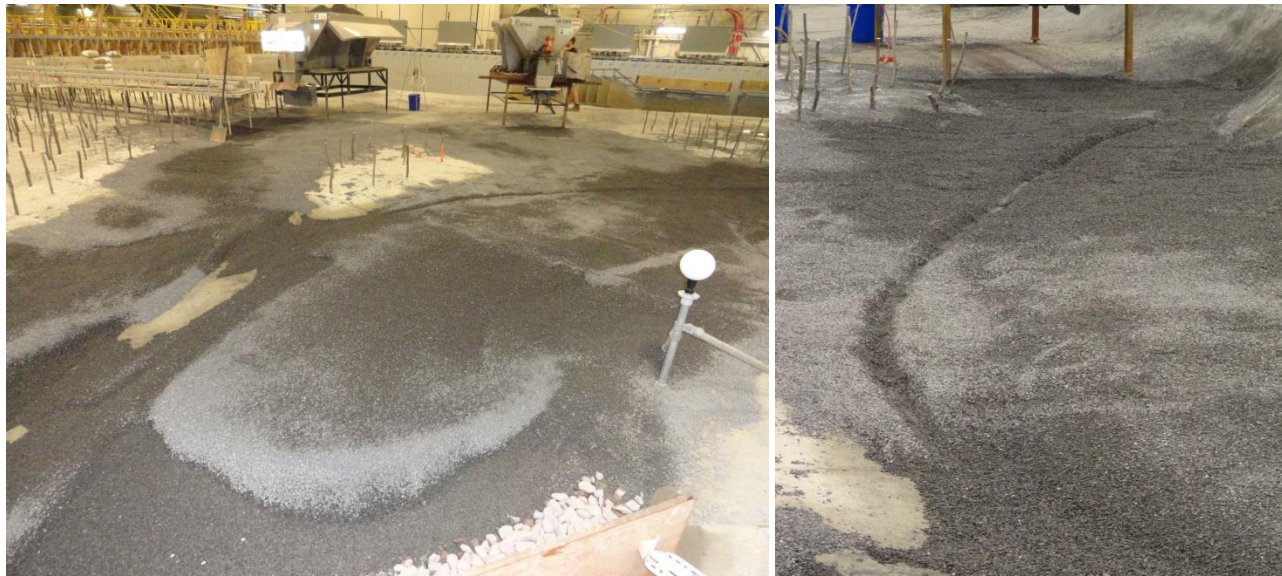
Figure 114. Initial upstream mobile bed conditions prior to the 1240 m³/s flow condition.

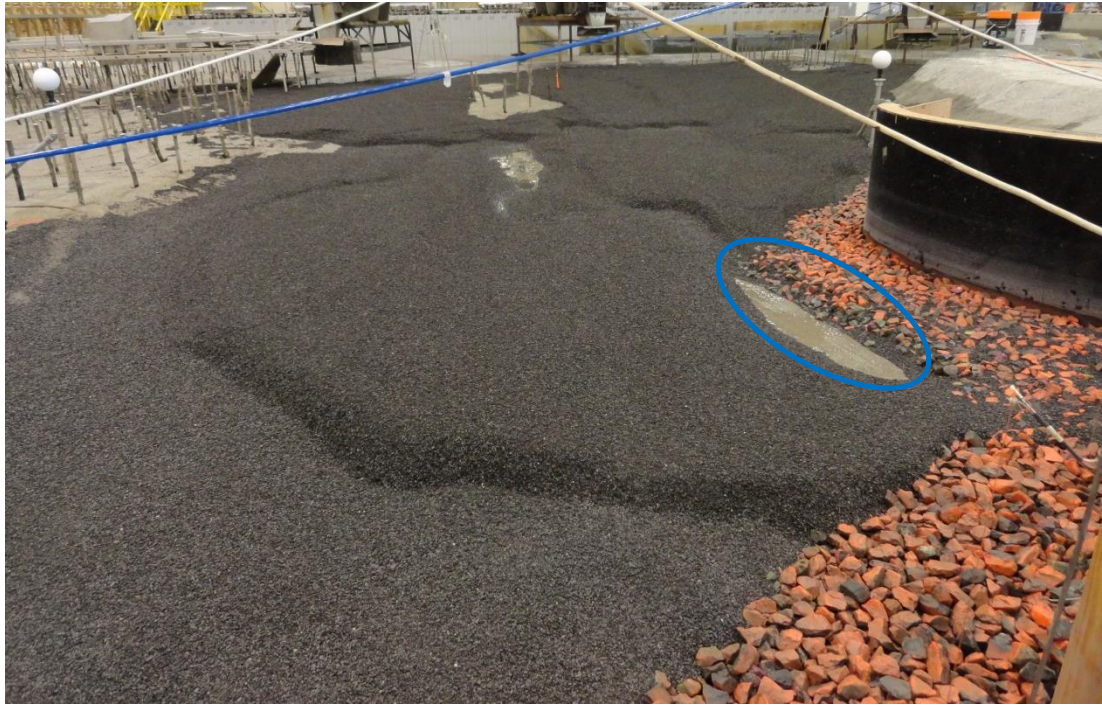
Figure 115. General view of the mobile bed in the forebay area after the 1240 m³/s flow condition (new scour hole highlighted).

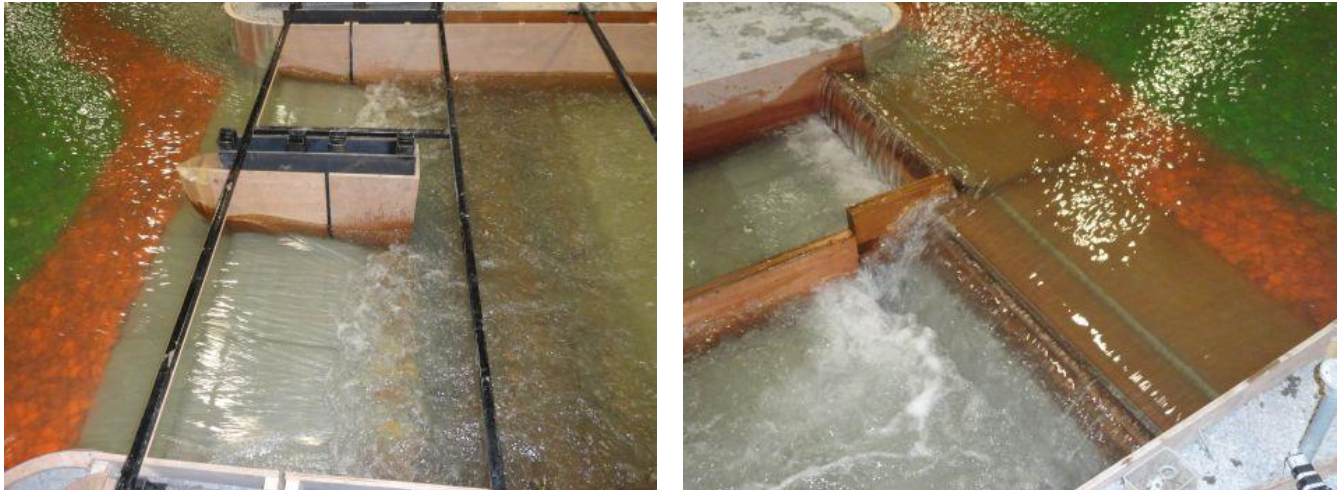
Figure 123. Flow conditions at the structure during the 760 m³/s event with the Obermeyer gates set to 1213.4m (LHS) and 1215m (RHS). Left - facing southwest at the diversion, right - facing southeast at the service spillway.

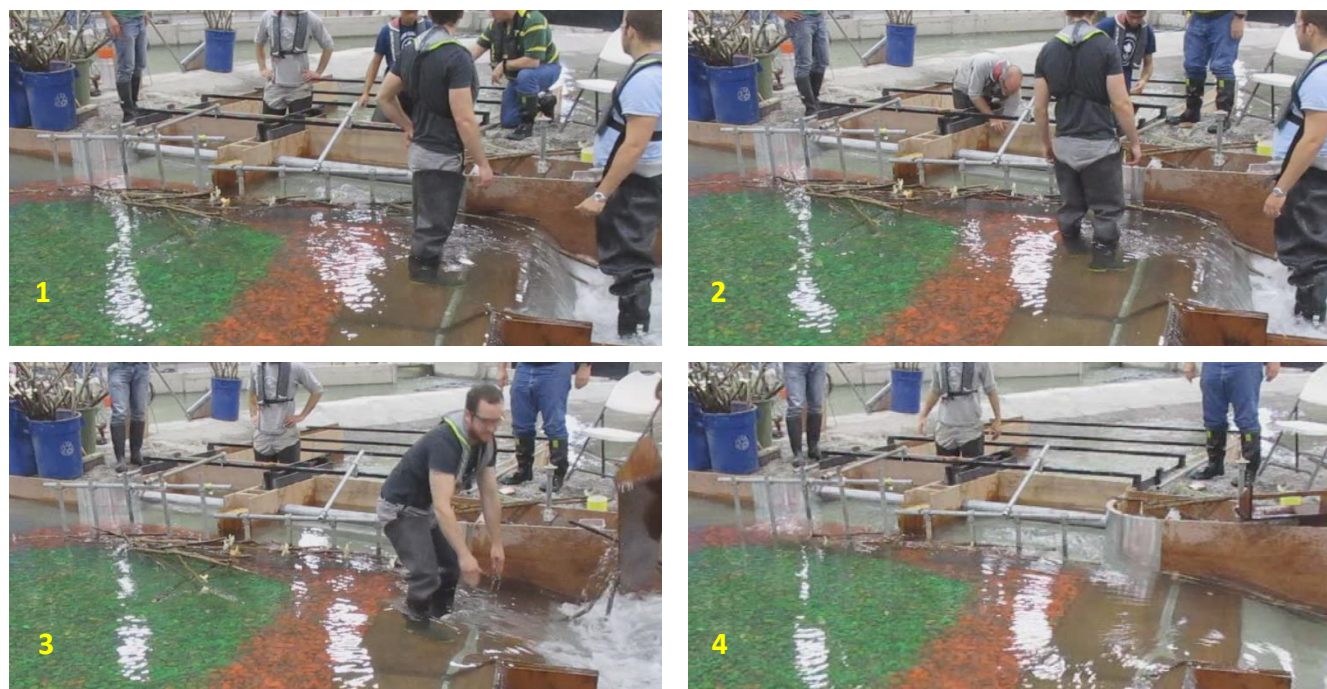
Figure 140. Debris caught on Debris Barrier D , the diversion inlet was closed and LHS Obermeyer gate was lowered to pulse the trees off the barrier.

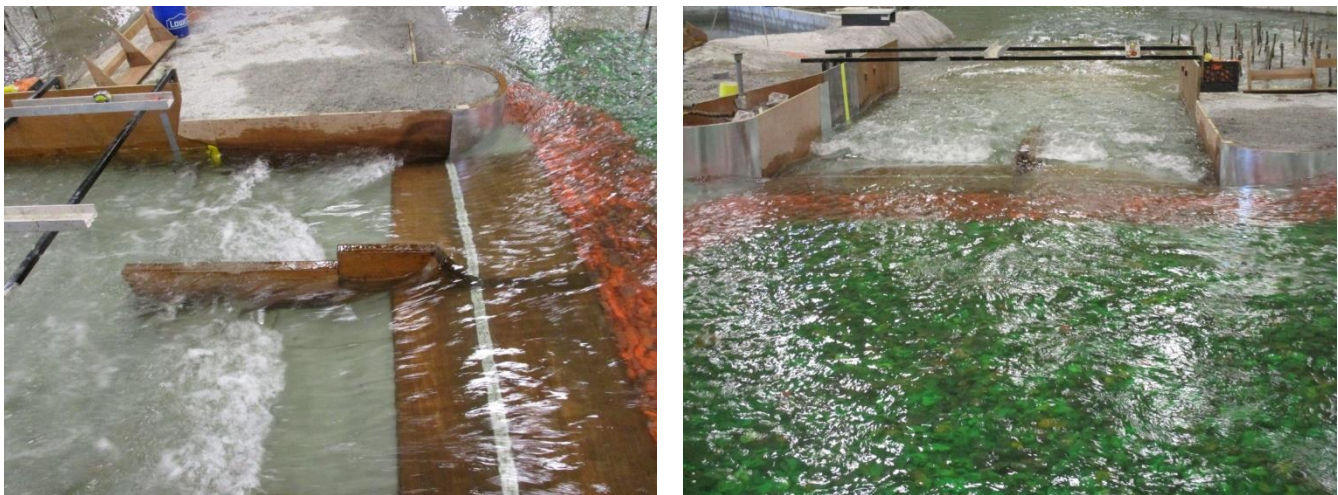
Figure 142. Flow patterns generated in the service spillway with the diversion inlet gates closed at $760 \text{ m}^3/\text{s}$.

The split point for the debris to pass down either the LHS or RHS of the service spillway was to the north of the small island of trees in the floodplain (location 3 in Figure 141). The debris did not get caught on the central pier between the Obermeyer gates. With the flood flow restricted entirely to the service spillway, the flow patterns were fairly energetic, and the hydraulic jump on the RHS was relatively unstable as the wake from the central pier combined with the wake emanating from the circular retaining wall on the RHS of the service spillway (see Figure 142).

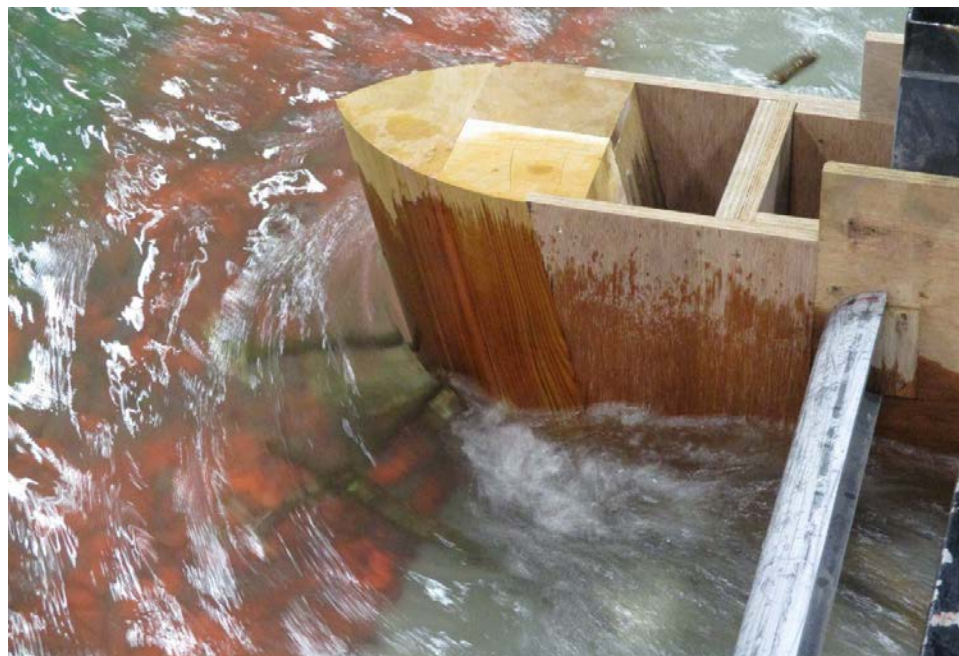
Figure 145. Debris caught on Pier Nose 3.

several points in the floodplain and tracked through the model (see Figure 143 for the insertion points and pathways). Table 23 shows a summary of the debris behaviour and performance of the model with pier nose 3 installed in the diversion. In general, the pier nose passed most of the debris through the diversion, with only a small portion of the trees of the 40-pack raft getting caught (see Figure 145).

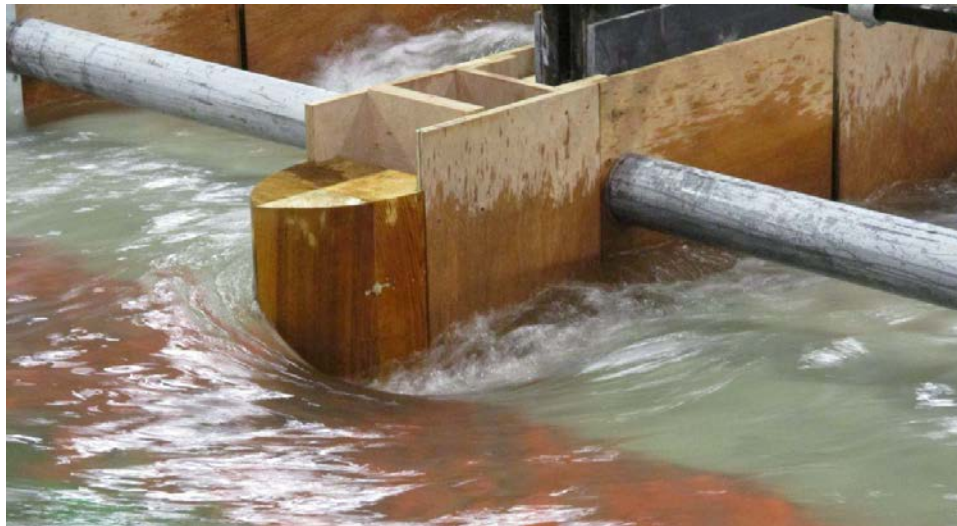
Figure 146. Wake emanating from pier nose 2 during the 1240 m³/s event.

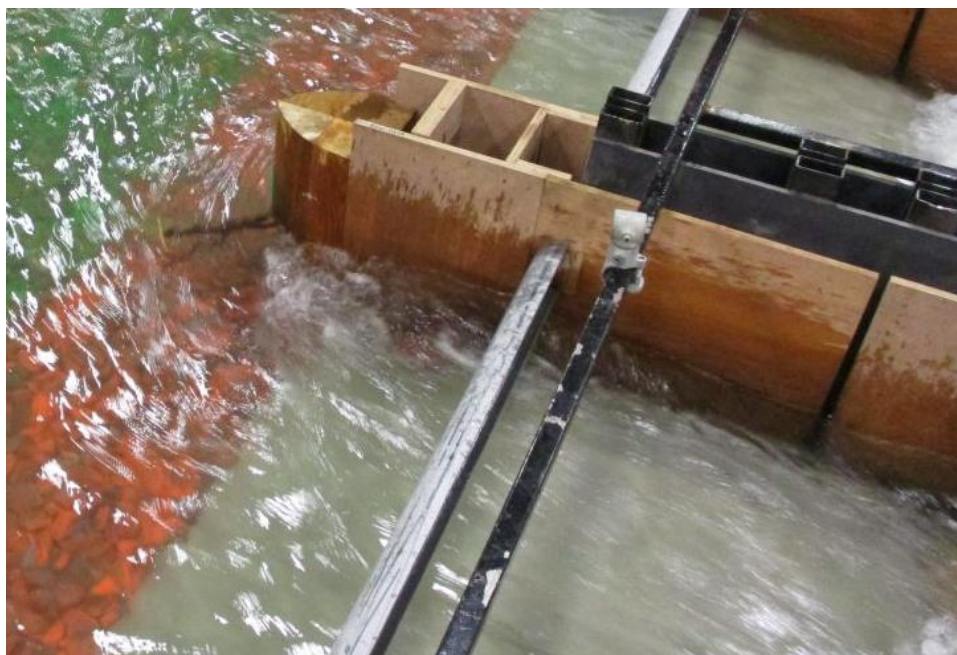
Figure 147. Debris caught on Pier Nose 2.

The flow conditions through both the diversion inlet and the service spillway were similar for pier nose 2 and pier nose 3. The wake cast from pier nose 2 appeared to be slightly deeper and more turbulent (see Figure 146). As before, debris was inserted at several points in the floodplain and tracked through the model (see Figure 143 for the insertion points and pathways). Table 24 shows a summary of the debris behaviour and performance of the model with pier nose 2 installed in the diversion. When debris came from the left hand side of the main floodplain channel (location A) a small portion was caught on the pier nose (see Figure 147).

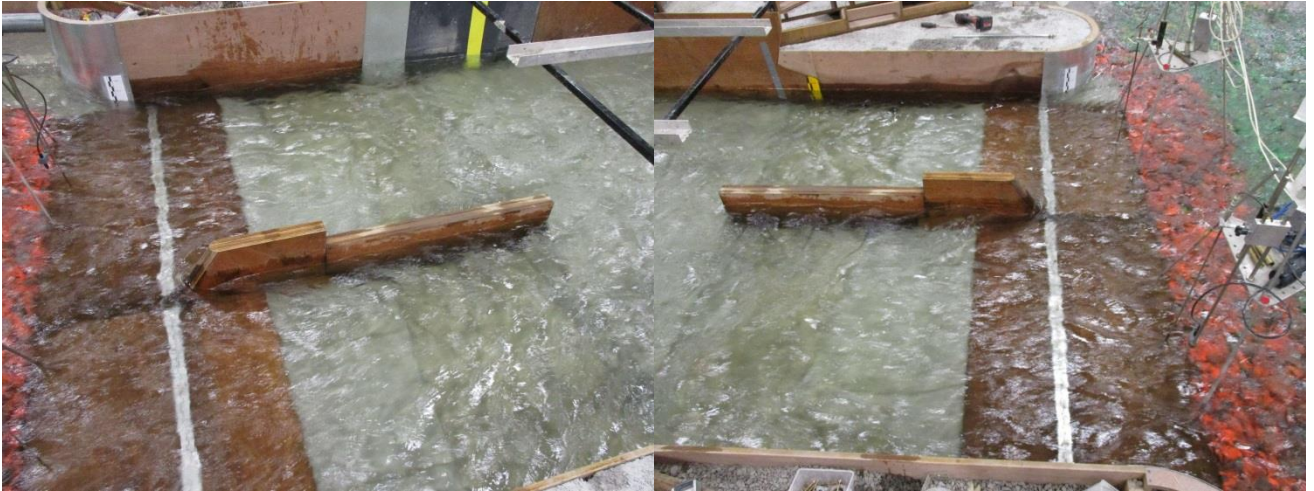
Figure 158. Flow through the service spillway during the 320 m³/s case (b) flood condition with the diversion inlet closed.

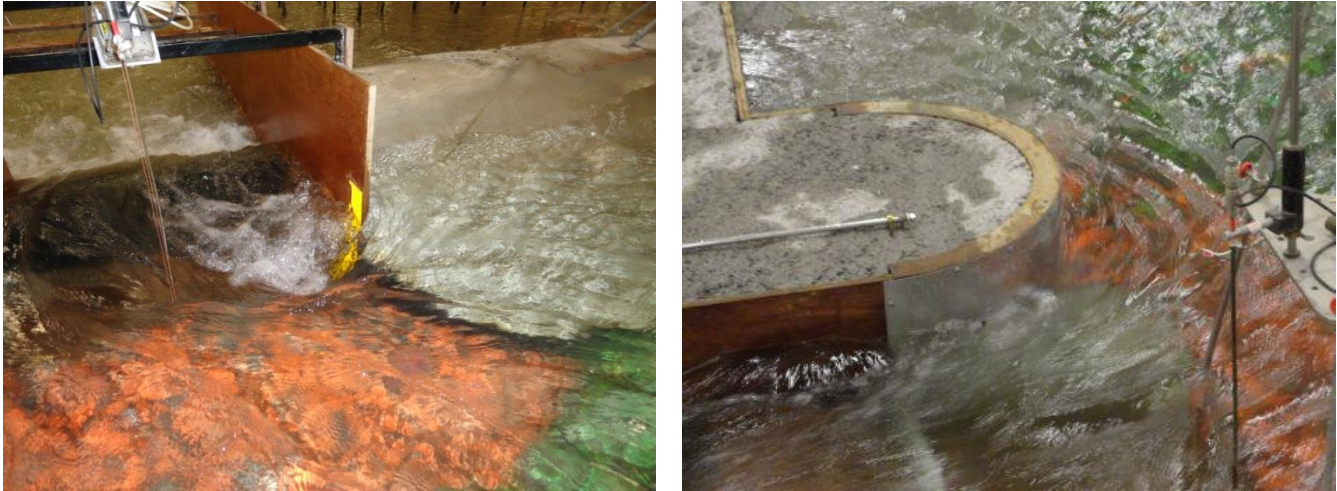
Figure 163. Wakes generated by the retaining wall on the RHS of the service spillway – left: straight wall of the initial design, right – circular design for TSD-H.

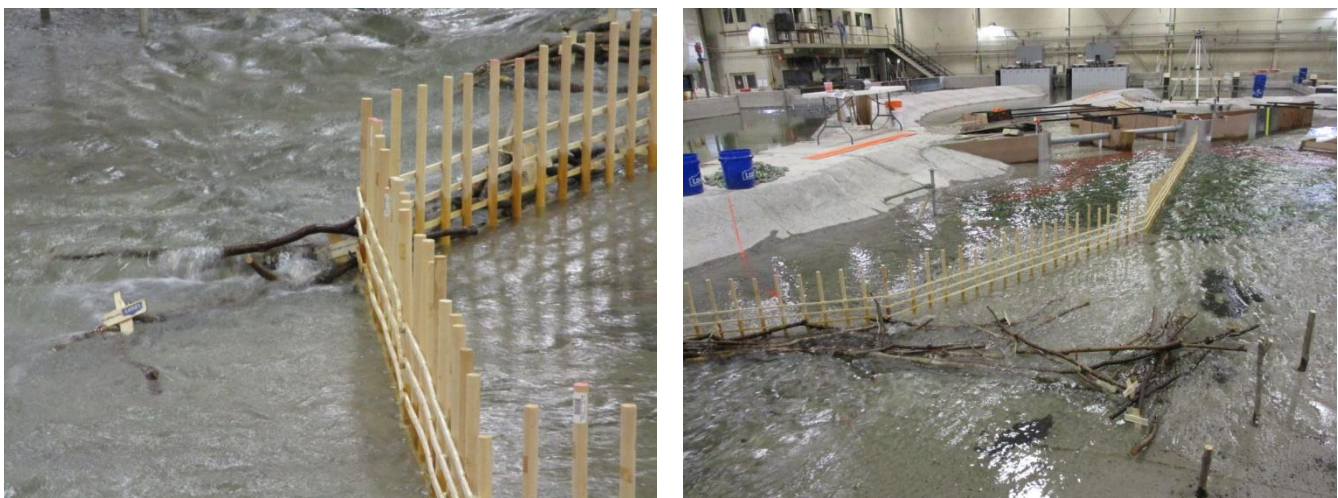
Figure 168. Debris being caught on the barrier and protruding out into the river (left), and this phenomenon continuing to bridge across the river against the standing trees producing a jam (right).

divided into legs AB, BC and CD as shown in the figure. Debris inserted into the left hand side of the western floodplain (locations 1 and 2) collected on leg AB and the debris tended to tumble along the barrier coming to rest at point B. Here, debris would collect and protrude out into the river beyond point B. When larger rafts of trees originated at location 2 the debris rafts bridged across from the debris barrier (at point B) to the standing forest in the floodplain, thus blocking the river channel (see Figure 168). At the end of the tests at 320m³/s, there was some debris caught in the barrier on leg AB, but legs BC and CD were clear of debris. In general the debris from locations 3-7 would pass through the LHS of the service spillway. Some of the single debris entries would remain caught in the hydraulic jump beyond the service spillway gate, but this debris would eventually be knocked downstream by later debris passing over the crest gates. Large rafts of debris tended to pass all the way through the structure and not hang at the hydraulic jump.

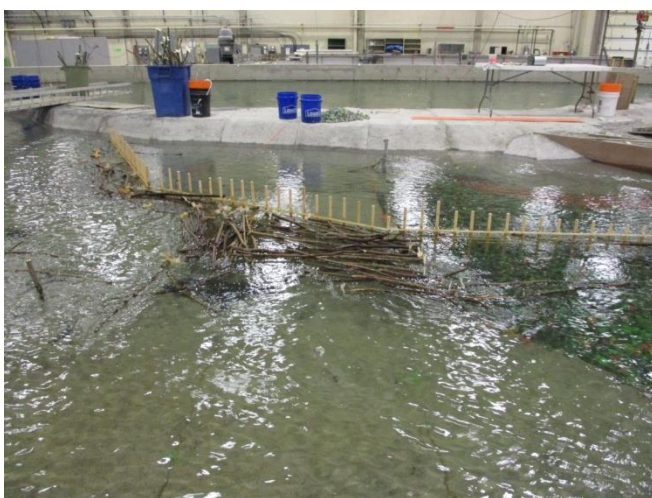
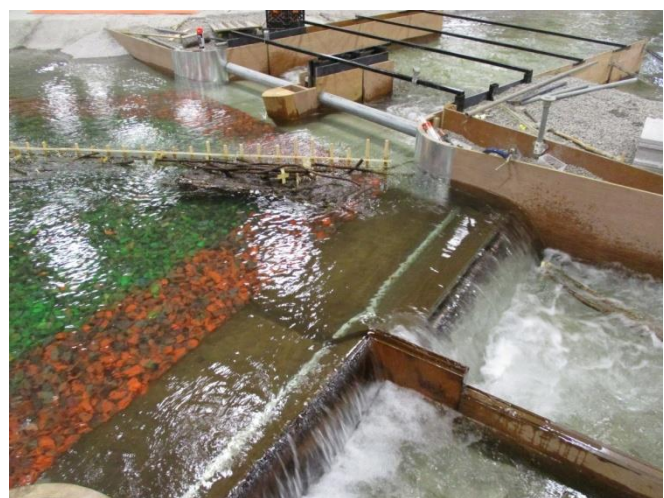
Figure 170. Debris left on barrier at the end of the 760m³/s tests for leg AB and BC (left) and at the end of the barrier on leg CD (right).

through the service spillway. At the end of the tests much debris remained on the barrier on all three legs (see Figure 170).
