Appendix IR454-1 Physical Model Study of the Springbank Off-stream Storage Project Diversion Structure
on the Elbow River Report
May 2019

Physical Model Study of the Springbank Off-stream Storage Project Diversion Structure on the Elbow River

Paul Knox, Andrew Cornett, Mitchel Provan
Ocean, Coastal and River Engineering
NRC Technical Report: OCRE-TR-2016-028

December 2016

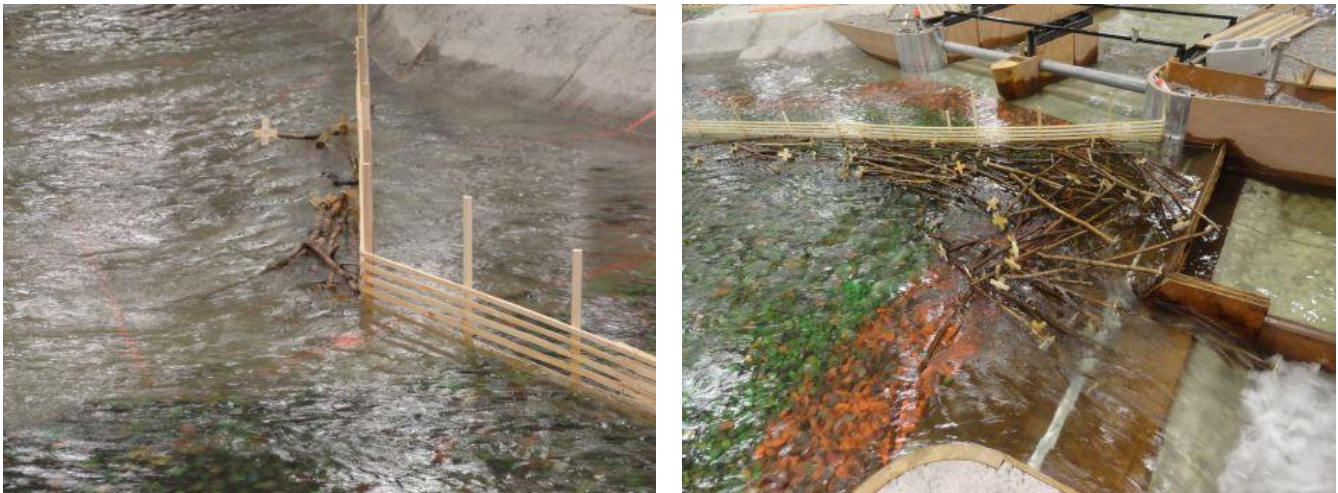
Figure 177. Debris caught on the upstream end of the barrier (leg AB) at the end of the Case B tests (left) and at the downstream end of the barrier (leg BC) in front of the raised LHS Obermeyer gate (right).
