# Compliance Directive

**Directive #:** CD 24-01

This directive relates to unauthorized construction of a manure collection area (MCA) and the failure to comply with the terms and conditions of Approval RA06036, at Beaver Valley Cattle Co. Ltd., which is a beef feedlot.

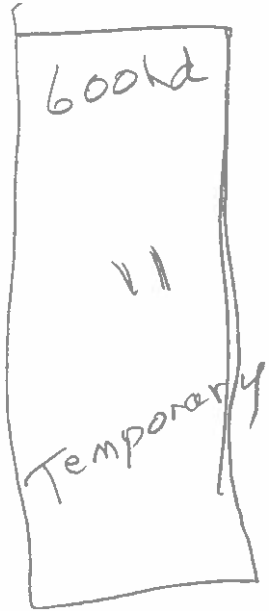
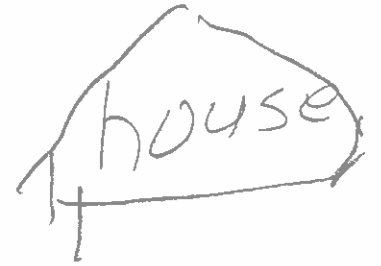
**Appendix A - Klassen Livestock Records & Pen Layout - April 30, 2024**

Pen ID	Livestock Type (Finisher/Feeder/Calves)	Average Cattle Weight (lbs)	Current Number of Cattle in Pen
1	Bulls	1200	20 head
2	Feeder str	800	30
3	✓ ✓	700	100
4	✓ ✓	800	100
5	✓ ✓	750	125
6	✓ ✓	750	150
7	✓ ✓	750	175
8	✓ ✓	750	175
11	✓ ✓	750	600
9	✓ ✓	800	125
10	✓ ✓	800	125
12	✓ ✓	750	100
			Total 1825 head

# Temporary  
12 100 hd

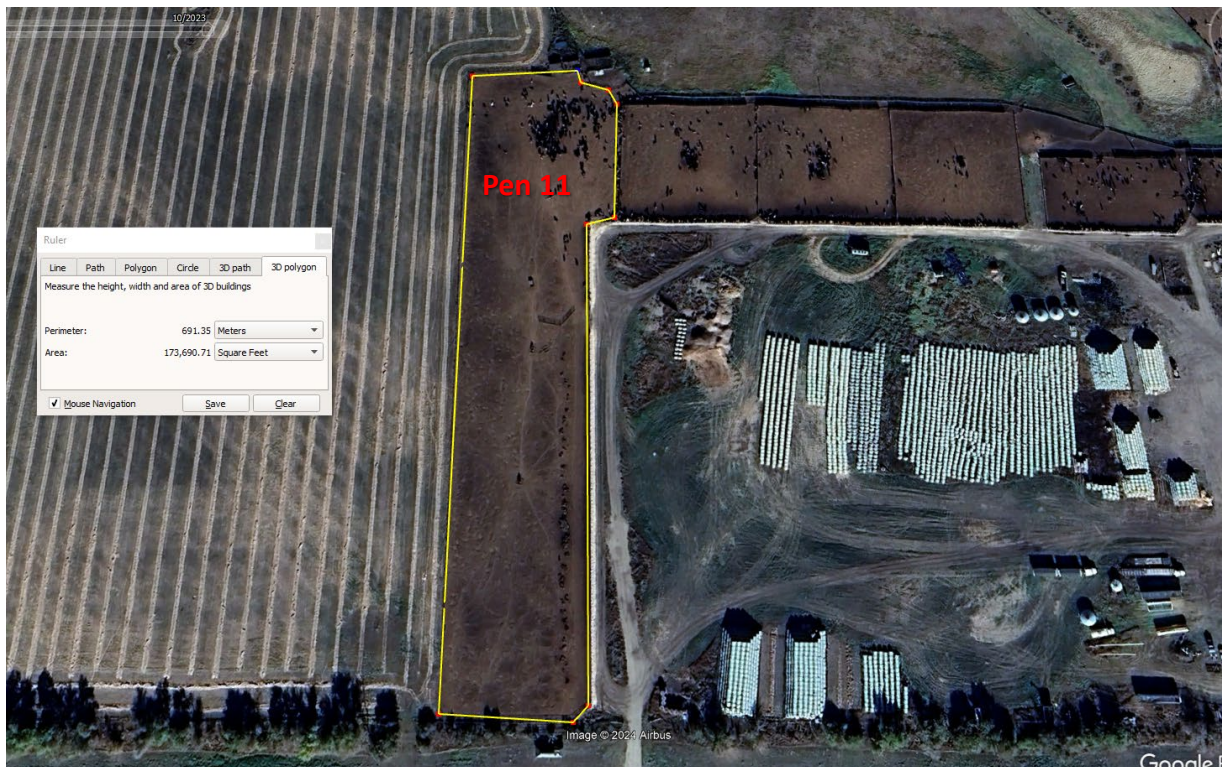
- This pen was constructed of a permanent wooden fence with posts utilizing fenceline feeding along the east side of the pen. The remainder of the pen was constructed of temporary steel fencing. There were panels throughout the pen.
- There was no evidence of seeded vegetation in the pen and the soil appeared compact.
- The operator advised he had recently removed the solid manure from the pen which was stockpiled in the yard to the east of the pen.
- The pen had access to grazing lands to the north and west.
- The pen was populated at the time of inspection.
- The operator had identified on the LPVP spreadsheet and on the pen layout plan that there were 600 head of beef feeders with an average weight of 750 lbs., currently in unauthorized pen 11.

Pen 11 Measures approx. 691.35 m<sup>2</sup>

1. By August 1, 2024, depopulate pens 11 & 12 as identified on the Google Earth Pro Aerial Imagery from October 2023 (Appendix B), if an NRCB permit for the new manure collection area(s) of pens 11 & 12 has not been obtained; and
2. By August 1, 2024, pens 11 & 12, as identified on the Google Earth Pro Aerial Imagery from October 2023 (Appendix B), must be permanently closed in accordance with Technical Guideline Agdex 096-90 Closure of Manure Storage Facilities and Manure Collections Areas for a solid manure collection area, if an NRCB permit for the manure collection area(s) of pens 11 & 12 has not been obtained. This includes removal of all the manure; and

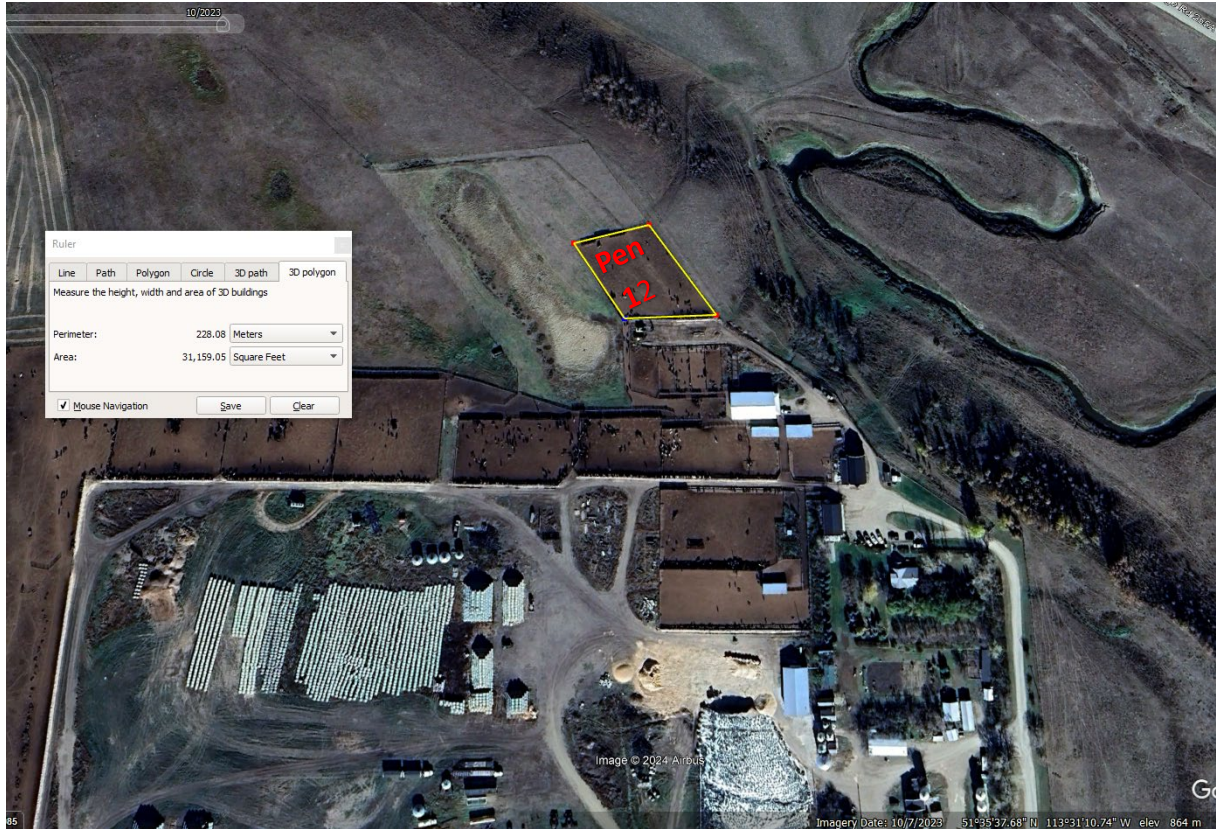
When asked about surface run-off control towards Kneehill Creek in unauthorized pen 12 (Appendix B), the operator advised it had been dry and that a berm had been constructed along the east side of the surface run-off interceptor. Upon returning to the office, a further review of NRCB records was conducted and it was identified that a portion of the berm along the east side of the surface run-off interceptor, as

recommended in the Engineer's Report from 2007 and as required by Approval RA06036, had been removed with the construction of unauthorized pen 12.

- Pen 12 was constructed of permanent wood fencing (post and rail) which included fenceline feeding along the south side of the pen. Barbed wire and wooden panels appeared to make up the remaining perimeter. When reviewing my photos back at the office, it appeared there may also be fenceline feeding along the north side of the pen.

- There was a small manure stockpile located just outside of this pen on the southeast side.
- The pen was populated at the time of inspection. As per the population numbers and pen layout plan provided by the operator there was 100 head of feeders weighing on average 750 lbs. in the pen at the time of inspection.

**Pen 12 Measures approximately 228.08 m<sup>2</sup>**

By August 1, 2024, after permanently closing pen 12 (Appendix B), reconstruct the portion of the berm removed along the east side of the surface run-off interceptor in accordance with engineer's report required in Condition 1a of permit RA06036.
