# COUGAR CREEK, 2013 FORENSIC ANALYSIS AND SHORT-TERM DEBRIS FLOOD MITIGATION FINAL

PROJECT No: 1261-001

Document No: TC13-004

# 2013 FORENSIC ANALYSIS AND SHORT-TERM DEBRIS FLOOD MITIGATION

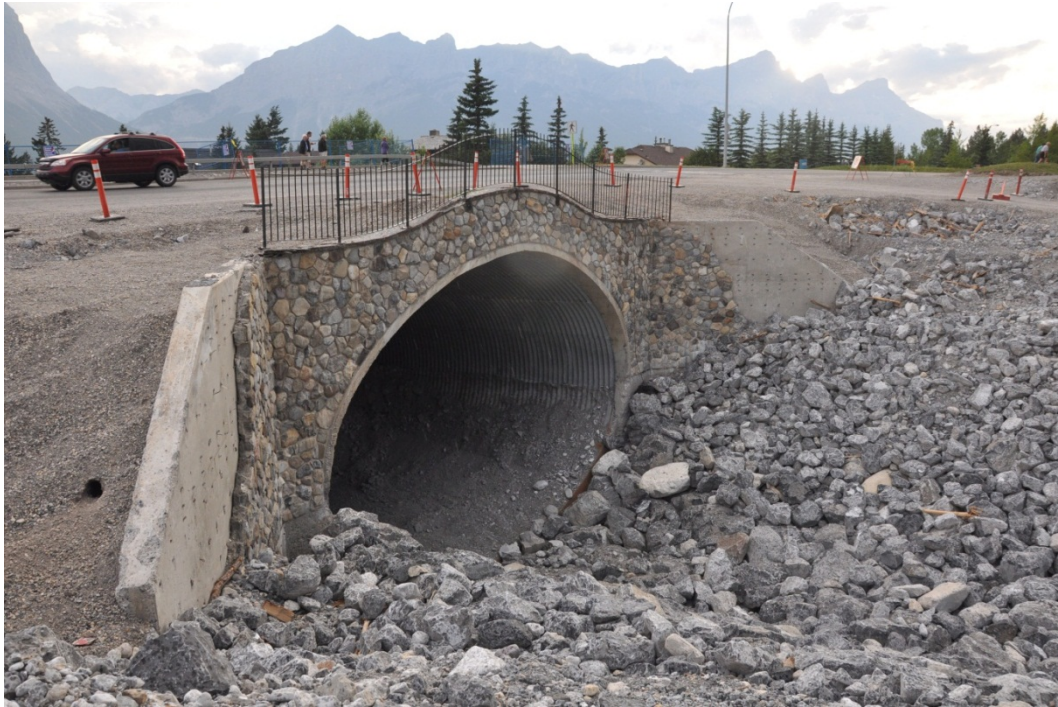
Crossing	Description
Elk Run Boulevard (Photo 2-1)	<ul style="list-style-type: none"> <li>• elliptical, multi-plated steel culvert</li> <li>• design drawings by Engineering Associates Canada (1982) show the culvert is approximately 6.45 m high, 9.5 m wide and 29 m long with a gradient of 5%</li> <li>• capacity = 160 m<sup>3</sup>/s (CH2M HILL, 1993a)</li> <li>• concrete wingwalls at 45° are located at both the inlet and outlet, and extend out about 5 m</li> <li>• concrete cutoff wall extends about 1.4 m below the culvert invert.</li> <li>• The culvert was rehabilitated in 2012. Design drawings by Associated Engineering (2012) show the installation of an invert protection plate, repairs to the cutoff wall and placement of a concrete liner at the base of the culvert.</li> </ul>
Highway 1 (Photo 2-2)	<ul style="list-style-type: none"> <li>• three concrete box culverts: 2.44 m wide x 2.75 m high x 64 m long</li> <li>• constructed in 1967</li> <li>• capacity = 64 m<sup>3</sup>/s (CH2M HILL, 1993a)</li> <li>• culverts installed with a concrete apron and wingwalls</li> </ul>

**Photo 2-1. Culvert inlet at Elk Run Boulevard. BGC photograph of July 23, 2013.**

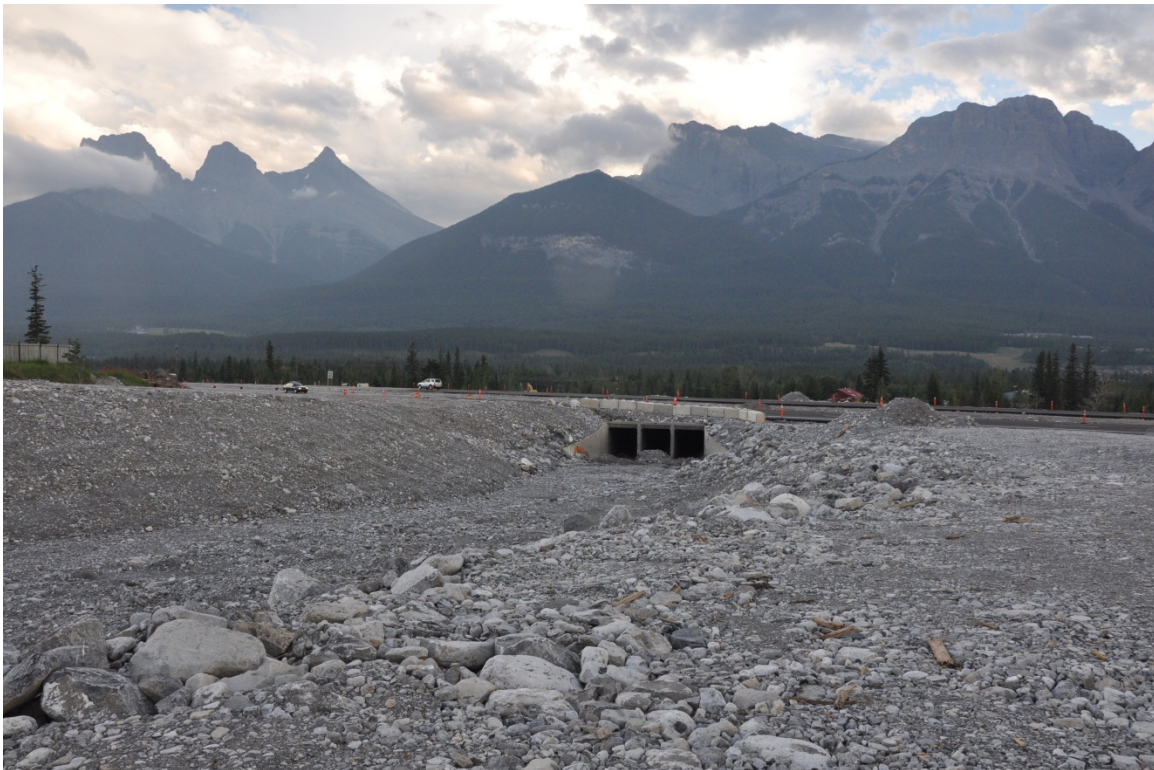
**Photo 2-2. Downstream view of the culvert inlet at Highway 1. BGC photograph of July 23, 2013.**

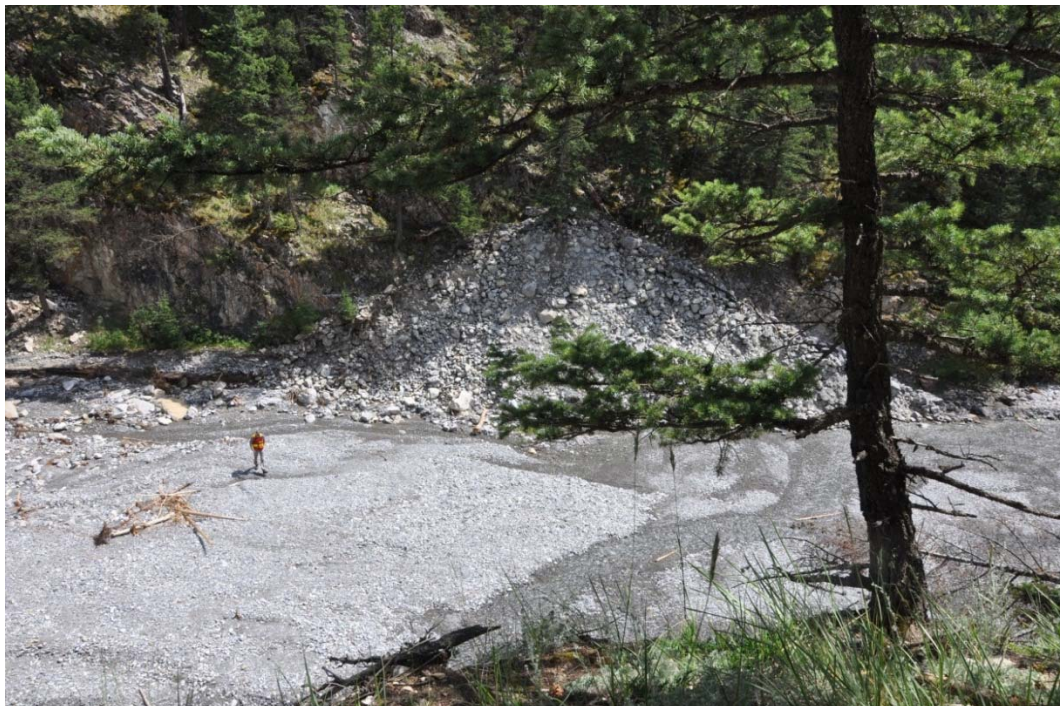
The dam failure caused major erosion downstream. The channel bed was scoured to bedrock in the middle of the breach and most of the dam material was mobilized downstream, except for a portion on the left abutment (Photo 3-4). Remnants of the rockfill dam are still present, as shown on Photo 3-5. The culverts under Highway 1, Highway 1A and the CP Rail tracks were either partly or completely filled with sediment, resulting in a partial washout of the CP Rail tracks. Minor damage also occurred to the shoulders of Highway 1 when the backed up flood waters partially overtopped the road. Damage to the rail tracks was repaired within two hours, although the track remained closed until the next morning while the culverts were unplugged. Photos 3-6 through 3-9 illustrate some of the downstream damage caused by the dam failure.

**Photo 3-5. On right bank looking to left bank of Cougar Creek at the site of the 1982 rockfill dam. The rockfill remnants of that dam are visible on the left bank. BGC photograph of July 23, 2013.**

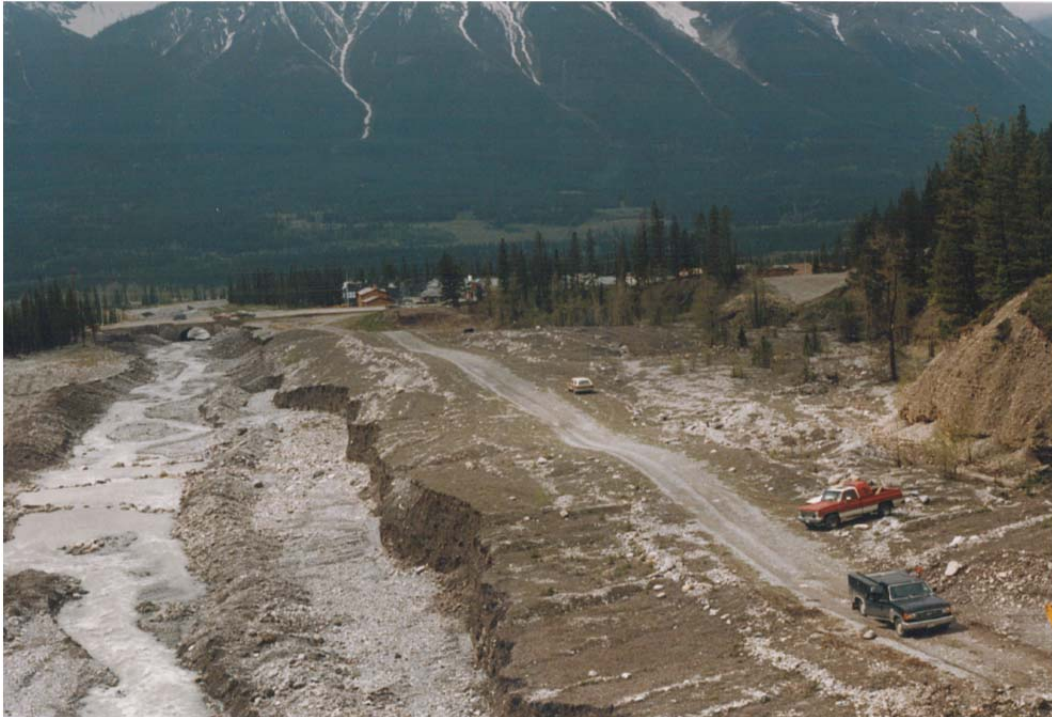
**Photo 3-6. Downstream view of Cougar Creek looking toward Elk Run Boulevard. Photo courtesy of Kent Berg, Alberta Environment and Sustainable Resource Development. May 26, 1990.**

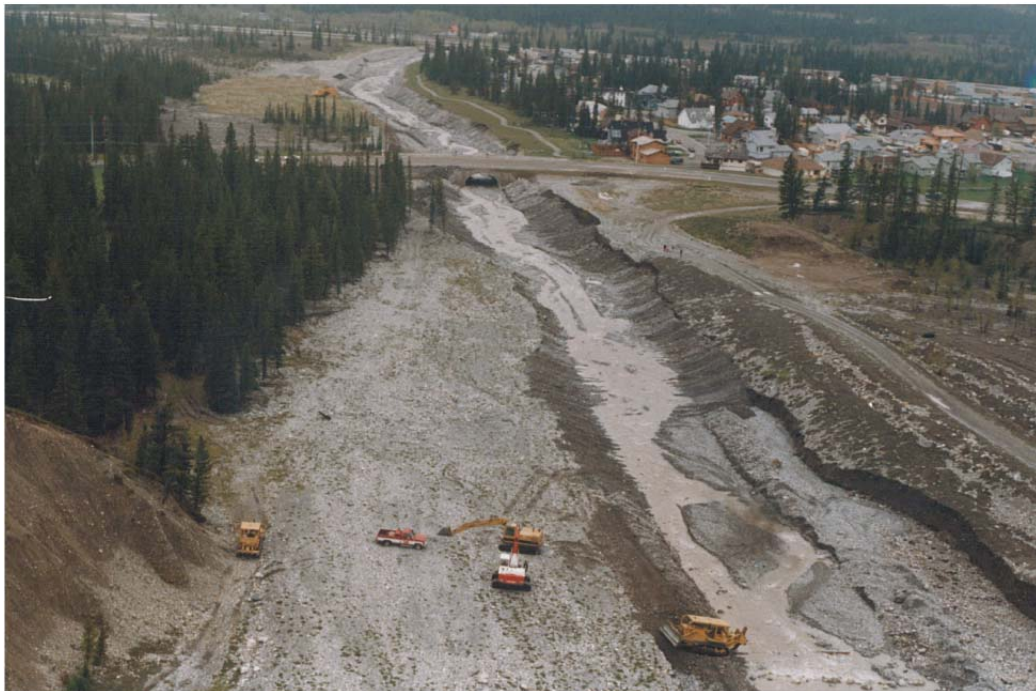
**Photo 3-7. Downstream view of Cougar Creek looking toward Elk Run Boulevard. Photo courtesy of Kent Berg, Alberta Environment and Sustainable Resource Development. May 26, 1990.**

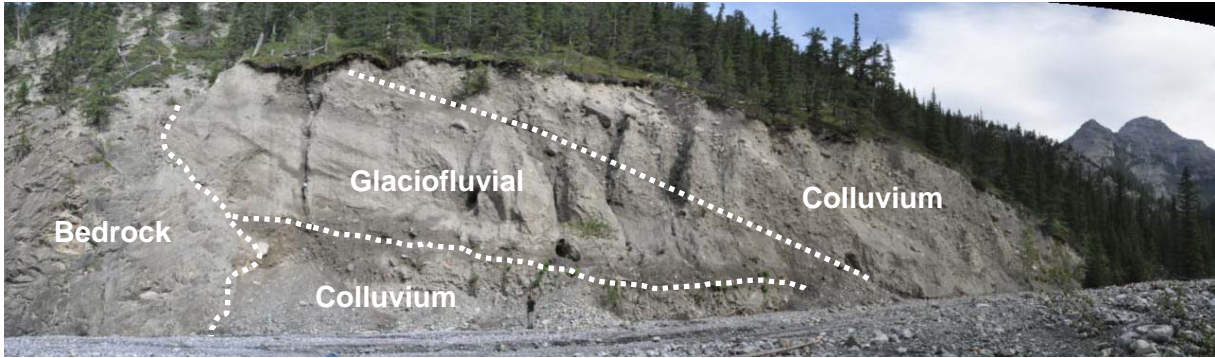
**Photo 5-1.** A section of the right (west) bank of Cougar Creek approximately 2.3 km upstream of the fan apex. The exposed section is approximately 20 m high.

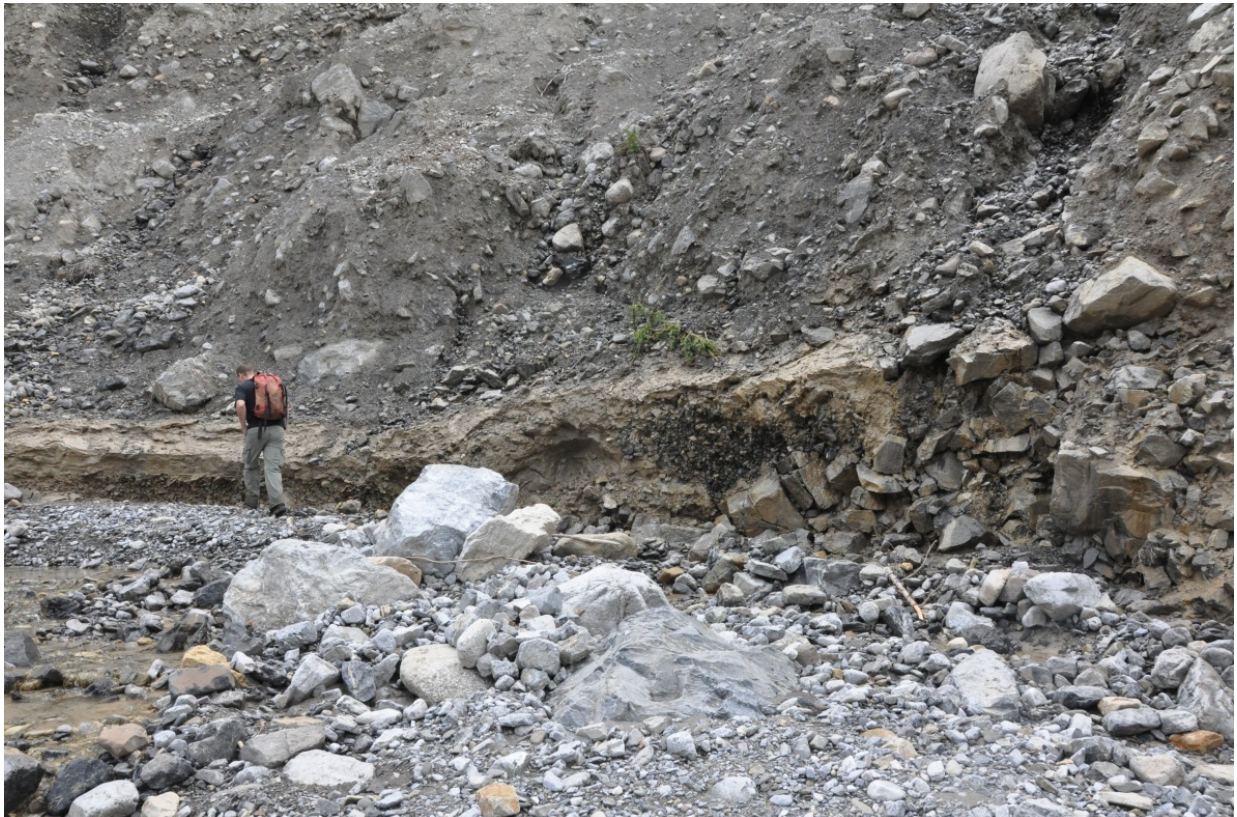
**Photo 5-2.** Glaciolacustrine deposits underlying a large debris flow fan deposit approximately 2.8 km upstream of the fan apex. The deposit is locally interrupted by a former creek channel. Photo 5-3 shows a detail of this exposure. BGC photograph of August 29, 2013.

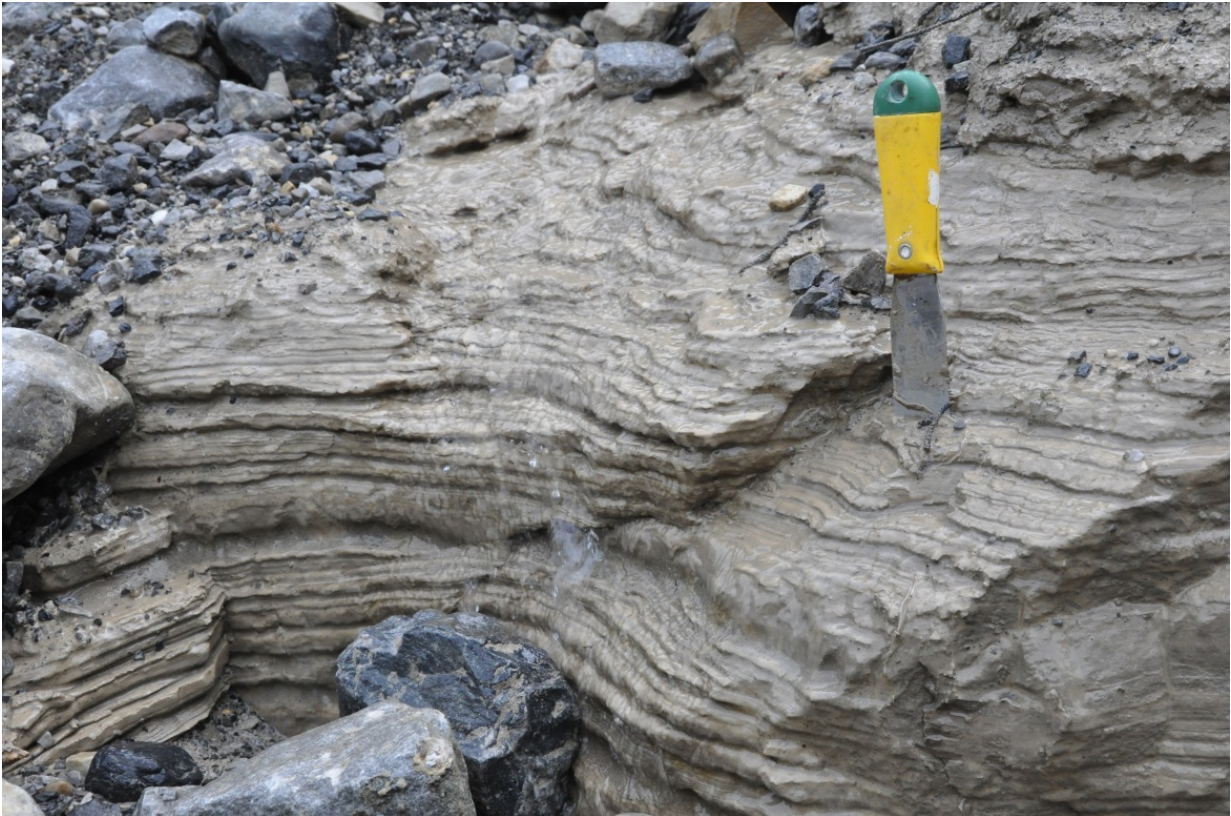
**Photo 5-3. Detail of varved (layered) glaciolacustrine deposits at the same location as Photo 5-2. Each layer may present one year of cyclical deposition of fine sediments (later summer and fall) and coarser sediments (spring and early summer). BGC photograph of August 29, 2013.**

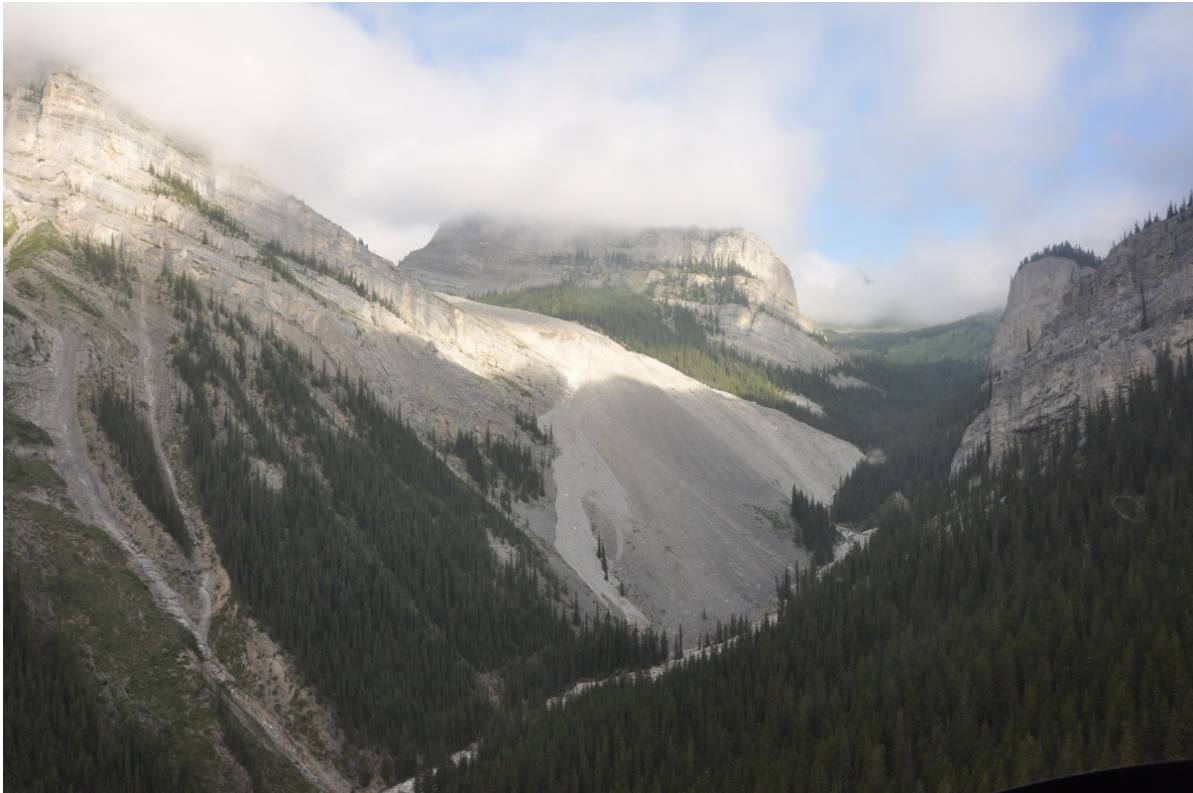
The Cougar Creek watershed is no longer occupied by any glaciers. However, one rock glacier has been identified in a west sub-watershed (Photo 5-4) indicating the presence of alpine permafrost at elevations in excess of approximately 2200 m, at least on north-facing slopes. This rock glacier may have originated from a rock slide onto remnant glacial ice which slowly transformed it into a rock glacier. At the present time, the rock glacier is still actively creeping and shedding material from its front into the Cougar Creek channel. During the June 2013 storm, a portion of the rock glacier's active layer (seasonally unfrozen layer) detached and evolved into a small ( $< 100 \text{ m}^3$ ) debris flow that discharged into a tributary of Cougar Creek (Photo 5-5).

**Photo 5-4. The front of an active rock glacier in the upper Cougar Creek watershed, approximately 7.2 km upstream of the fan apex. Photo 5-5 shows a detail of the active layer detachment on the left flank of the rock glacier. BGC photograph of July 24, 2013.**

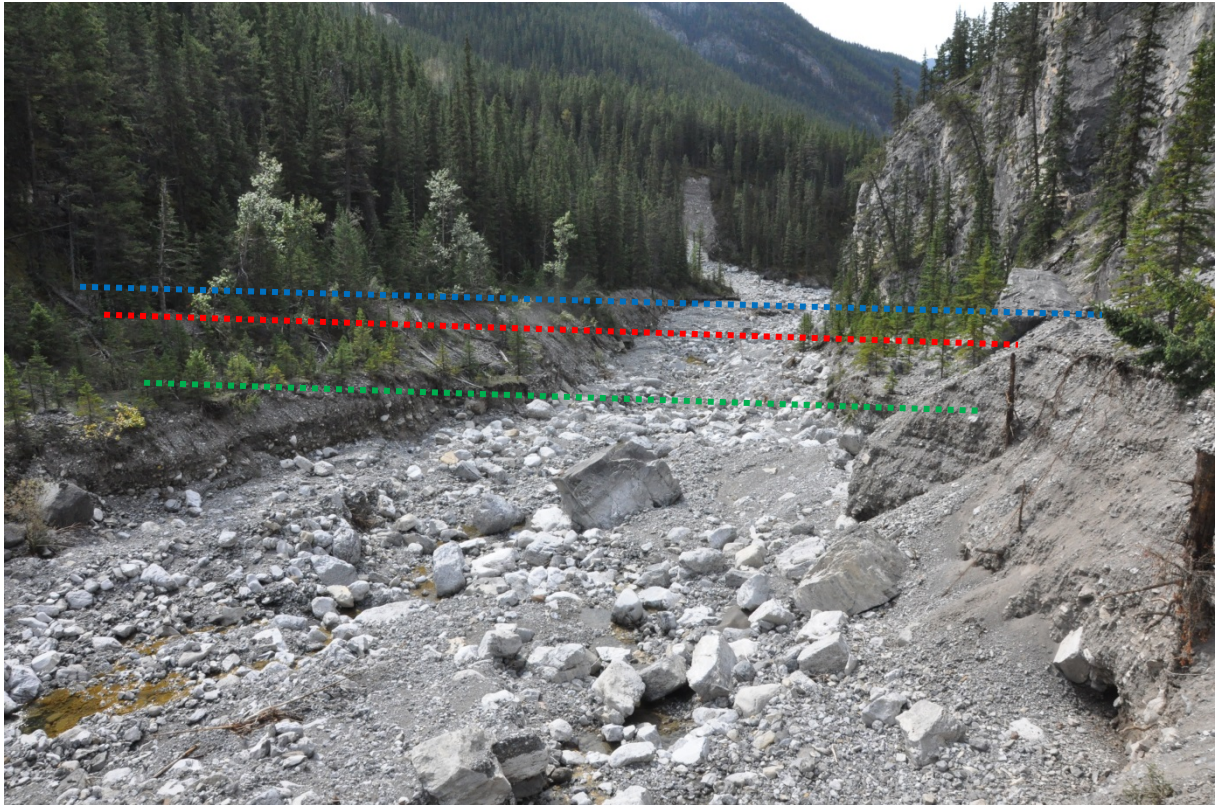
Also of note are debris flows from tributaries that have left high terraces and which are likely to have evolved into debris floods as they diluted during their downstream descent. A good example is "Fork Creek" (informal name by BGC) (Photo 5-6). Here multiple terraces signal previous debris flow activity of a magnitude likely exceeding the event of June 19-21, 2013. The exact magnitude of these events cannot be determined accurately because the amount of channel fill at the time of the event cannot be reconstituted with any degree of certainty.

**Photo 5-6.** Downstream view of the “Forks Creek” tributary to Cougar Creek, located about 3.5 km upstream of the fan apex. The three lines indicate previous debris-flow surfaces of unknown age. The tree on the far right side of the image has been inundated by multiple events over time.

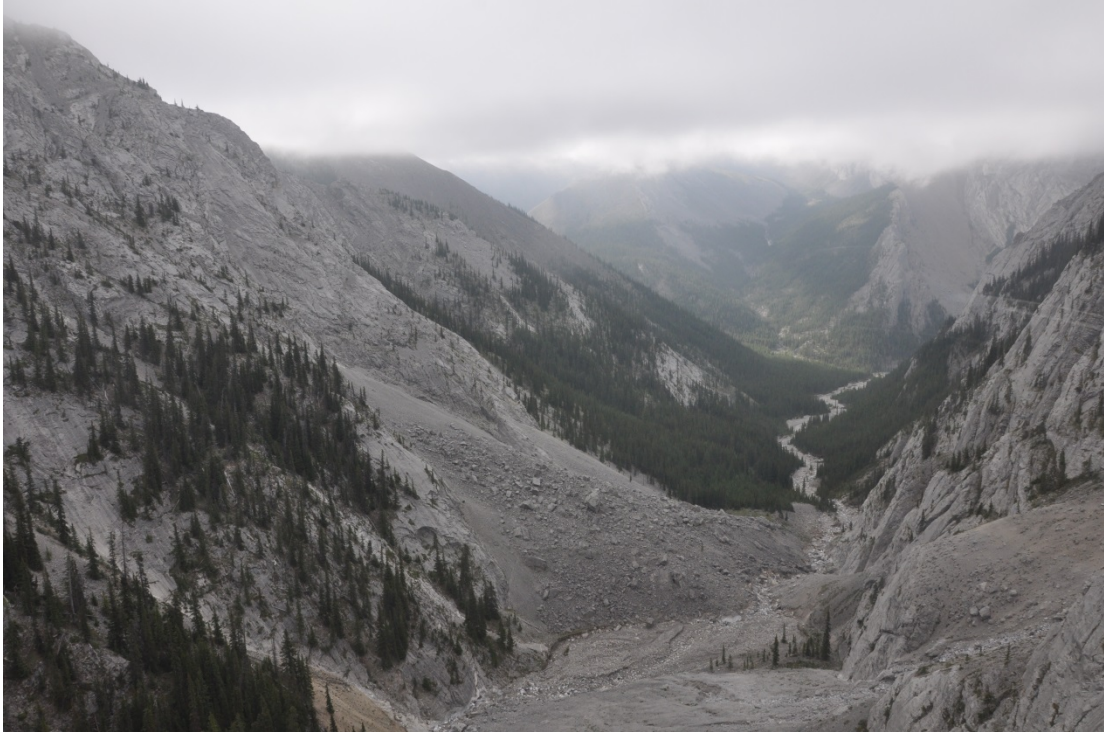
Apart from debris flows, numerous other mass movements were observed by BGC in the Cougar Creek watershed, such as rock slides, gully erosion and raveling, rock avalanches and rock fall. Photo 5-7 provides an example of a landslide (translational bedrock slide along the dominant bedrock dip) in a tributary of Cougar Creek. Given the confinement of the main channel, such landslides have likely dammed the creek on multiple occasions; creating temporary impoundments which failed at some point in time (see Photos 5-8 and 5-9). The presumed high rates of weathering and debris production have created a supply-unlimited condition in the main channel, where the exceedance of a critical hydro-climatic threshold will invariably lead to sediment movement and debris flooding on the fan.

**Photo 5-7. A large rock slide in a tributary of Cougar Creek. This event may have temporarily dammed this tributary. BGC photograph of July 24, 2013.**

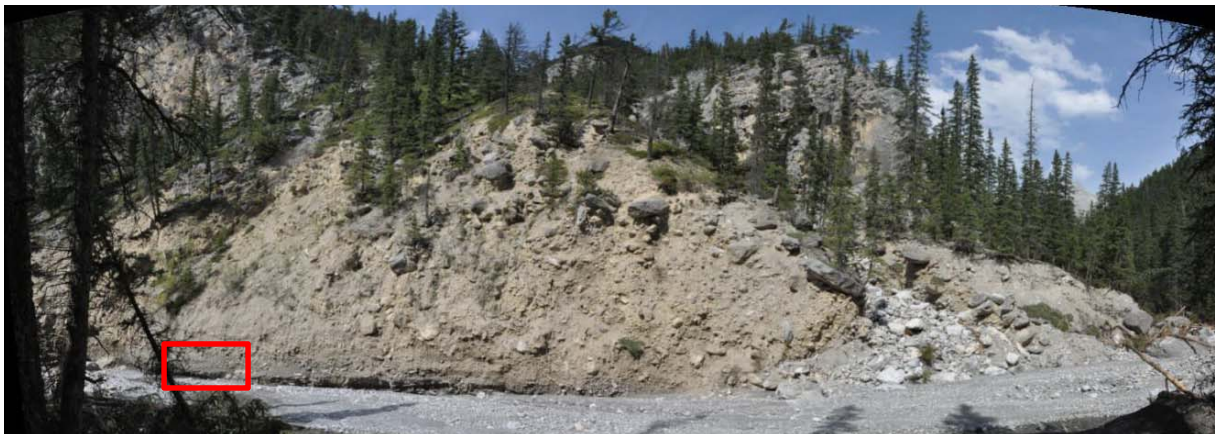
**Photo 5-8. Large landslide deposit overlying fluvial sediments approximately 1.1 km upstream of the fan apex. Photo 5-9 shows the detail delineated here as a red box. The height of the landslide deposit above the current channel bed is approximately 25 m. BGC photograph of August 29, 2013.**

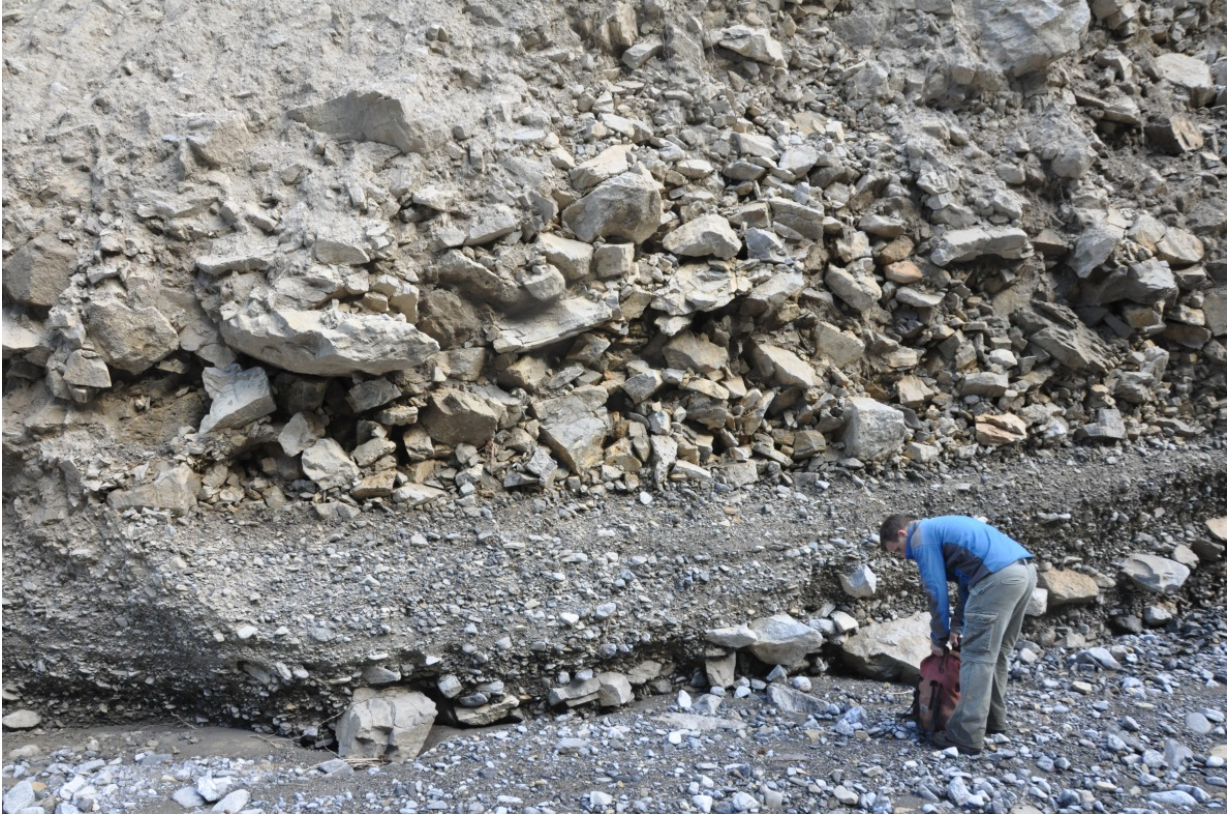
**Photo 5-9. Fluvial sediments underlying coarse, angular landslide debris at the location of Photo 5-8. BGC photograph of August 29, 2013.**

Ample source areas remain to produce renewed landslide activity of any of the above-listed processes. This is an important aspect as it forms an additional failure mode to normal bedload mobilization through exceedance of a critical discharge.

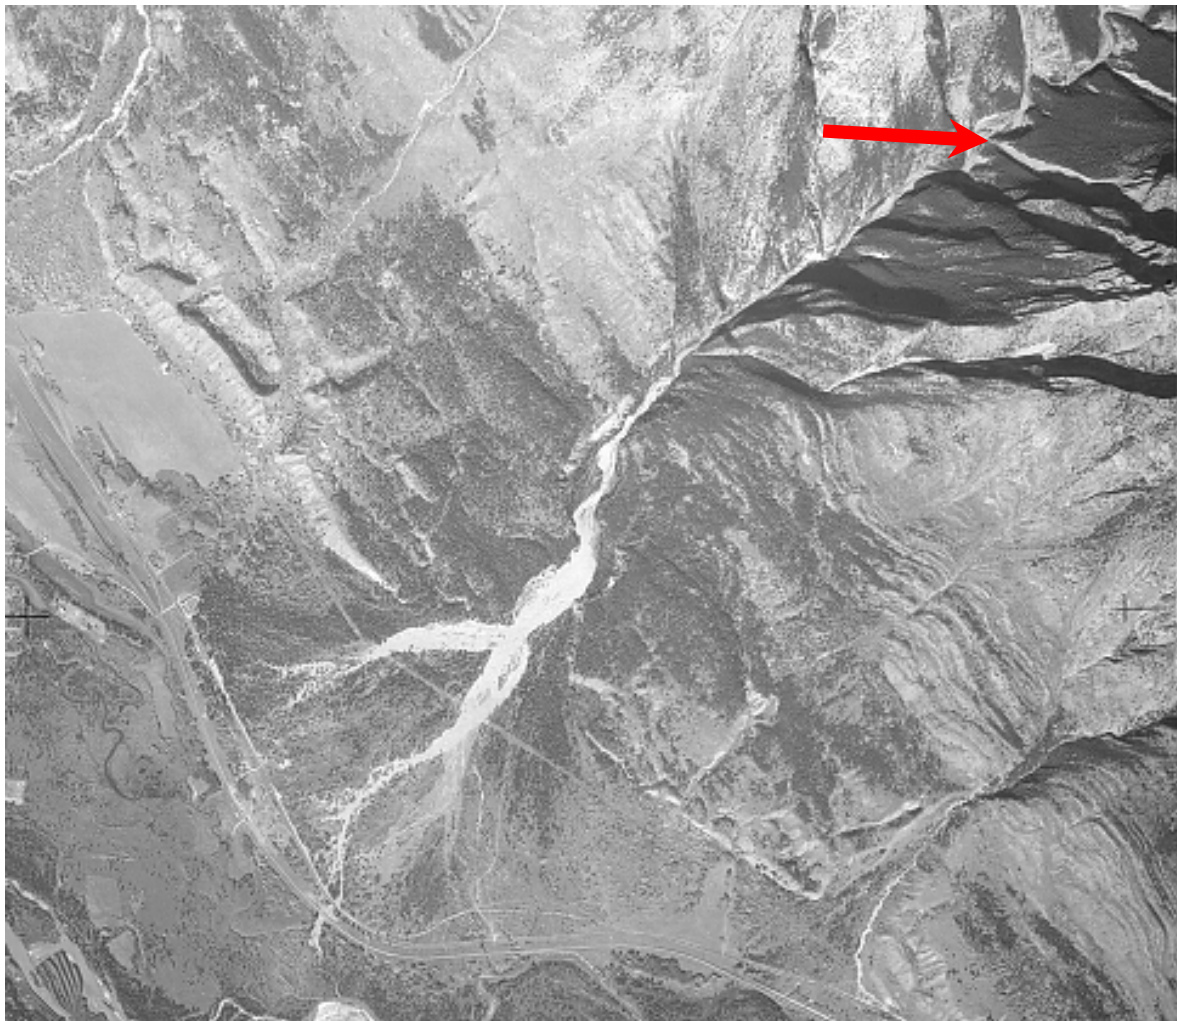
Review of the air photographs indicates that a large debris flood event occurred between 1947 and 1950. During a BGC interview with 94-year old Ms. Straw (August 7, 2013), a local resident of the fan, Ms. Straw remembered a large event occurred on May 24, 1948. Between May 21 and May 24 of that year, only 37 mm of rain fell at Kananaskis Village, which is located some 22 km east of Cougar Creek fan. In comparison, the recorded rainfall of June 19, 2013 at this station was 157 mm and had a return period of approximately 240 years, while the two day precipitation of June 19 and 20 had a return period of approximately 360 years. If the date of the 1948 event was indeed May 24, then the recorded rainfall appears inadequate to trigger a debris flood of the magnitude observed on the aerial photographs (although extreme convective rainfall in the mountains can be very local). However, analysis of the 1950 air photographs shows a fresh (date unknown) debris avalanche some 2 km upstream of the fan apex, which may have led to a temporary impoundment and a landslide dam outbreak flood (Figure 7-2).

**Figure 7-2.** 1950 air photograph of the lower reaches of Cougar Creek and the fan. The red arrow indicates a relatively fresh debris avalanche that may have dammed Cougar Creek leading to a landslide dam outbreak flood.

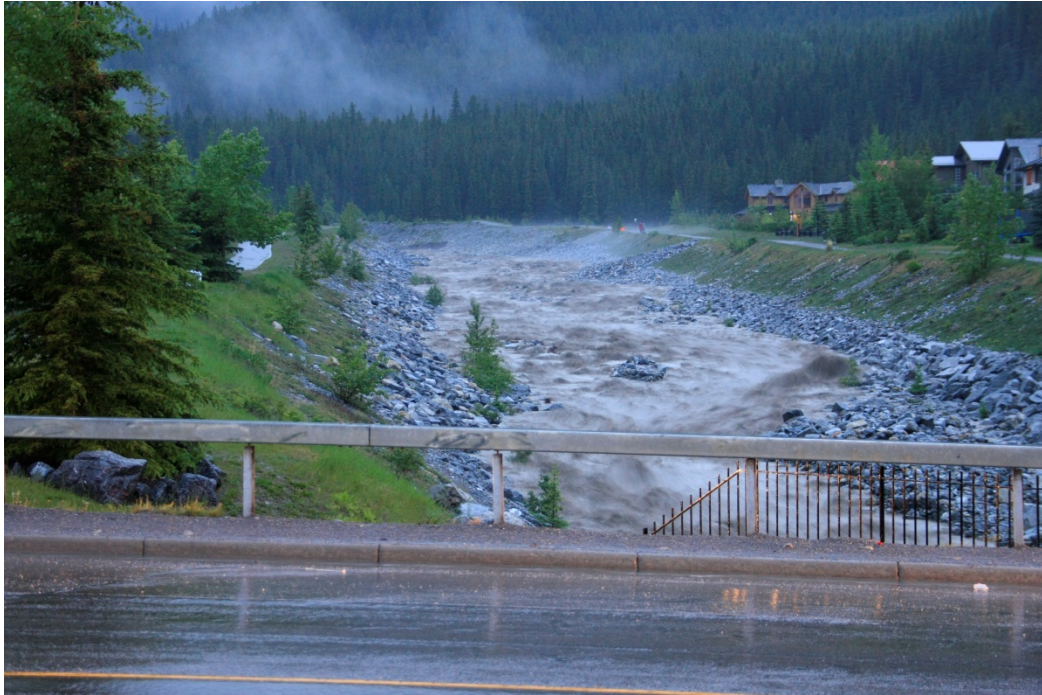
**Photo A-1. Upstream view of Cougar Creek from Elk Run Boulevard on June 19, 2013. Note the bank protection and vegetated banks. Photograph courtesy of the Town of Canmore.**

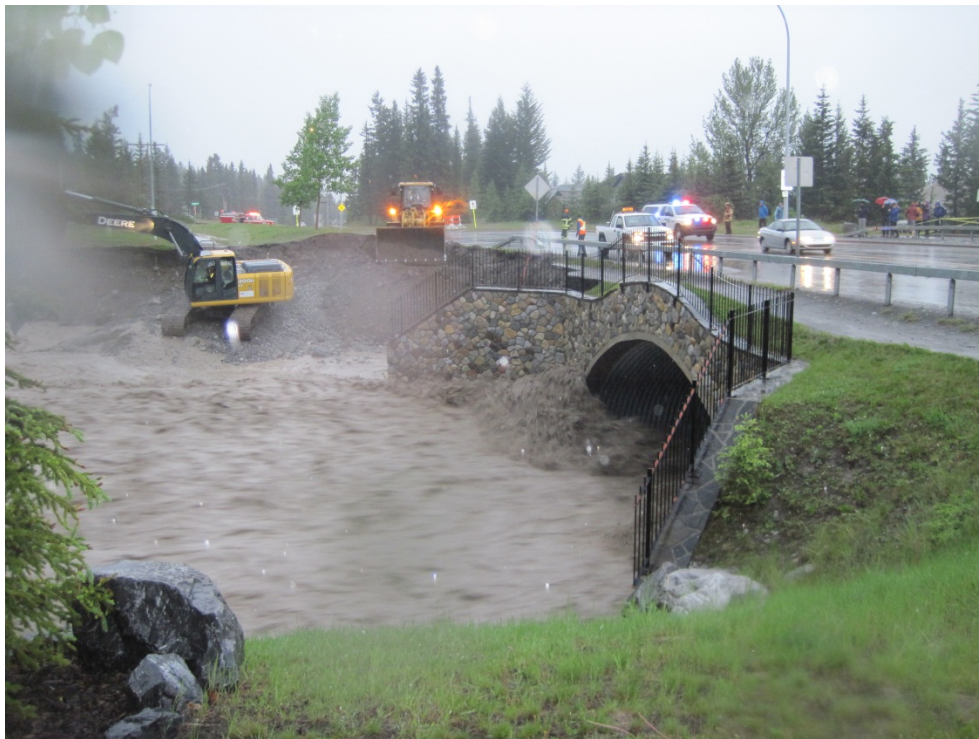
**Photo A-2. On right bank of Cougar Creek looking to left bank at the Elk Run Boulevard culvert. Emergency efforts to protect the outflanking of the culvert are underway. Photograph courtesy of the Town of Canmore.**

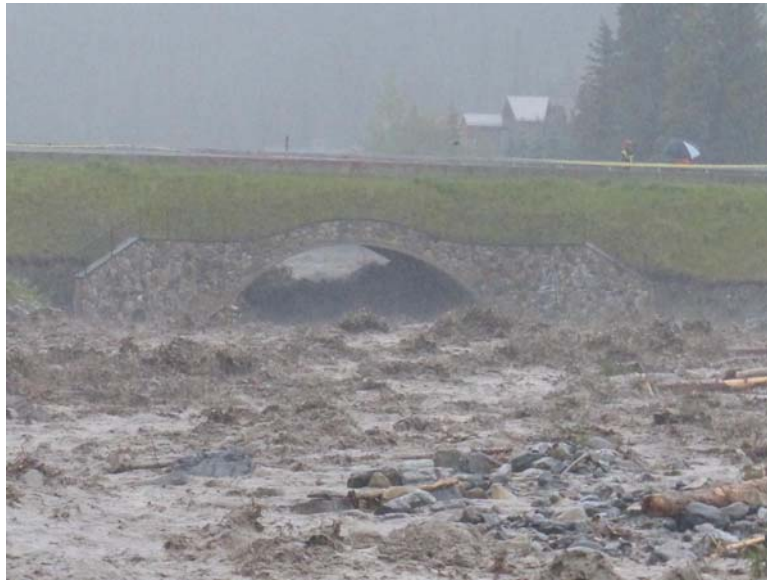
**Photo A-3. Downstream view of Cougar Creek to Elk Run Boulevard culvert. Photograph courtesy of the Town of Canmore.**

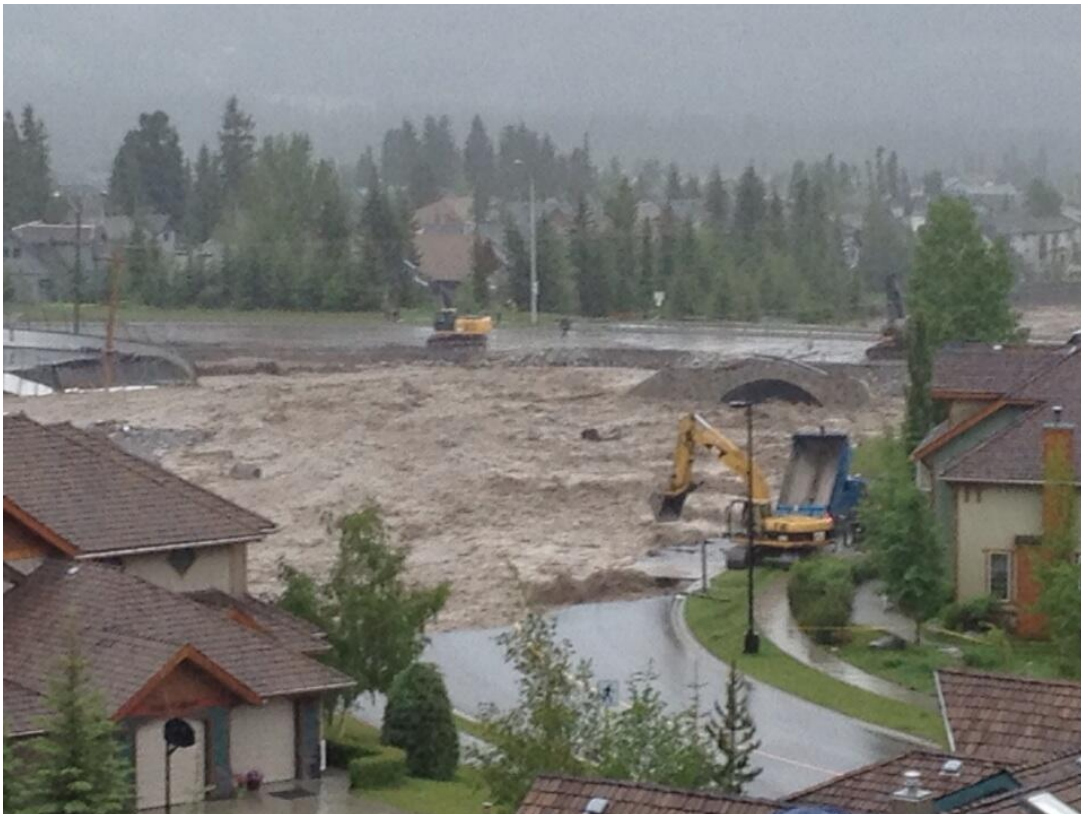
**Photo A-4. Downstream view of Cougar Creek from right bank looking to Elk Run Boulevard culvert. Photograph courtesy of the Town of Canmore.**

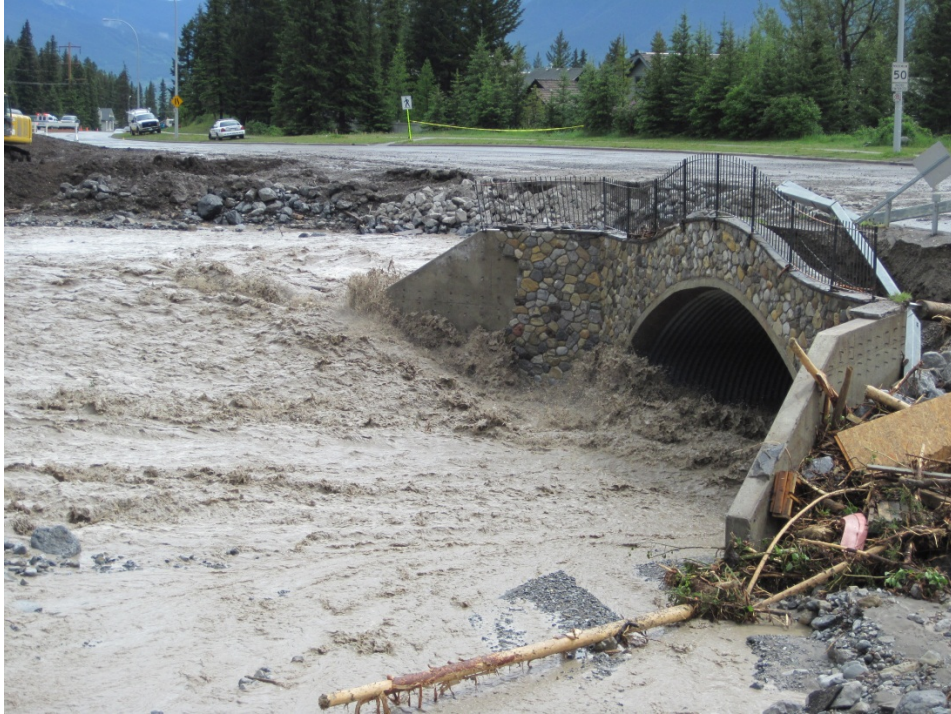
A major problem during the 2013 debris flood was that the concrete wingwalls at Elk Run Boulevard were outflanked and erosion occurred of the road embankment. This occurrence was not only an issue for equipment access to the culvert inlet, but the stability of the road embankment itself. As noted above, the gabion mattresses will tie in behind the concrete wingwalls at Elk Run Boulevard and Highway 1. For additional erosion protection at Elk Run Boulevard, Class IV riprap will be placed on both banks and on the channel substrate for a distance of about 10 m upstream of the inlet. Class IV riprap will also be placed at the Elk Run Boulevard culvert outlet for a distance of 20 m for scour protection. The recommended thickness of this riprap blanket is 2.5 m.

**Photo A-5. Side view of inlet to Elk Run Boulevard culvert. Note the outflanking of the culvert that has occurred. Photograph courtesy of the Town of Canmore.**

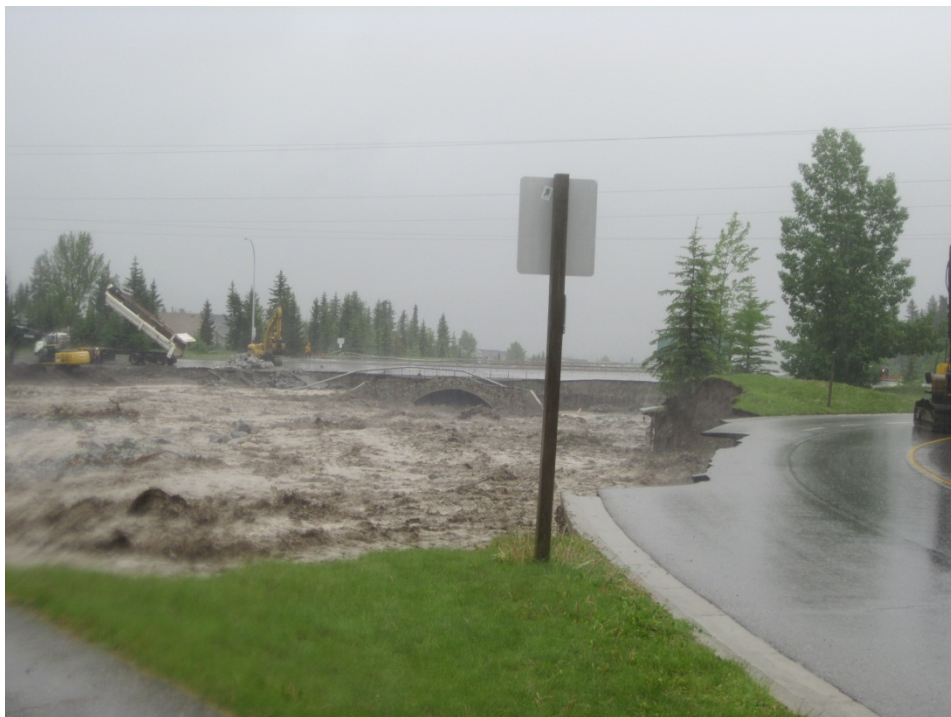
**Photo A-6. Downstream view to Elk Run Boulevard culvert from Benchlands Trail, which has partially eroded. Photograph courtesy of the Town of Canmore.**

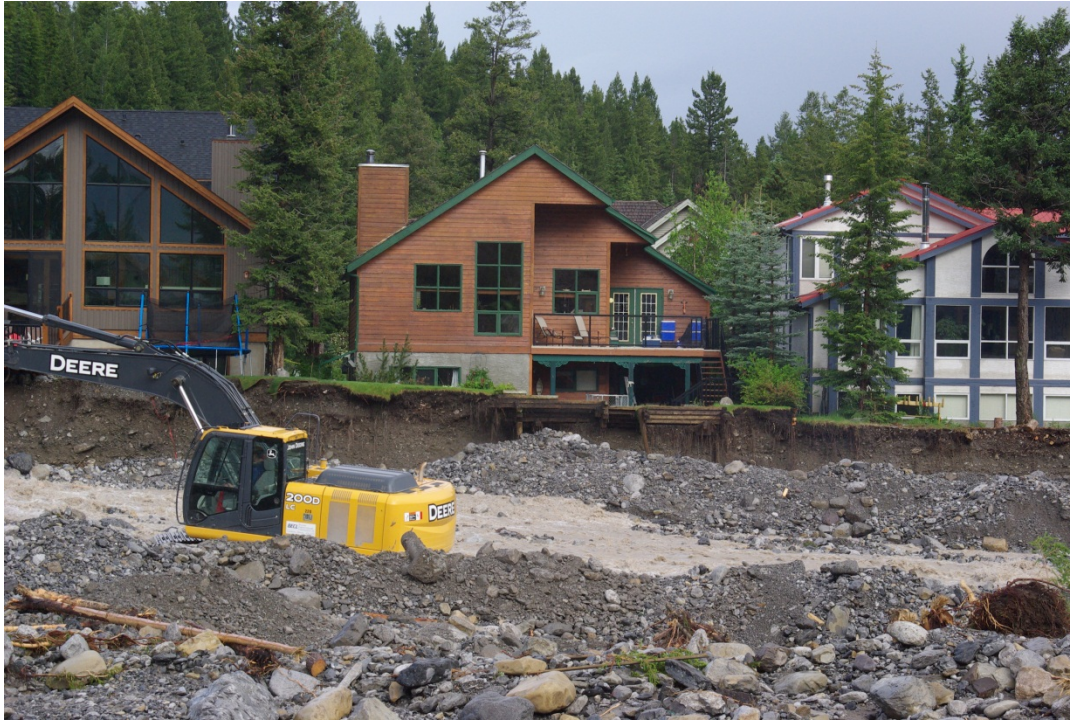
**Photo A-9. View from right bank looking over to homes located on Canyon Road. Photograph courtesy of the Town of Canmore.**

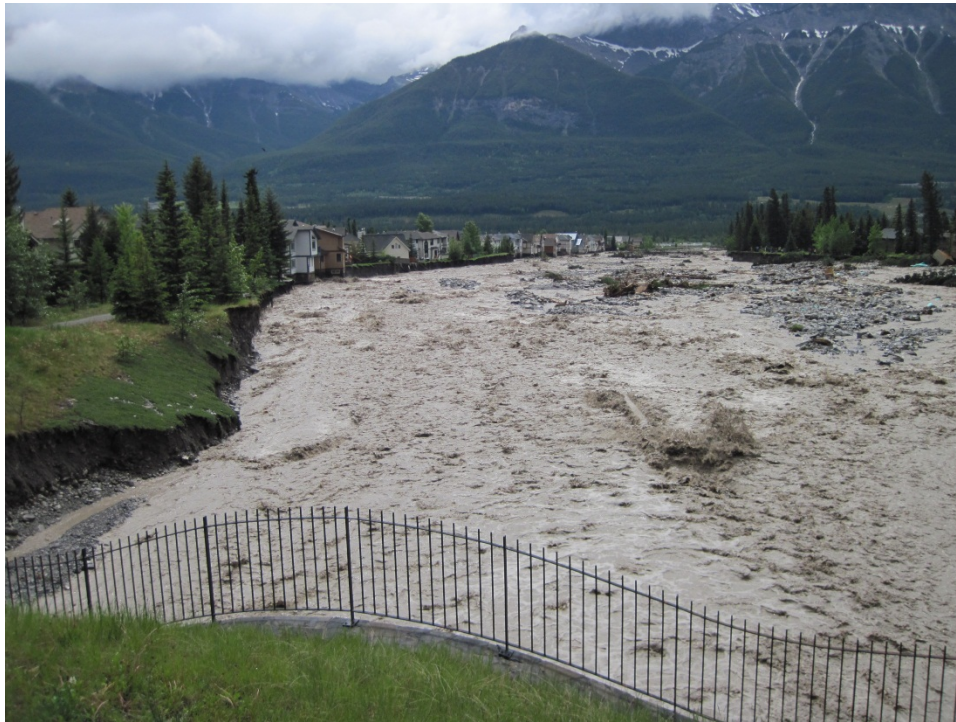
**Photo A-15. Downstream view of Cougar Creek from Elk Run Boulevard. Note the left bank erosion adjacent to Lady Macdonald Crescent. Photograph courtesy of the Town of Canmore.**

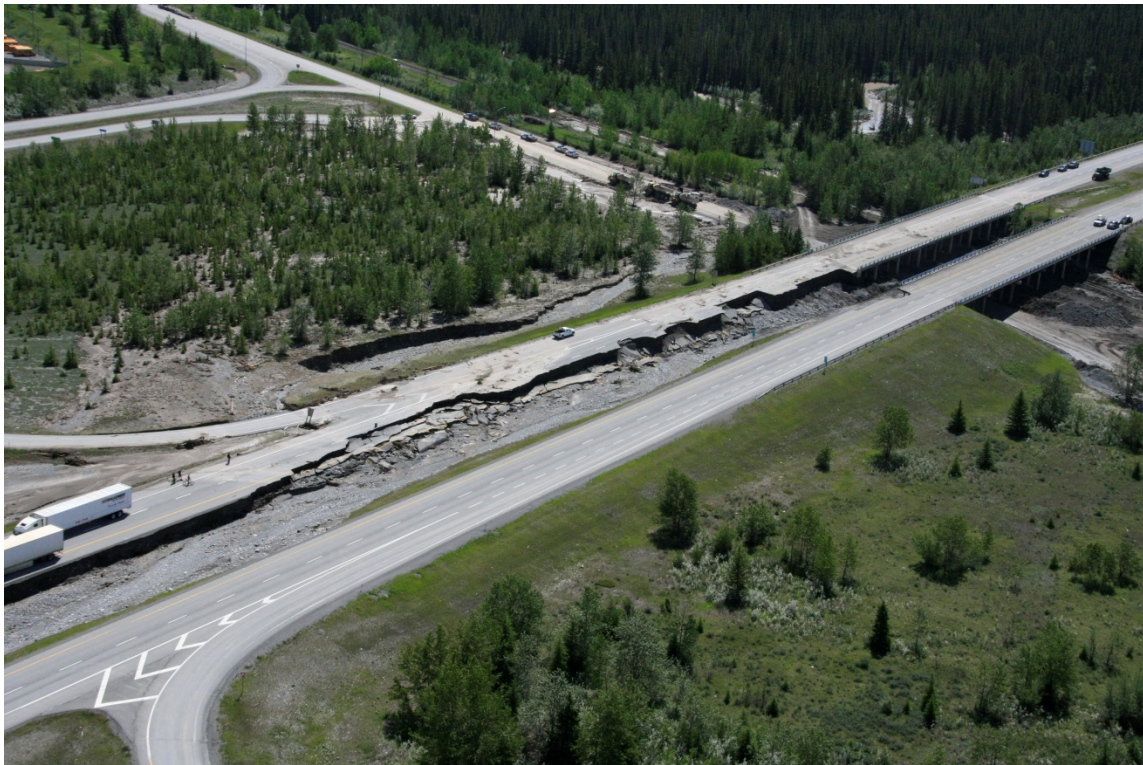
**Photo A-30. Aerial view (looking northeast) of Highway 1 following the 2013 debris flood. Photograph courtesy of the Town of Canmore.**

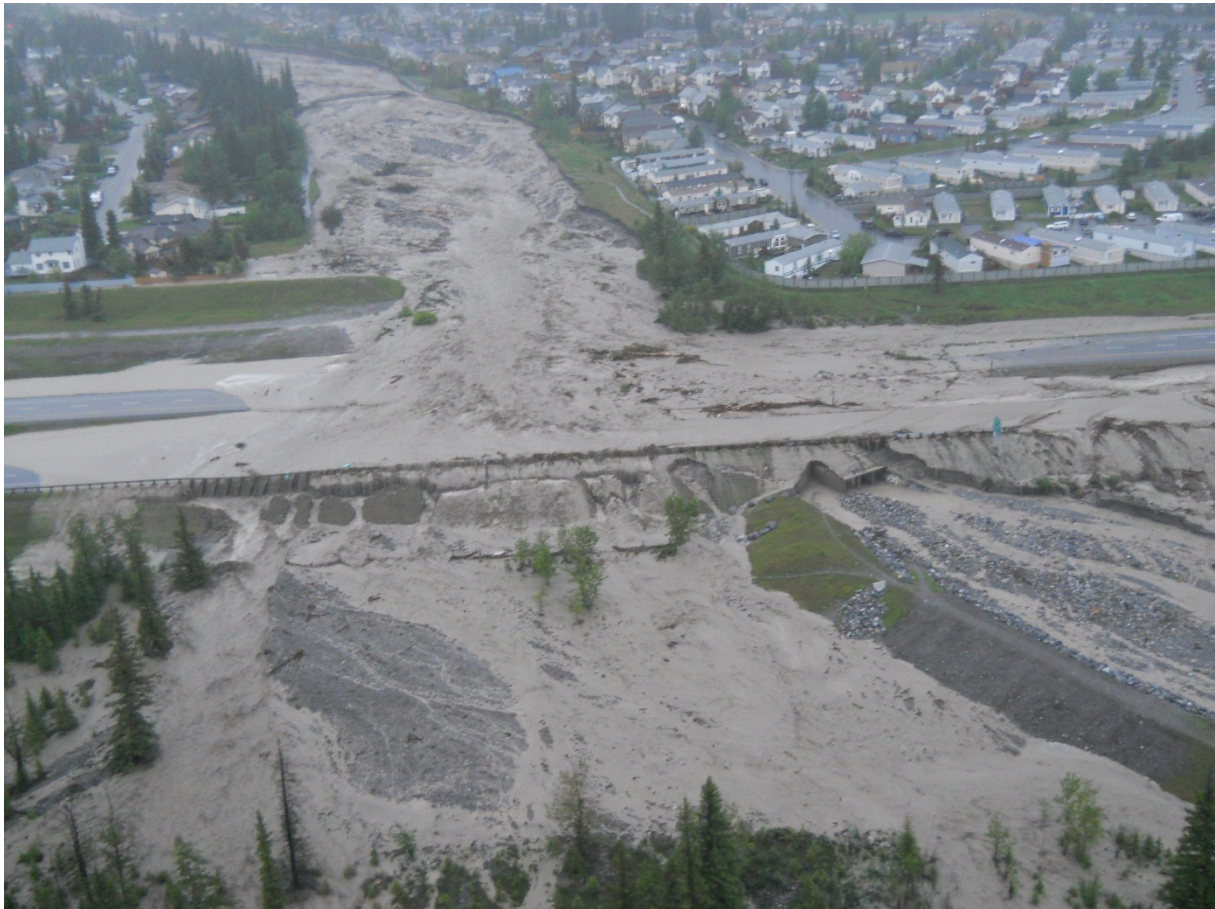
**Photo A-32. Aerial view looking upstream (north) of Cougar Creek at Highway 1 during the 2013 debris flood. Photograph courtesy of Alpine Helicopters.**
