Hazard Map - Large Debris Flood Event

Landslide Dam Outbreak Floods

Hazards with Recommended Long-Term Mitigation Installed

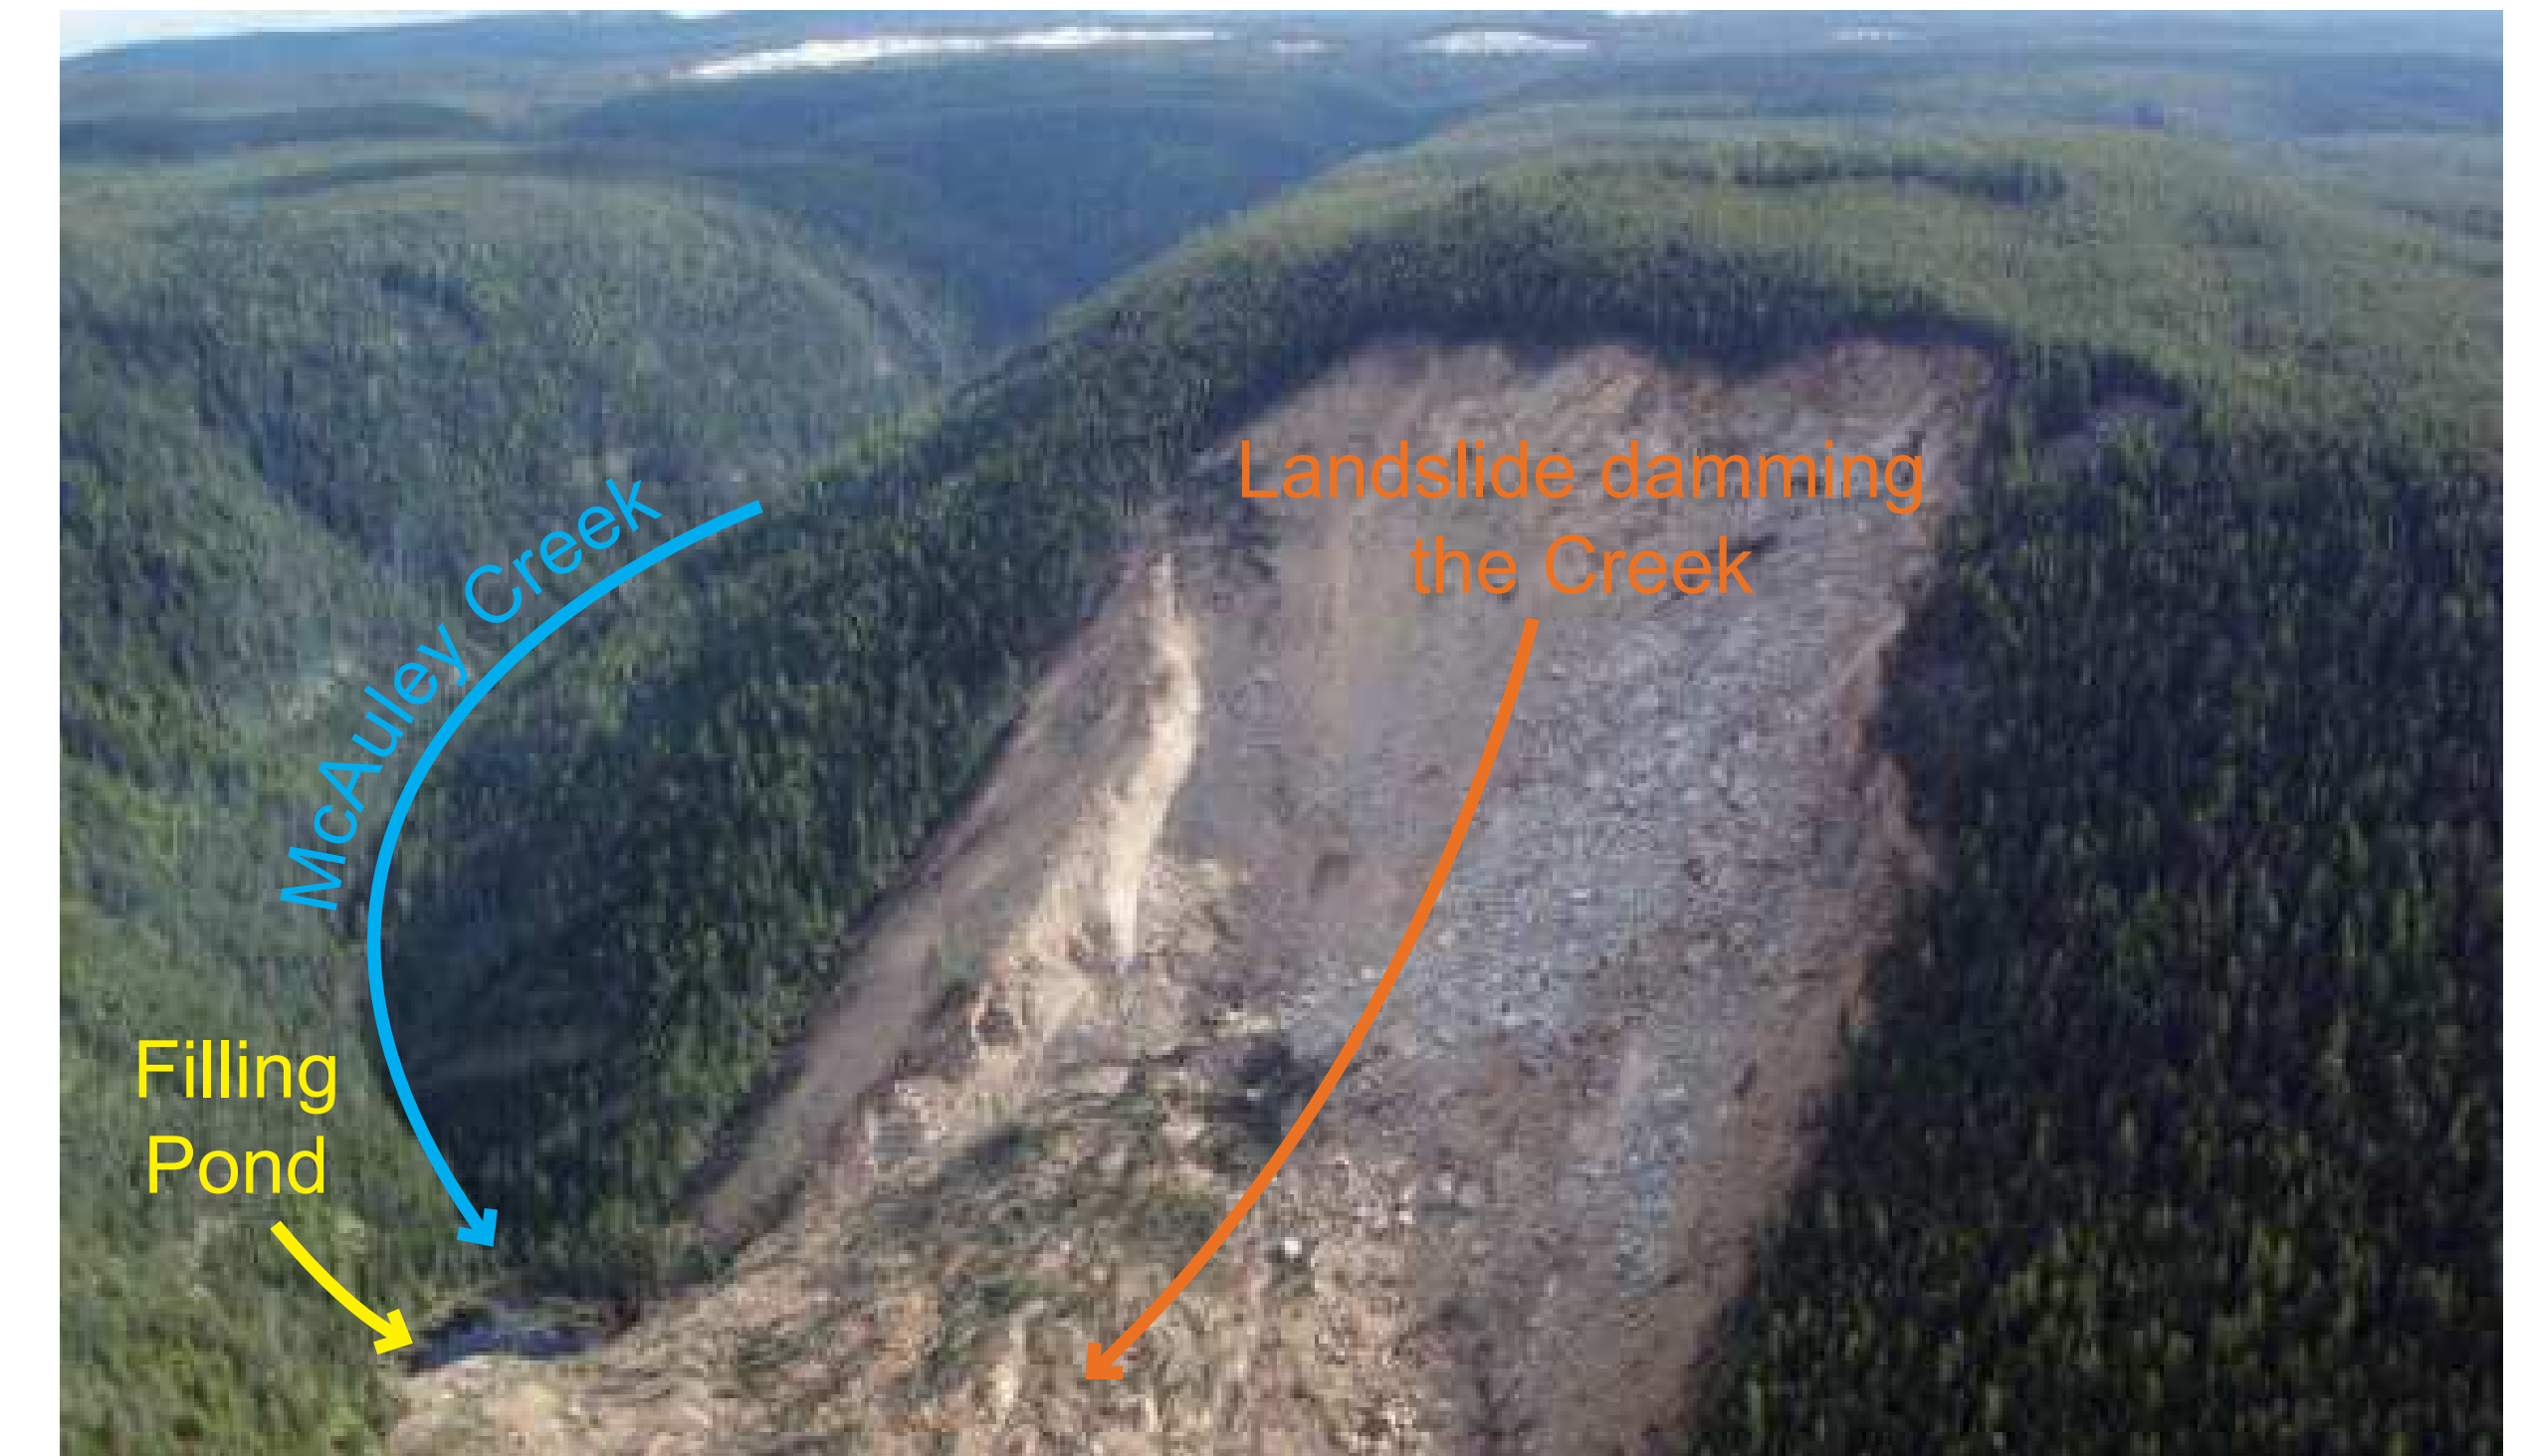
Landslide Dam Outbreak Flood at McAuley Creek Slide near Vernon, BC

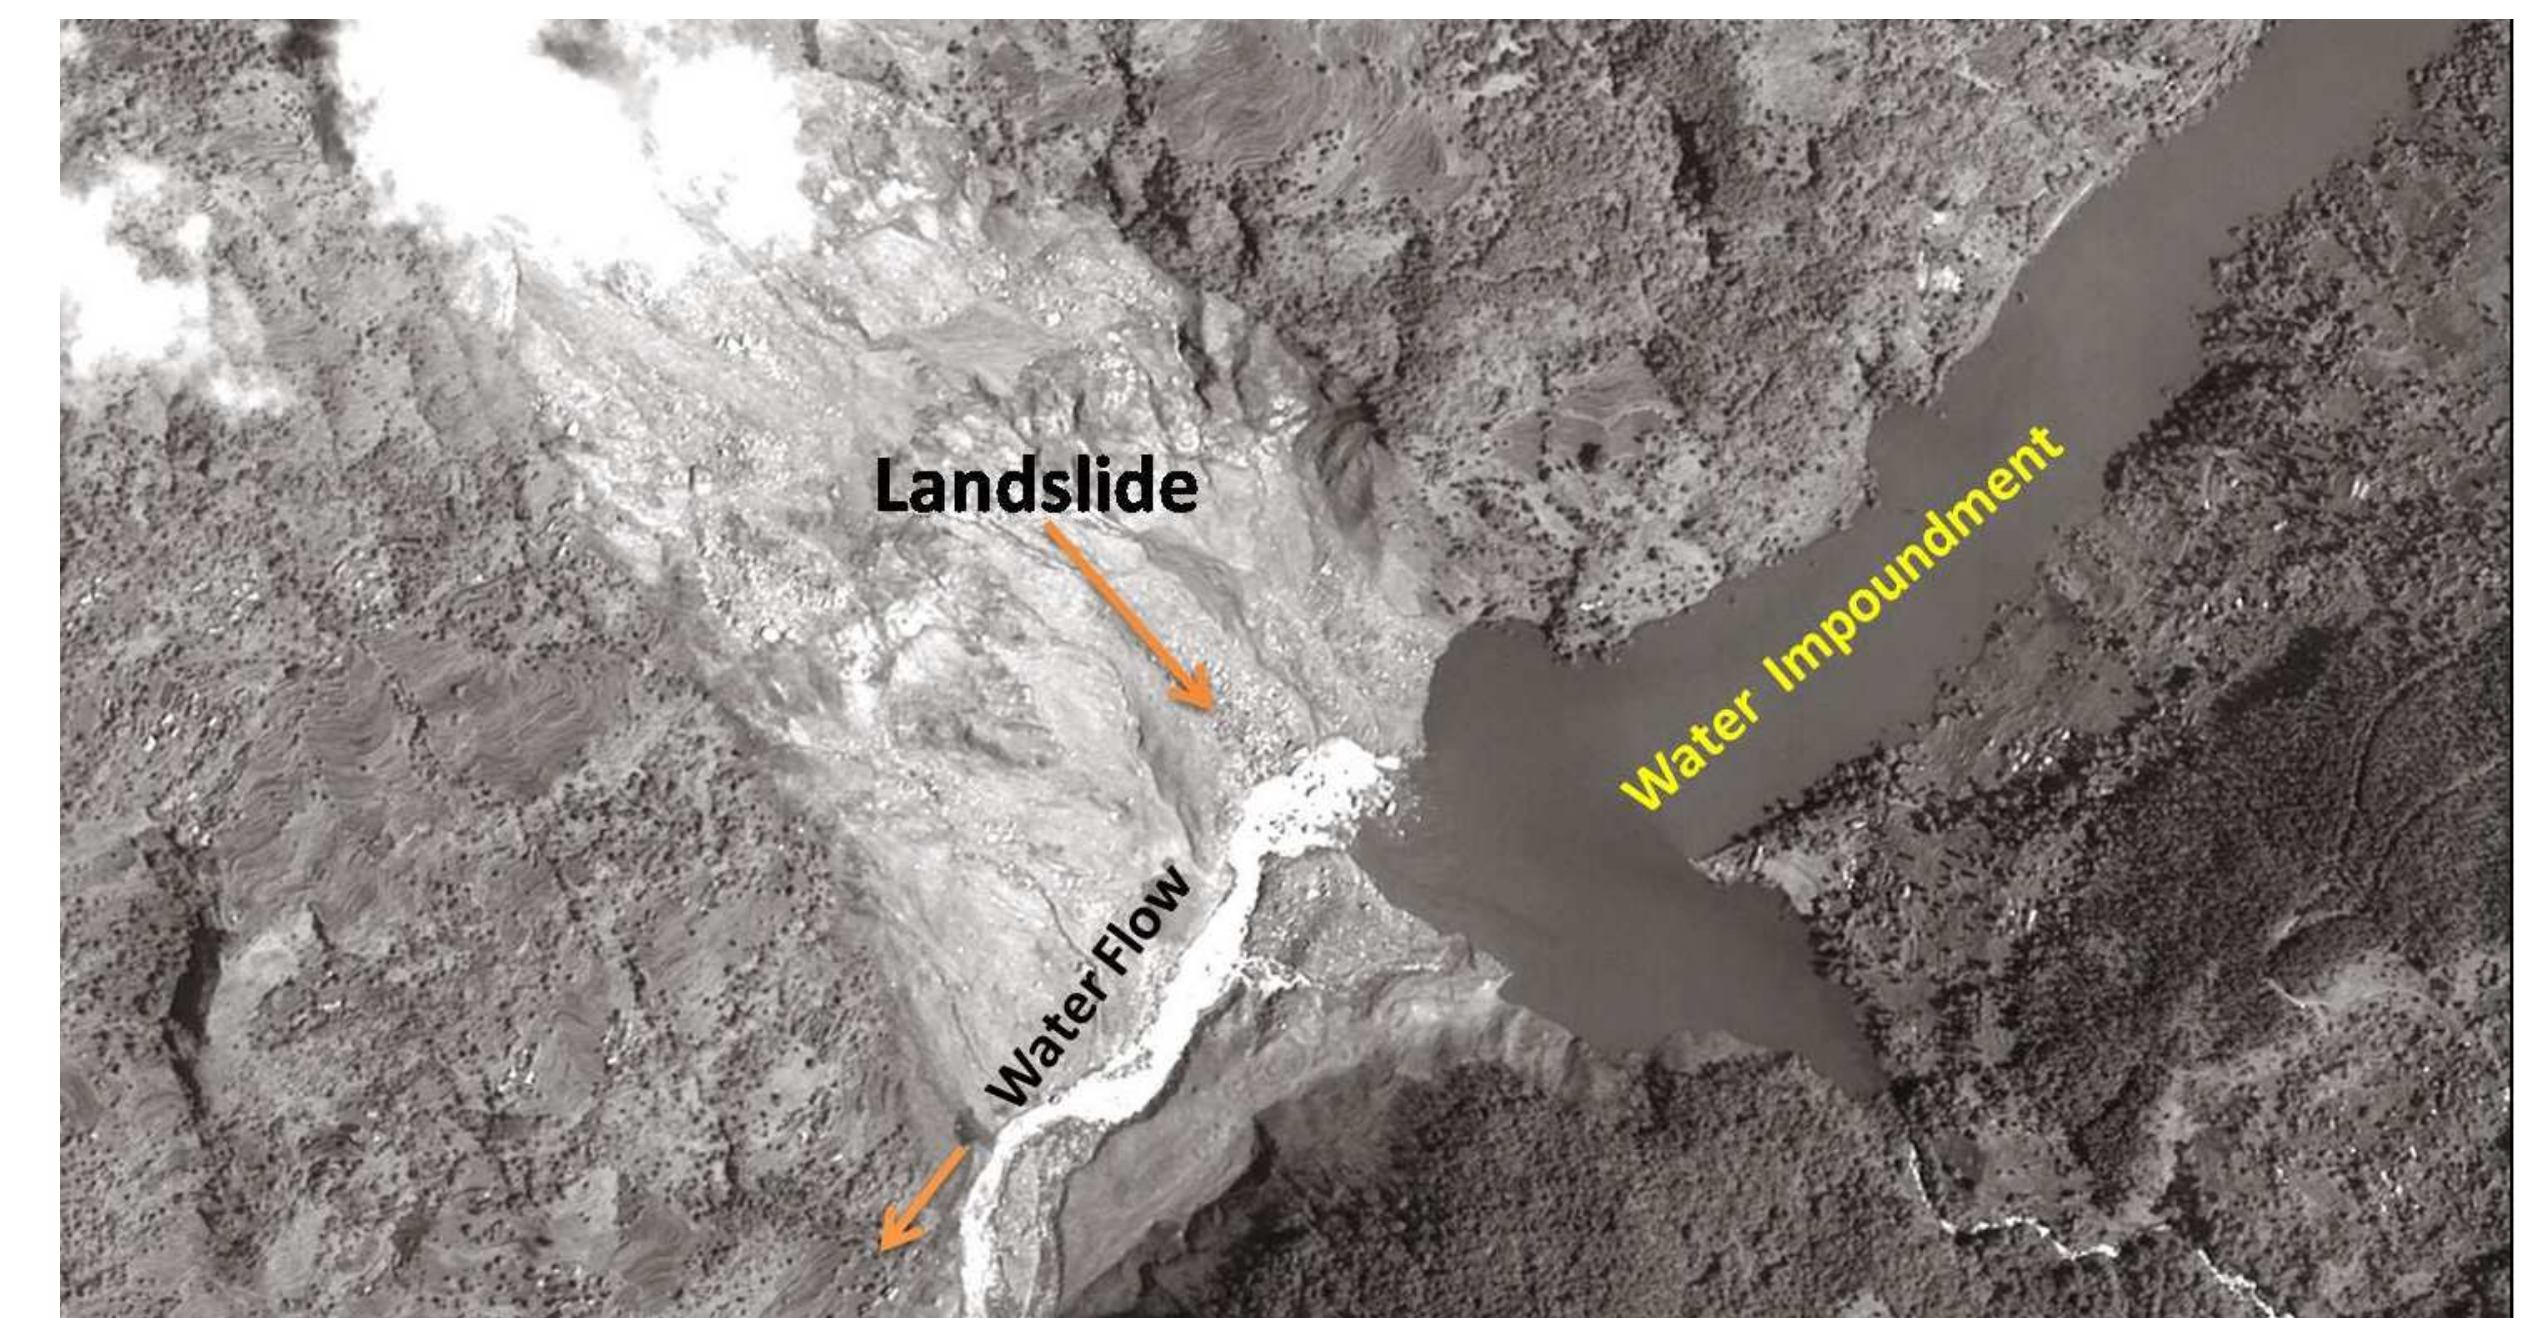
Sun Koshi landslide dam in Nepal

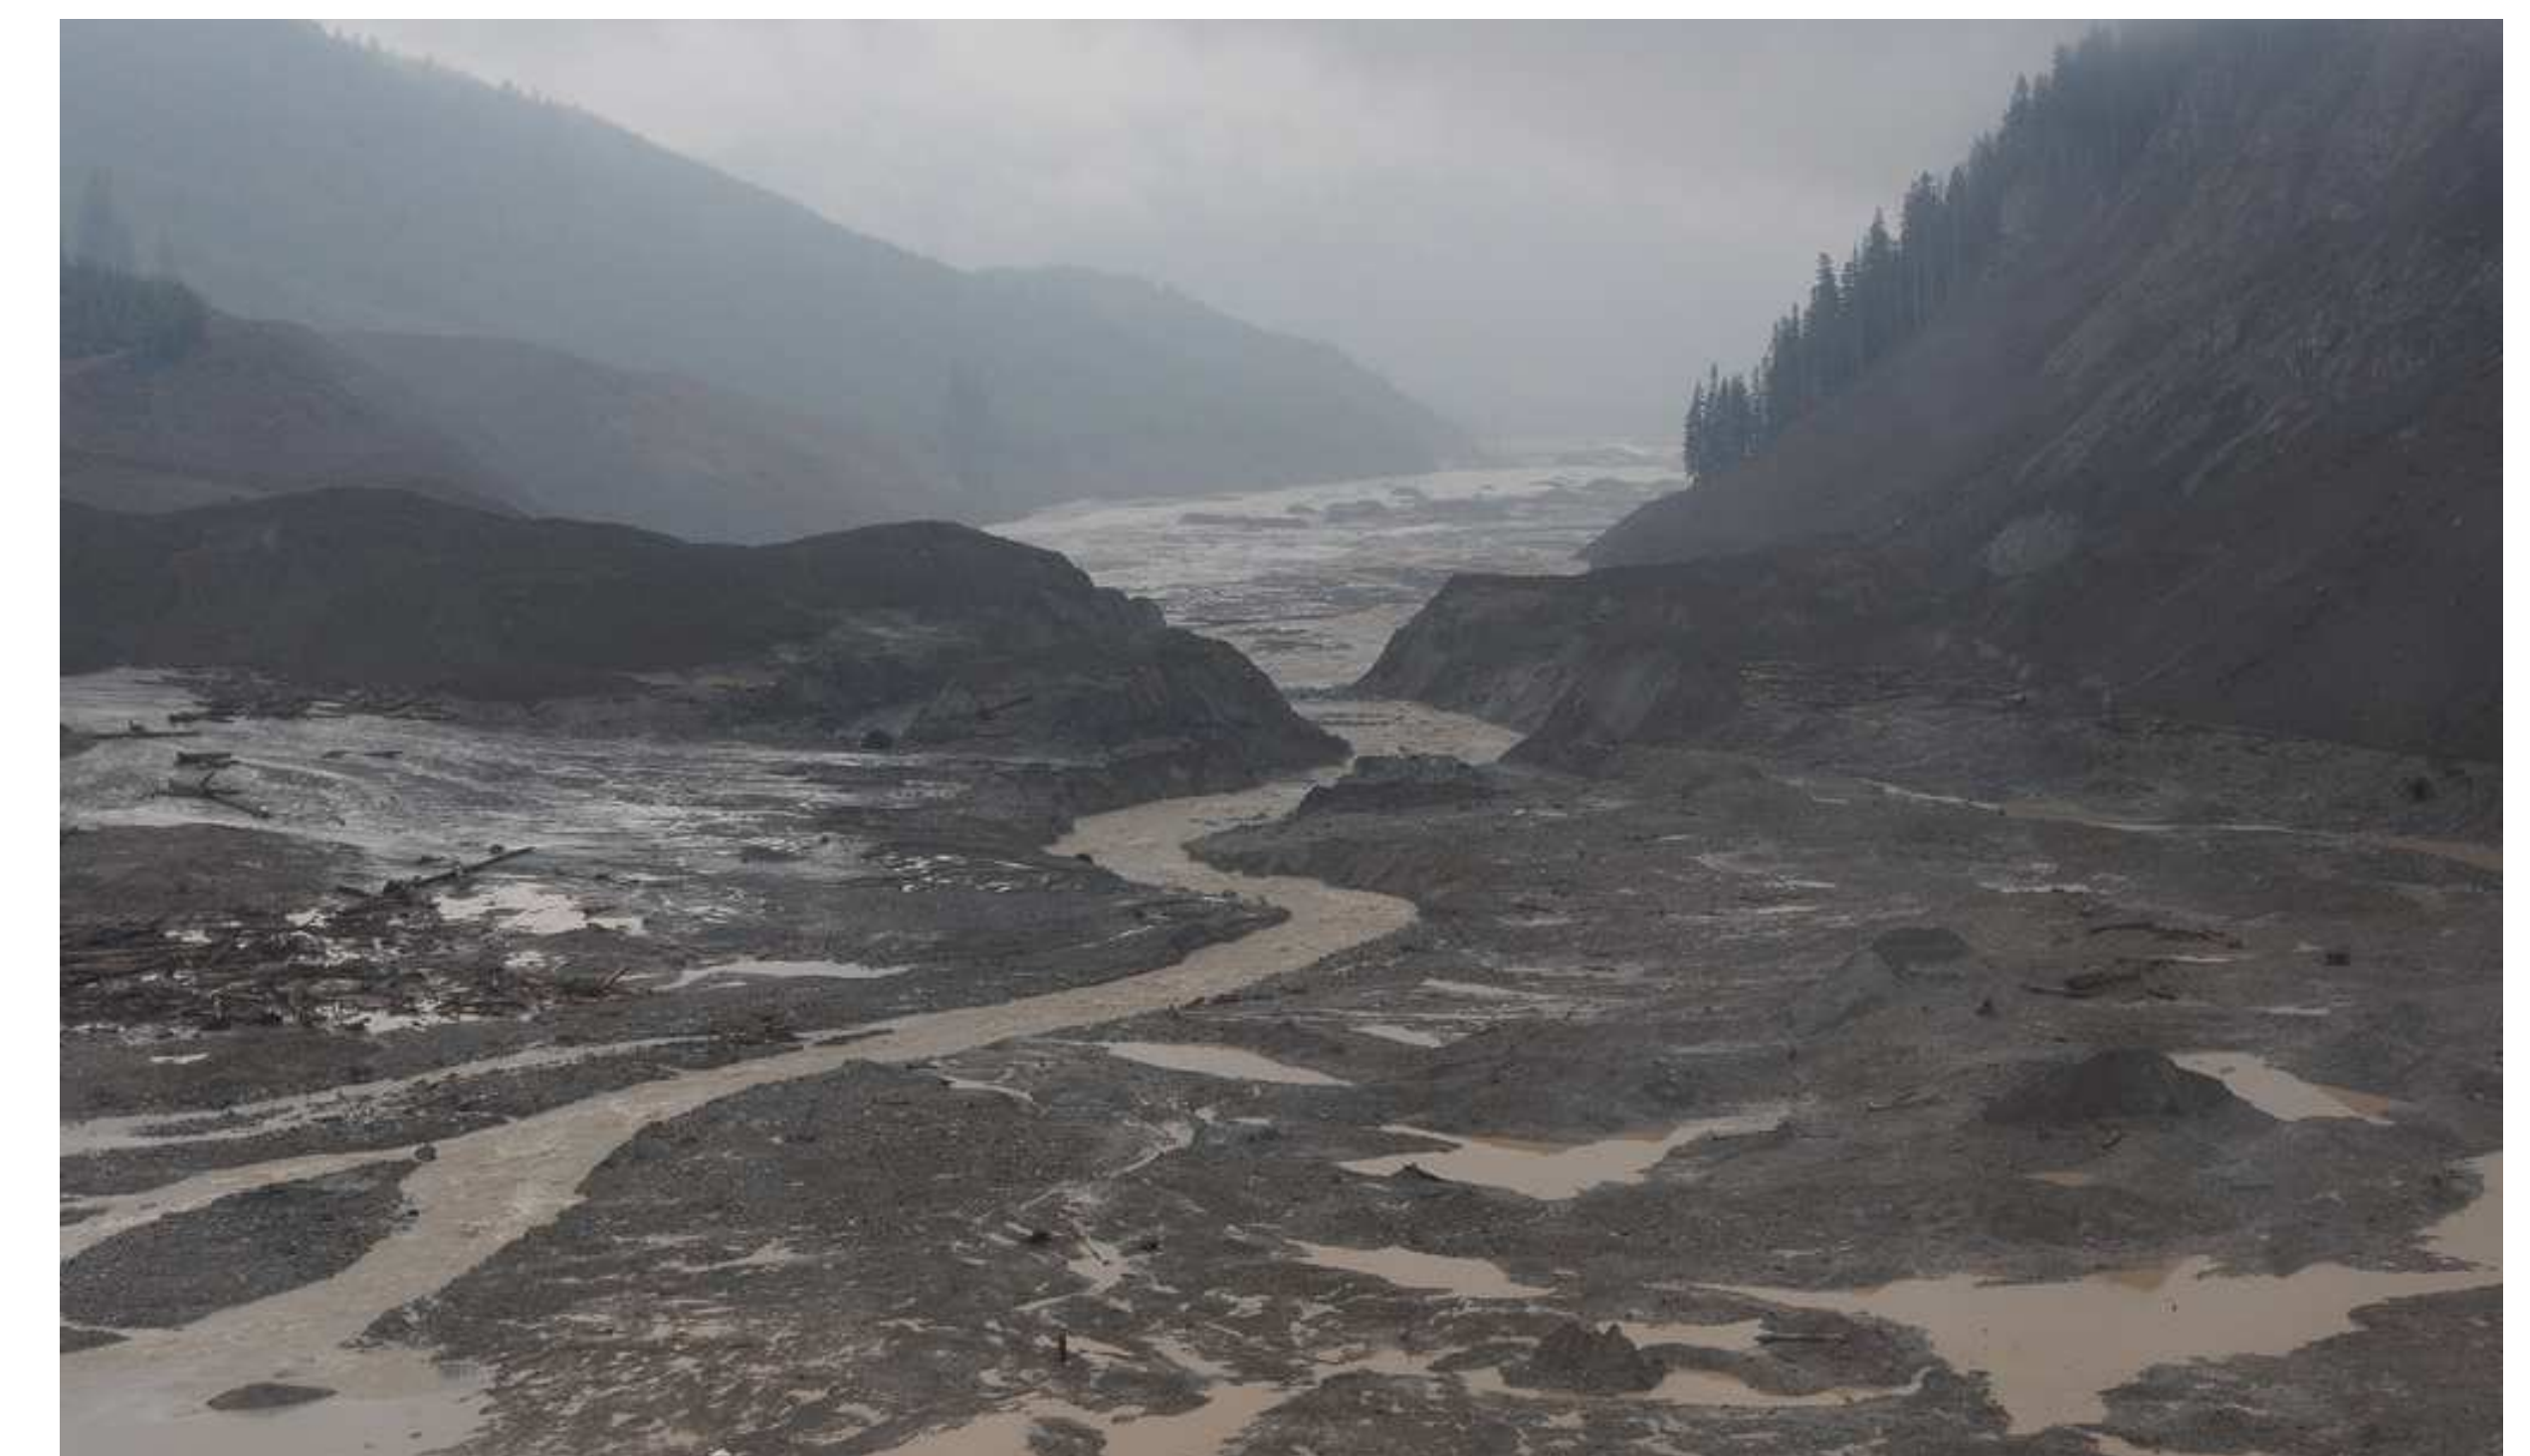
Landslide Dam Outbreak Flood at Meager Creek, BC

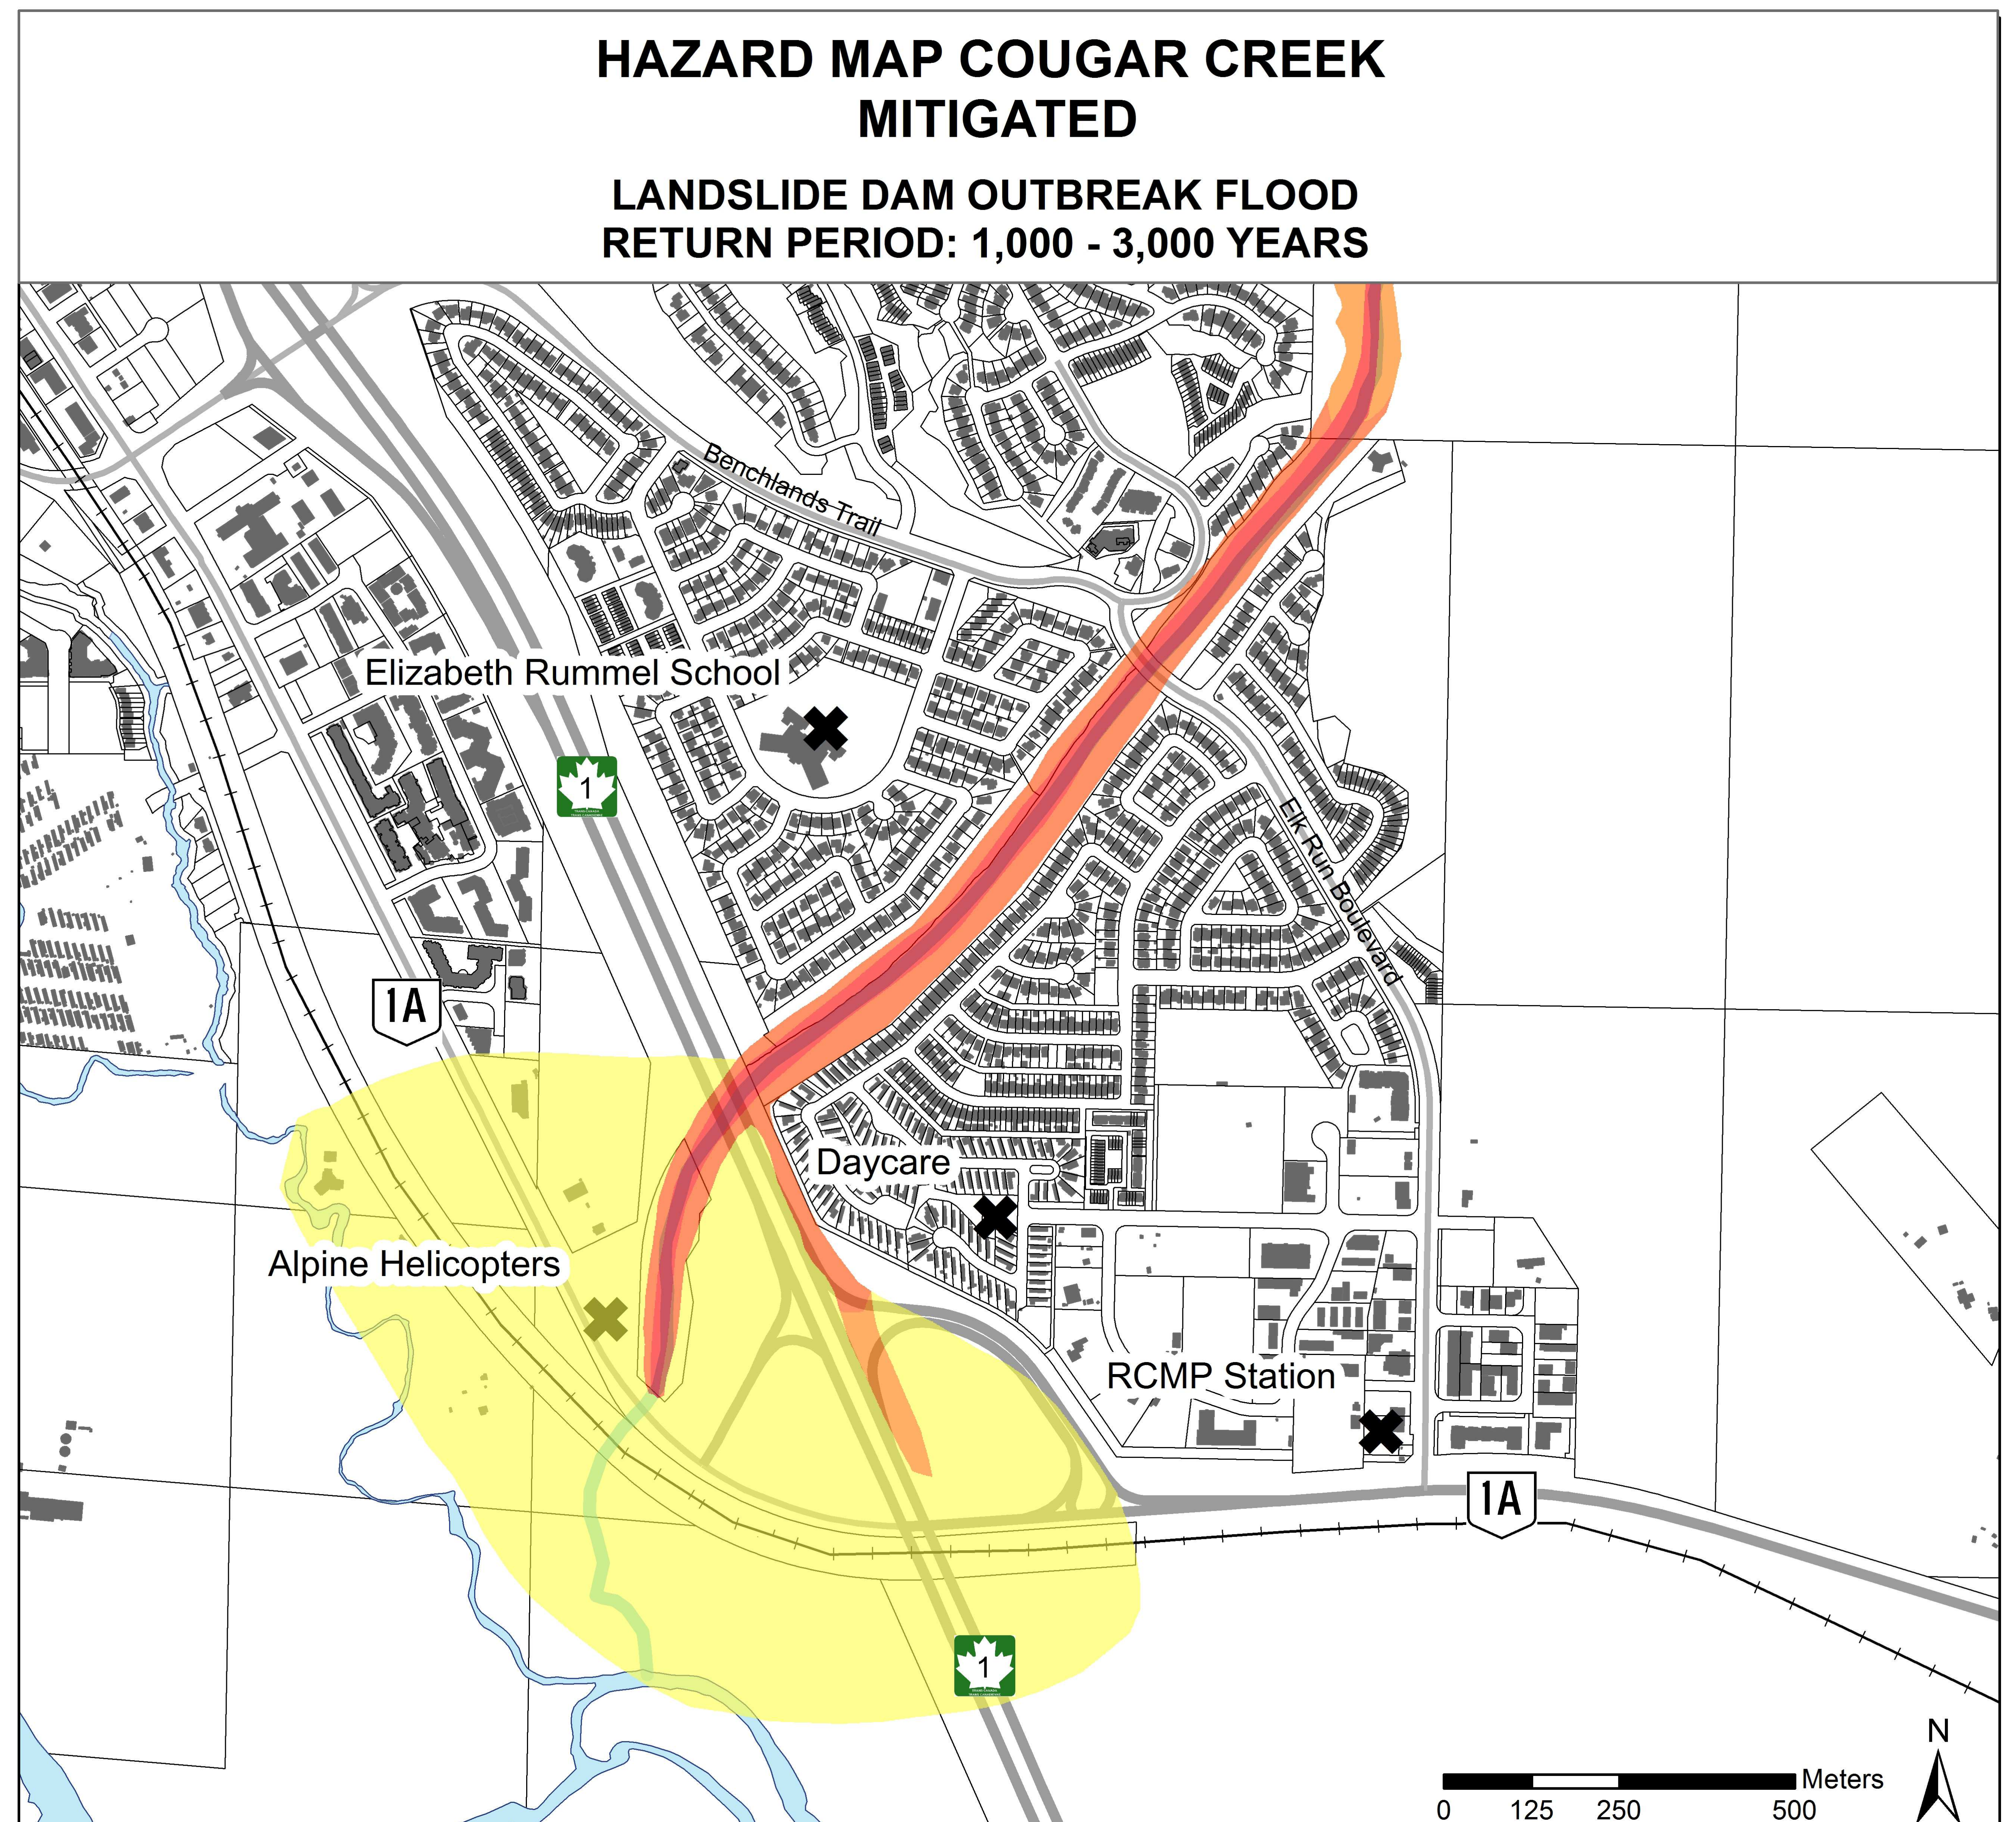
With the recommended debris flood retention structure in place the hazard of a 1,000 - 3,000 year event is significantly reduced as shown in the map.

The Elk Run Boulevard bridge and culvert will have enough capacity to convey the peak flow associated with this event.

There will be some avulsions at Trans Canada Highway, Highway 1A and CP Railway, as there are no current plans to upgrade existing culverts at these crossings.
