COUGAR CREEK DEBRIS FLOOD RETENTION STRUCTURE

Project Update

SUBMITTED TO:
Alberta Environment and Parks
and Natural Resources Conservation Board

February 2019

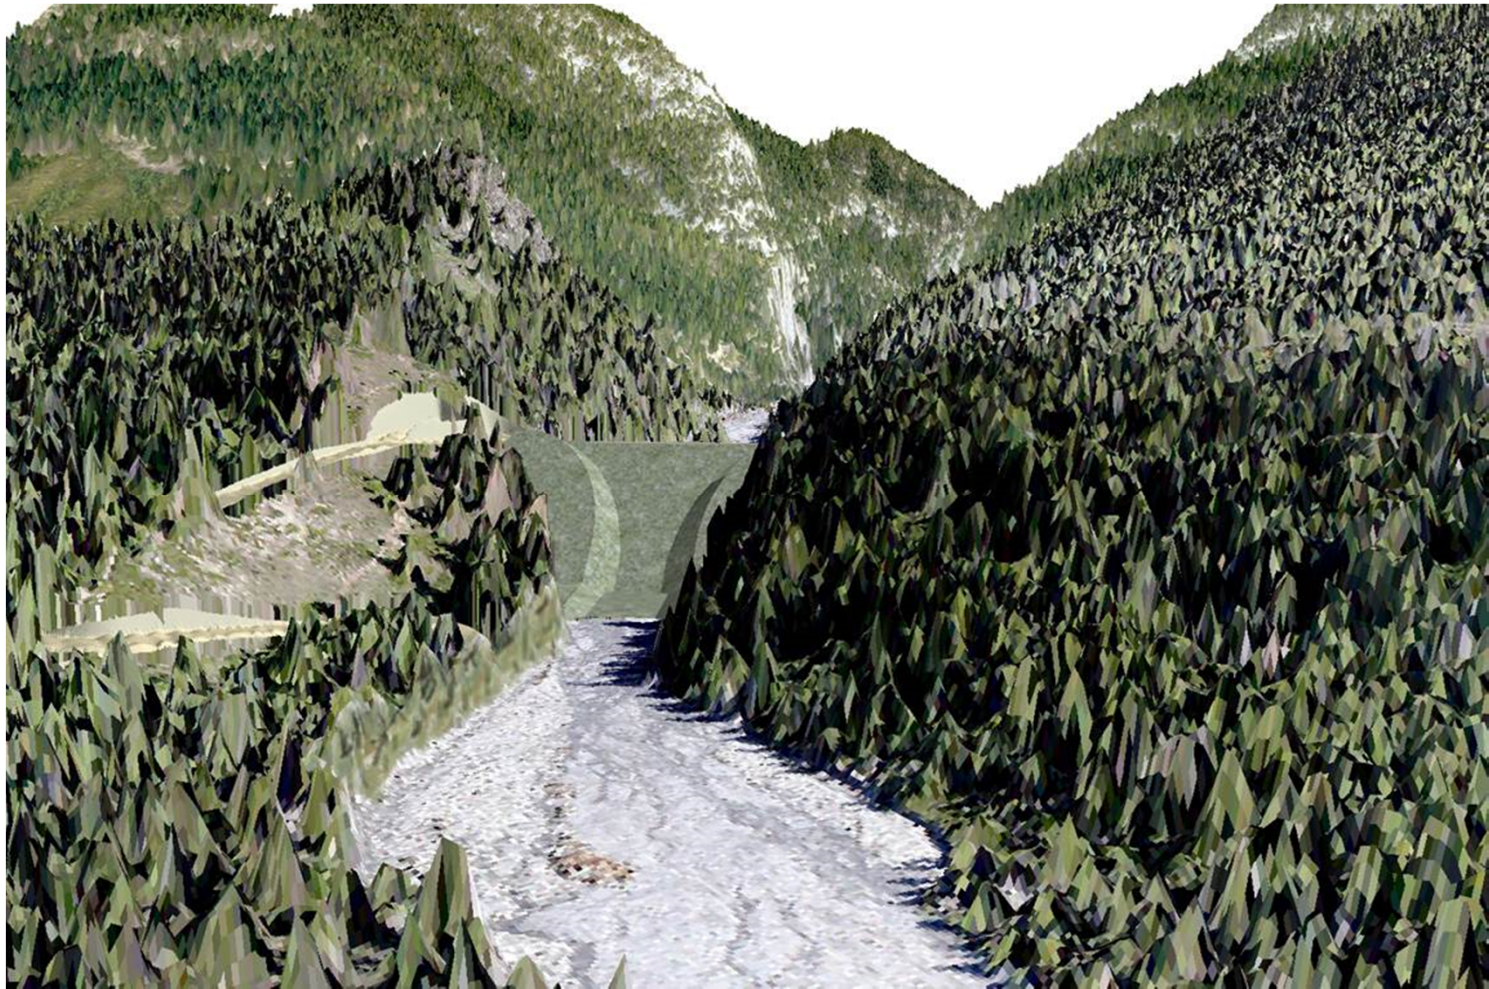
Figure
2

Cougar Creek Debris Flood Retention Structure

Original Design Rendering

The design changes are described in more detail below, along with key implications for EIA findings associated with each design change. A comparison of the original and revised Project footprint is presented in Figure 1, renderings illustrating the changes are presented in Figures 2 and 3 and a revised plan view is presented in Figure 4.

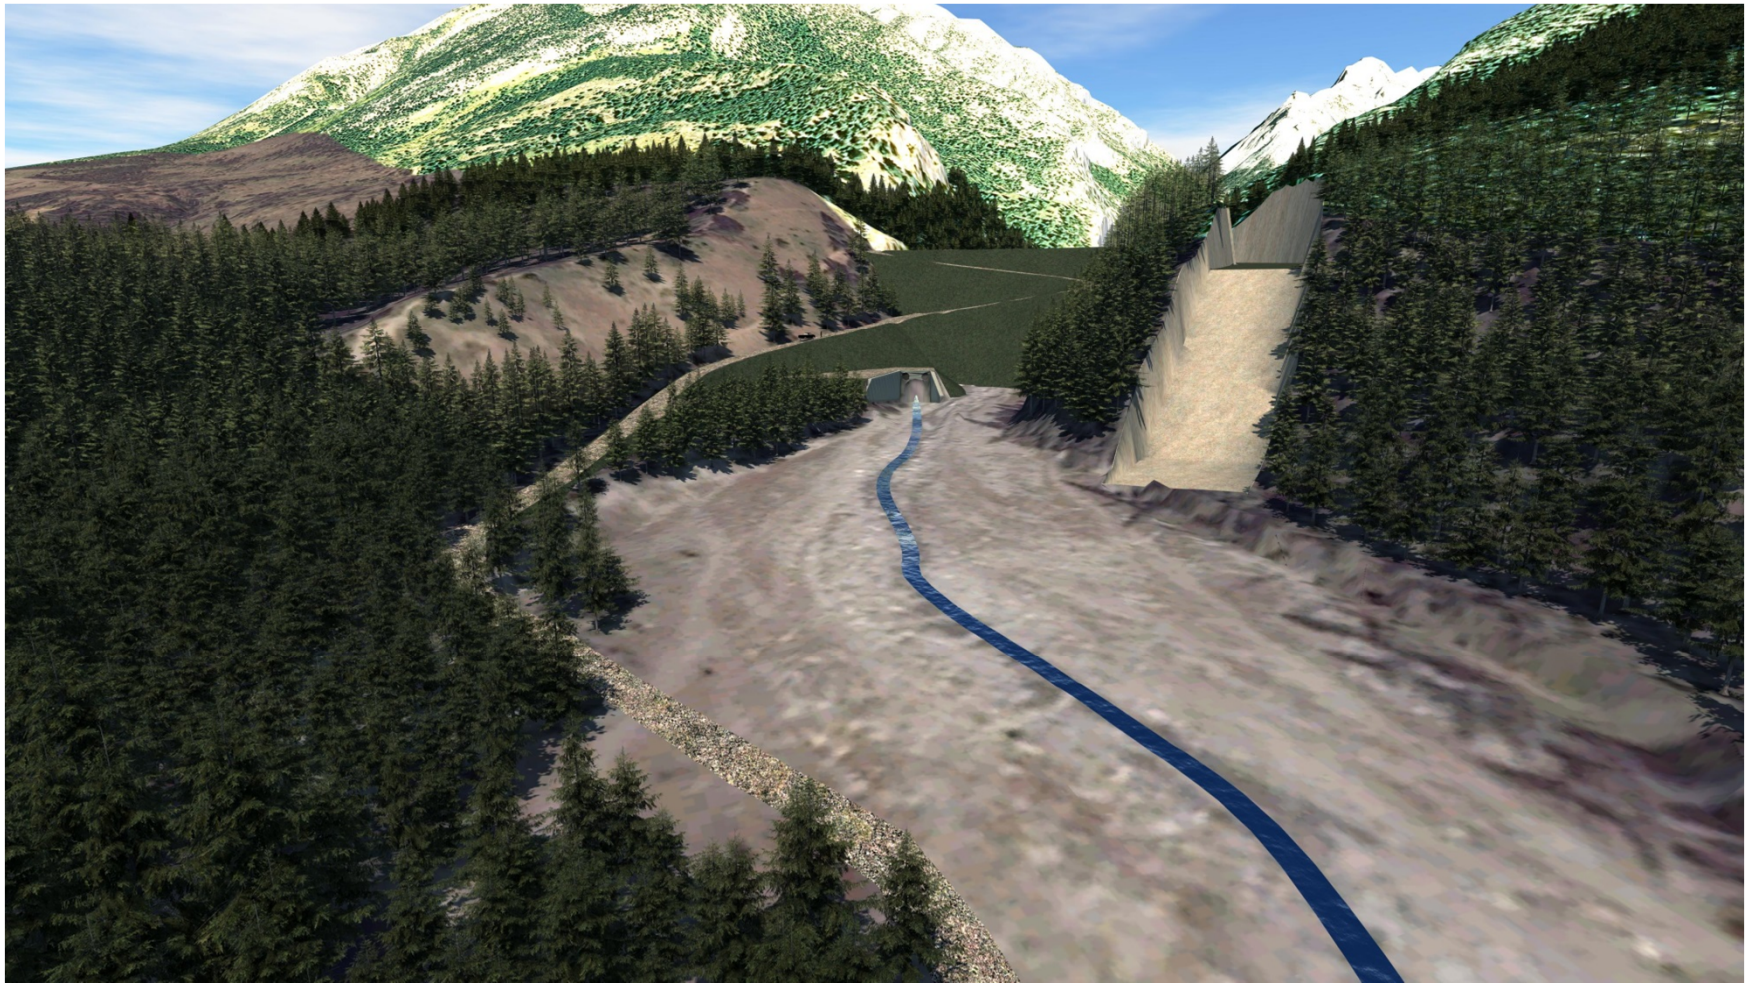
3

Cougar Creek Debris Flood Retention Structure

Revised Design Rendering
