**ALBERTA TRANSPORTATION SPRINGBANK OFF-STREAM RESERVOIR PROJECT
RESPONSE TO NRCB AND AEP SUPPLEMENTAL INFORMATION REQUEST 1, JULY 28, 2018**

Appendix IR14-5 Dam Alignment and Toe Location Relative to the Elbow River of the Springbank Off Stream Reservoir Project
May 2019

Reference: Dam Alignment and Toe Location Relative to the Elbow River

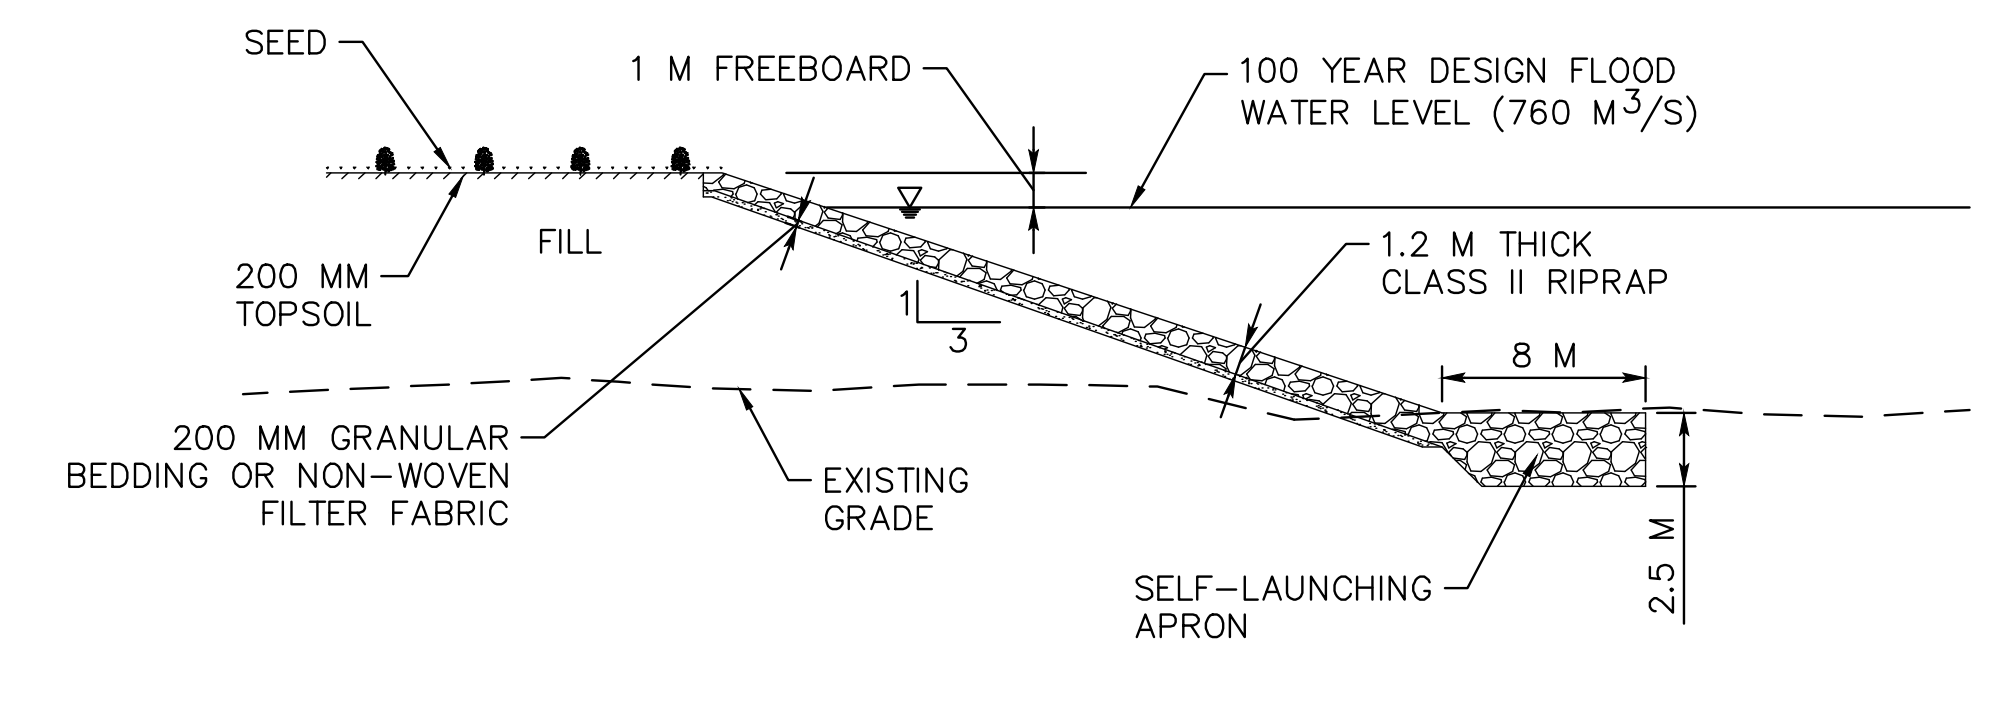
SECTION A-A'
GROYNE ARMOR DETAIL
NOT TO SCALE
