Dam Safety
May 2019

**ALBERTA TRANSPORTATION SPRINGBANK OFF-STREAM RESERVOIR PROJECT
RESPONSE TO NRCB AND AEP SUPPLEMENTAL INFORMATION REQUEST 1, JULY 28, 2018**

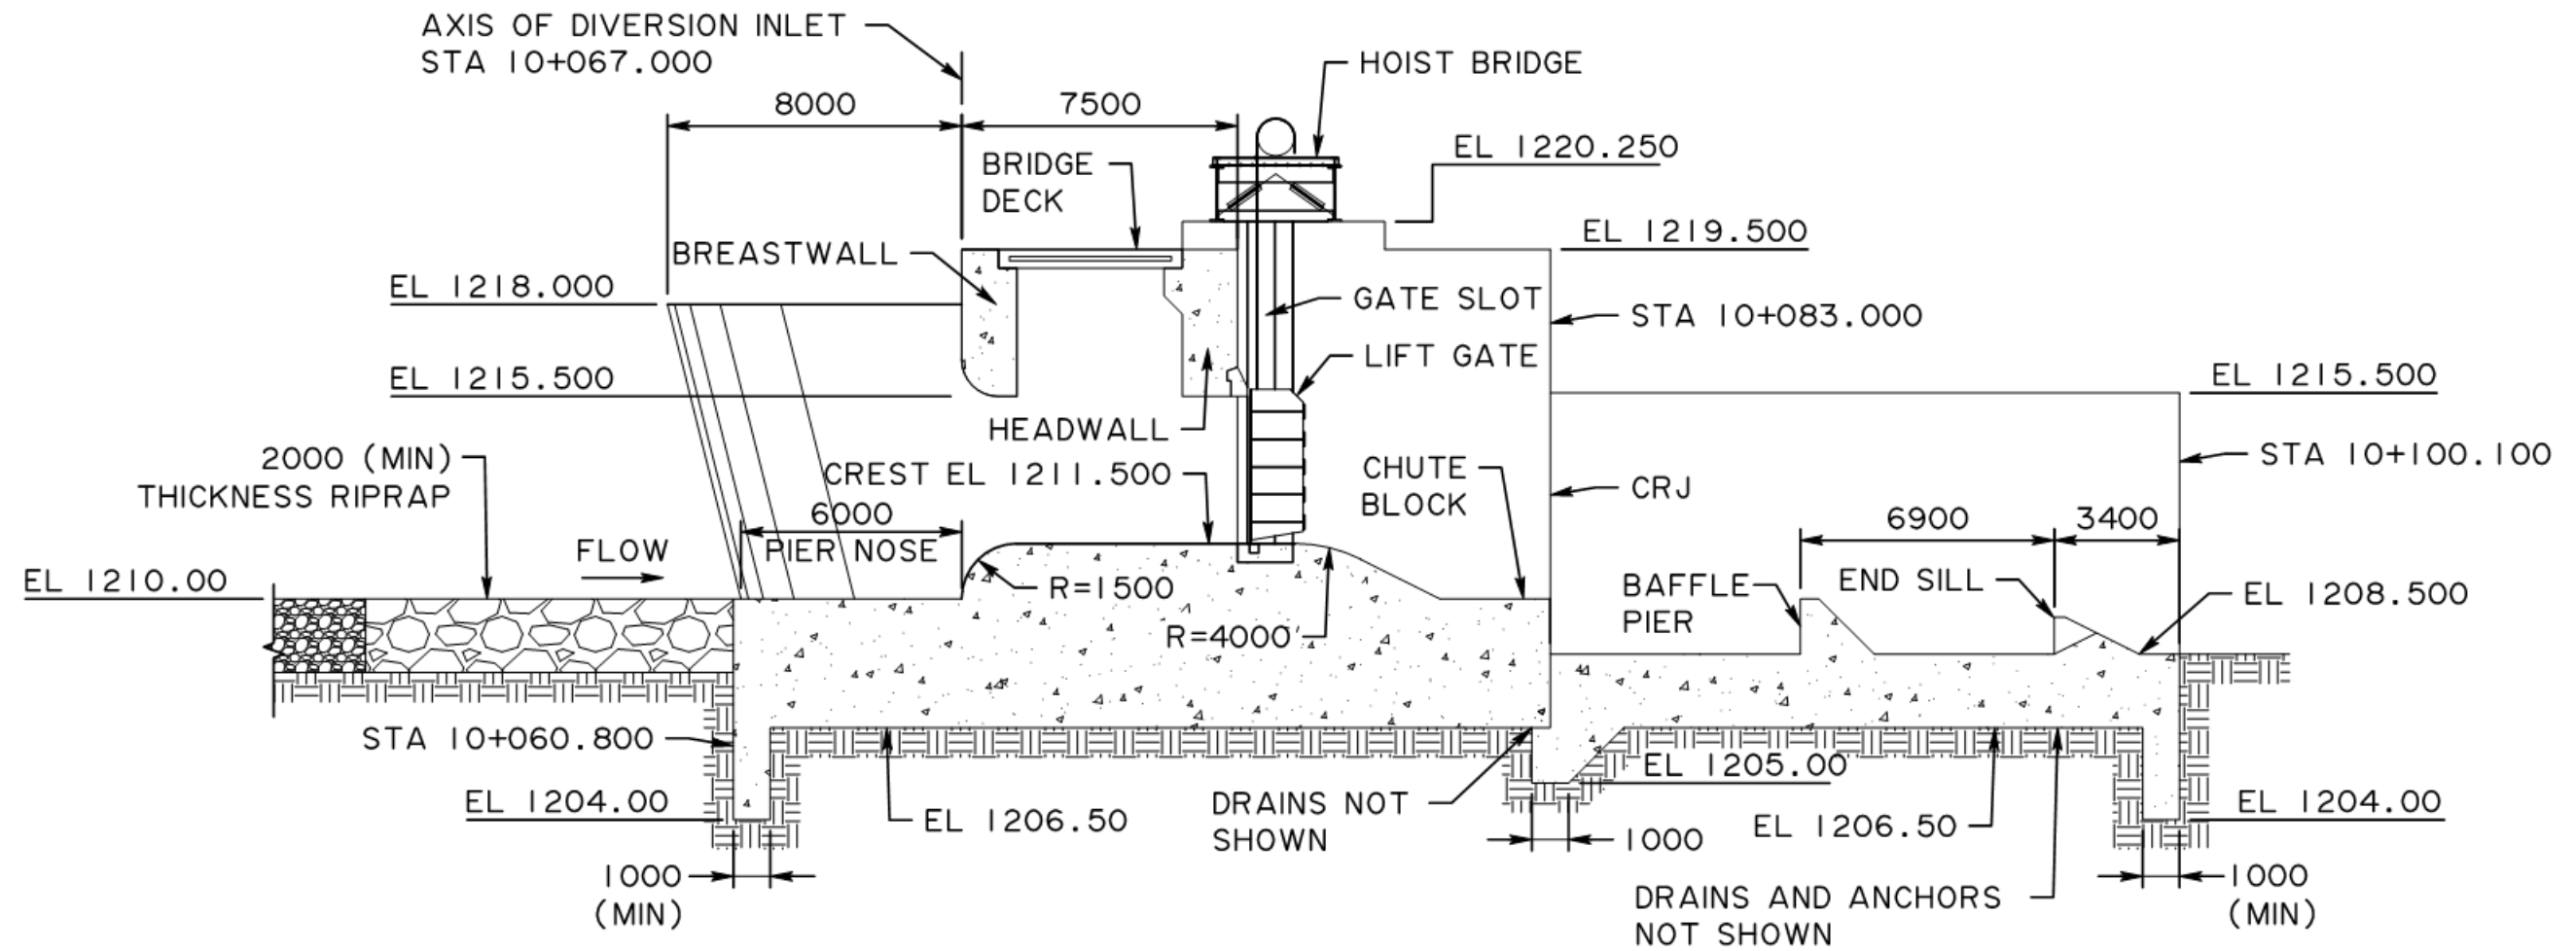
- a. The diversion inlet is a concrete gate structure located on the left bank of Elbow River at the entrance to the diversion channel. The primary elements of the diversion inlet are:
 - left abutment, retaining walls, and embankment transitions
 - two 20 m wide gate-bays with a center pier-divider and fixed crest El. 1,211.5 m
 - two 20 m wide by 4 m tall vertical lift-gates with wire-drum hoist and hoist support spanning the 20 m bay width
 - access bridge—comprising bridge deck, breastwall, and headwall—that provides access to gate equipment, vehicle access across the diversion channel entrance, and it is a debris and overtopping barrier during extreme flood events
 - stilling basin with chute blocks and end sills to provide energy dissipation and minimize channel erosion
 - right abutment, retaining walls, and embankment transitions

A cross section through the centerline of the diversion inlet is presented in Figure IR456-1. The design maximum discharge capacity (600 m³/s) is calculated to occur at headwater El. 1,215.8 m.

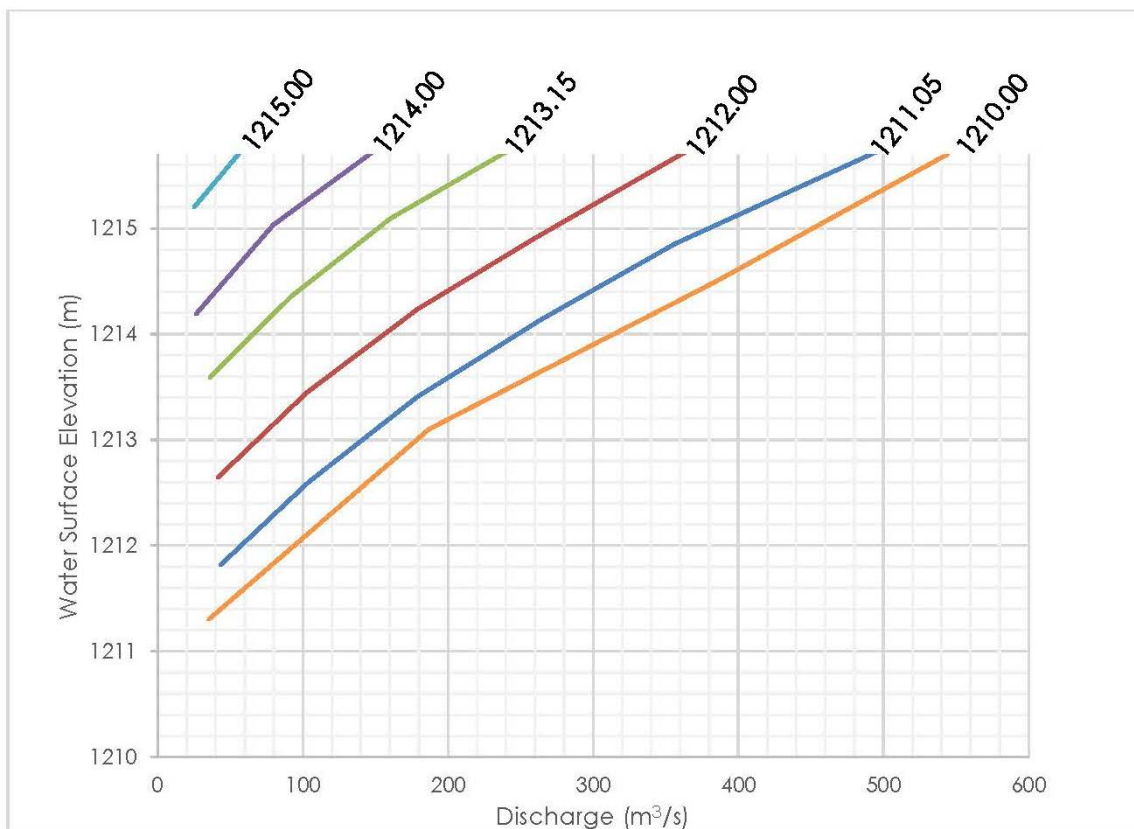
Figure IR457-1 Service Spillway Gate Rating Curve (24 m Wide Bay)

- a. A series of rating curves was developed for the service spillway for six gate positions, based on results of the physical model and numerical models. Figure IR457-1 provides the relationship between headwater elevation and discharge for the six corresponding gate positions for a single 24 m bay.

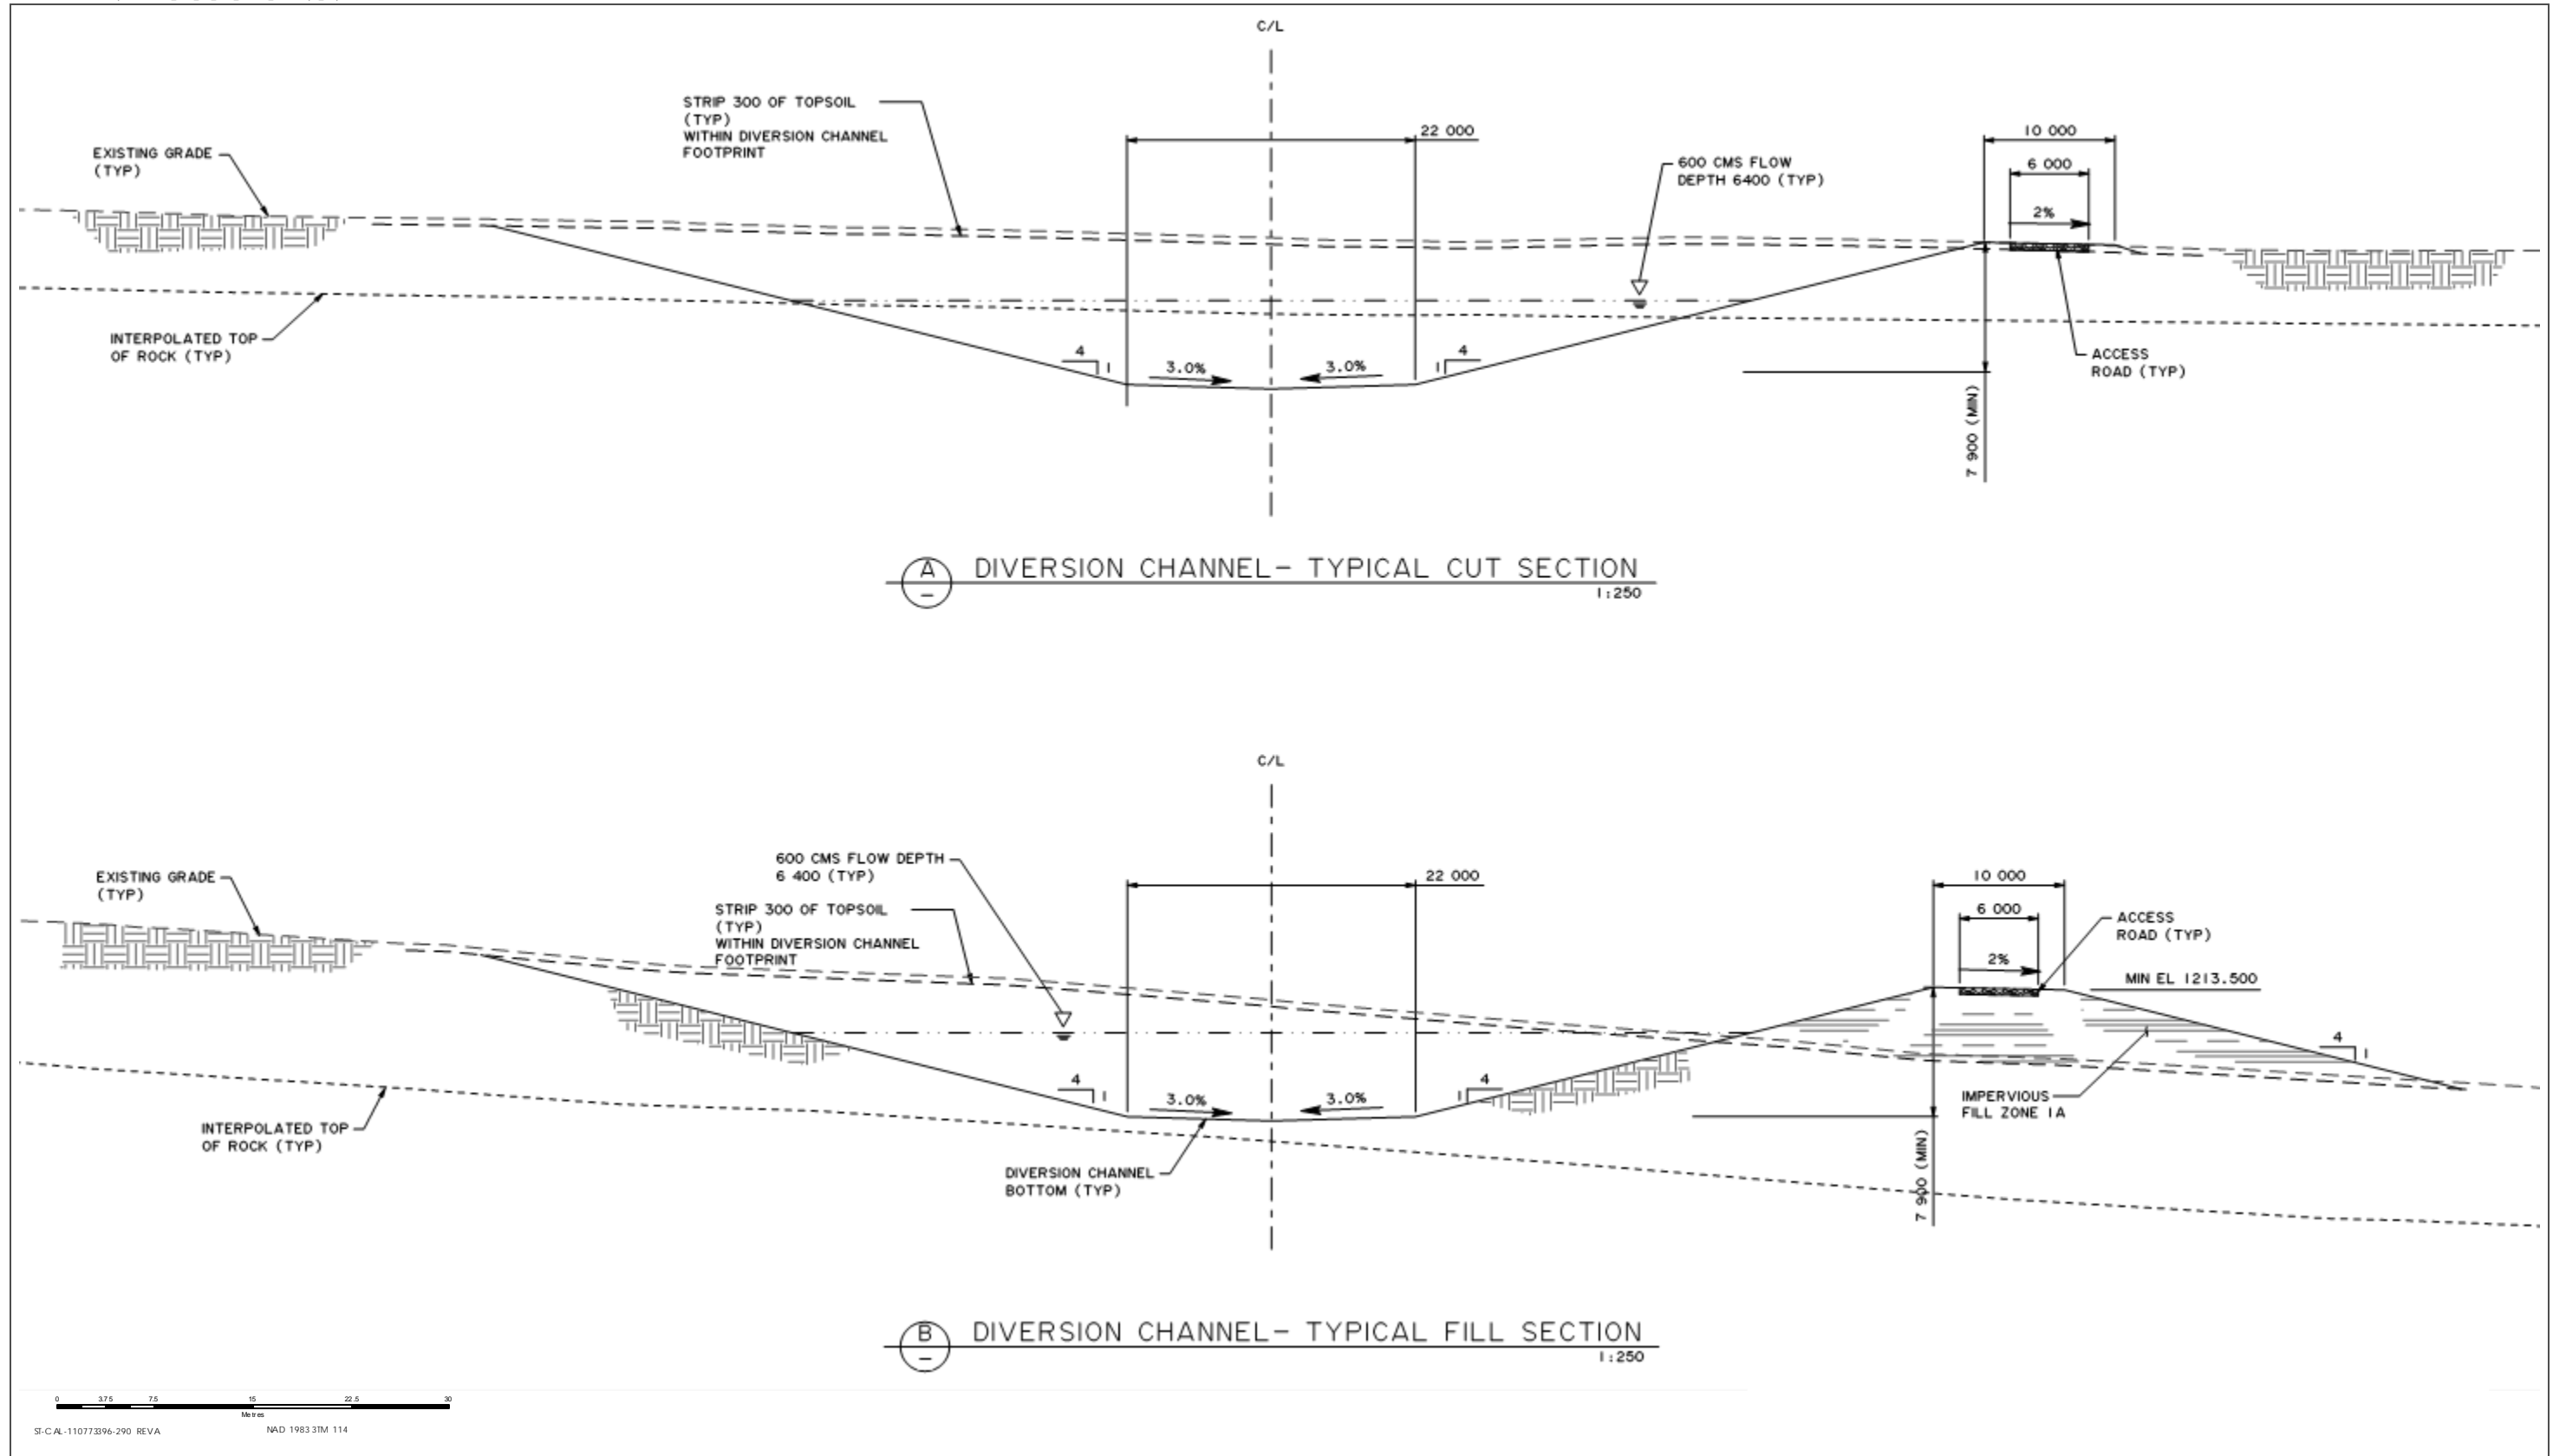
- e. Figure IR463-1 provides typical diversion channel sections in cut and fill sections. These are representative for the channel through rock and/or soil.

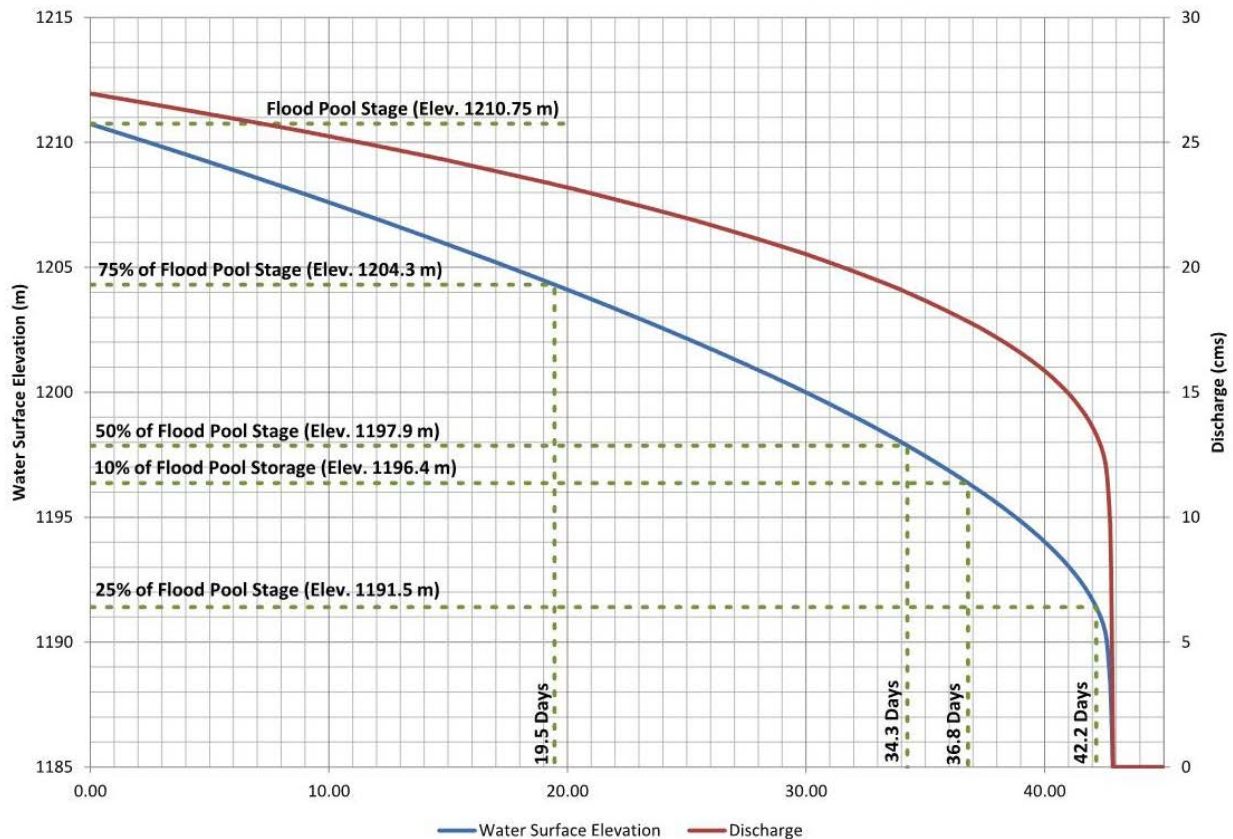
Figure IR465-1 Reservoir Drawdown from Full Service Level

Figure IR465-1 presents the drawdown rates for the off-stream reservoir with the prescribed flood pool stage identified. The blue line on the figure represents the reservoir stage over time. At each of the defined criteria stages, the elevation and drawdown time are noted. As an example, the 75% stage (El. 1,204.3 m) is achieved in 19.5 days, which meets the minimum criteria of 20 to 30 days.

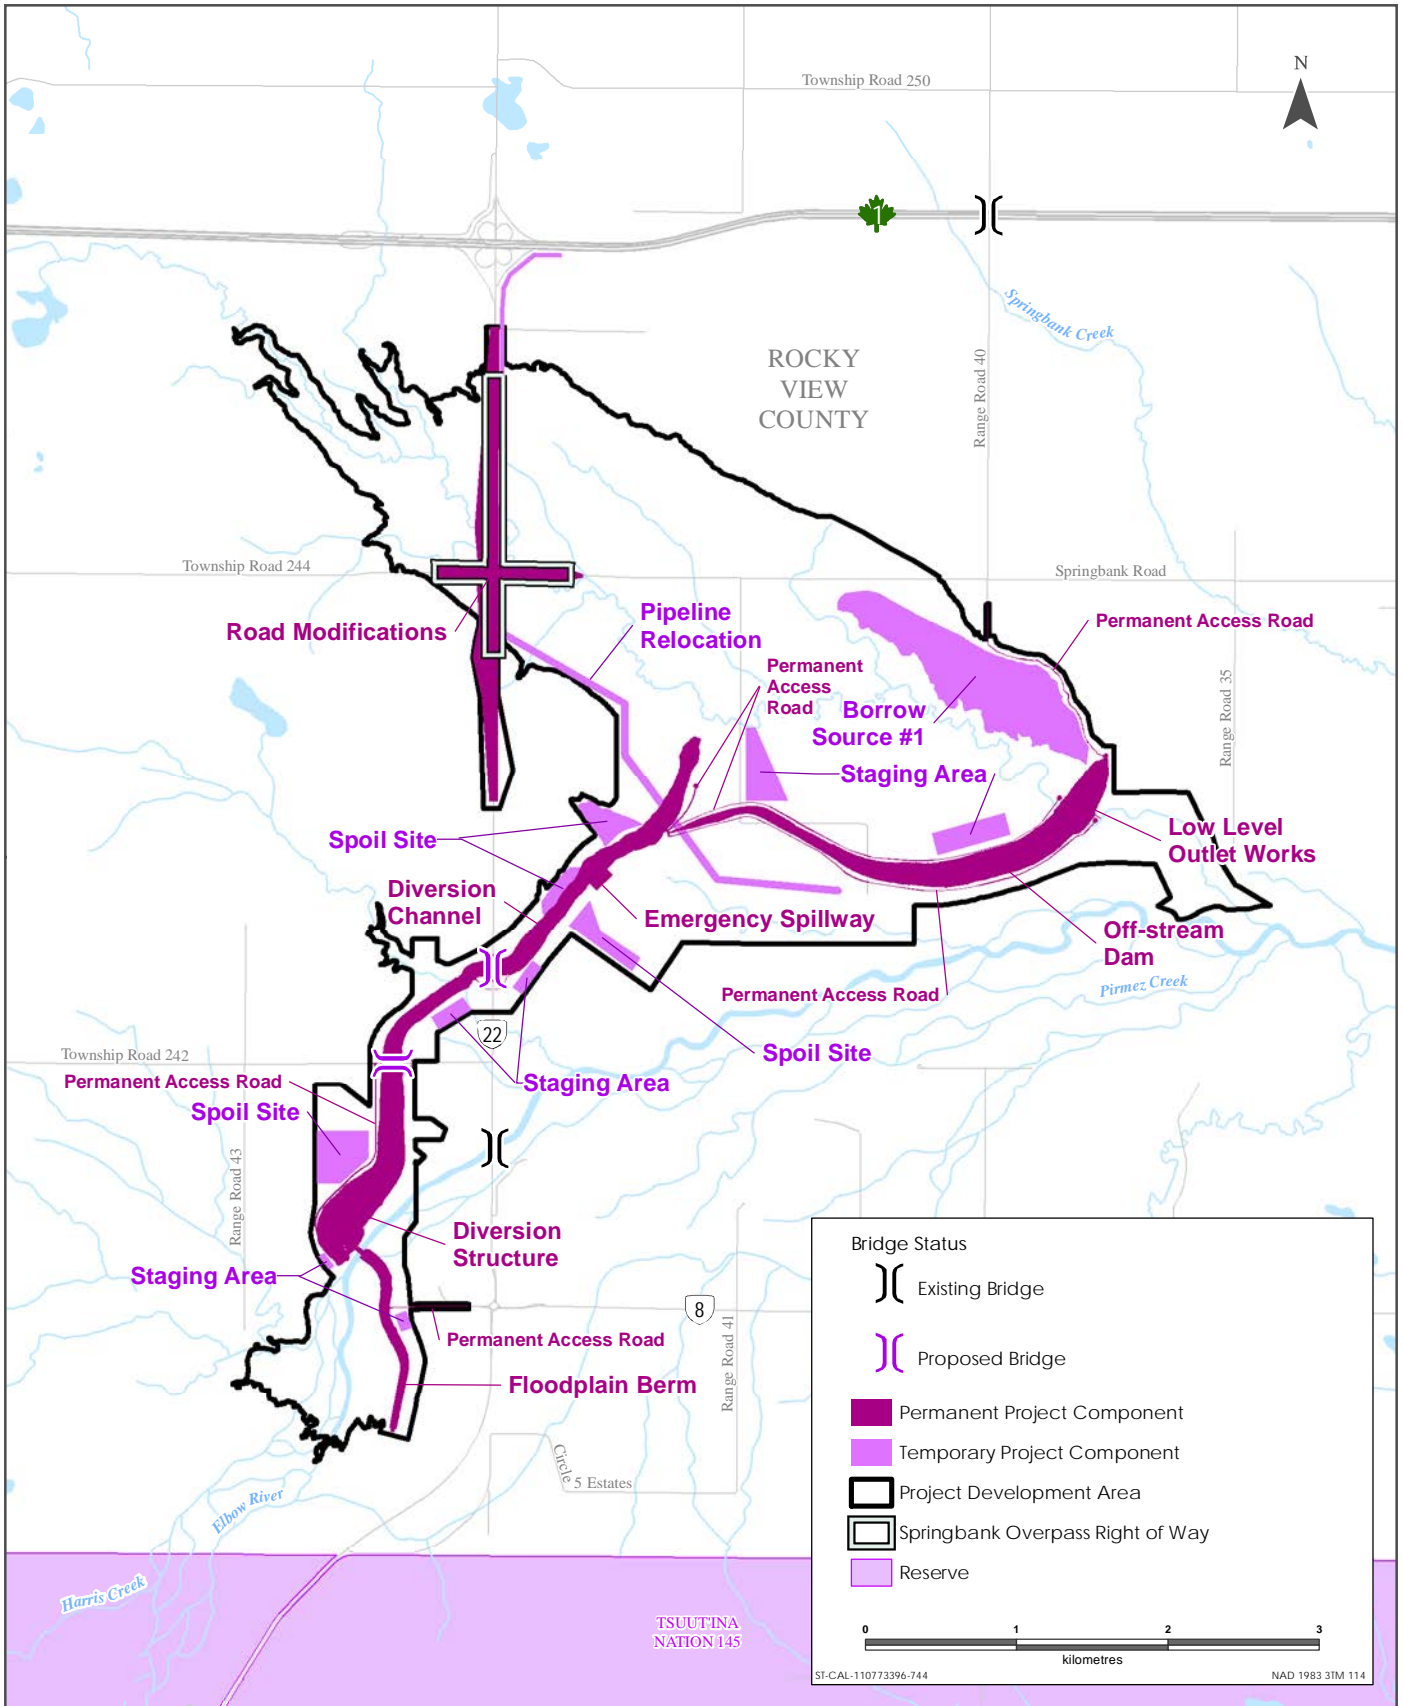
Permanent and Temporary Features of the Project

- a. The reference to Figure 3-1 is incorrect. The reference should have stated Volume 4, Appendix D, Figure 2-2. Figure IR482-1 (a duplicate of Figure 2-2) illustrates the temporary construction laydown areas (staging areas).

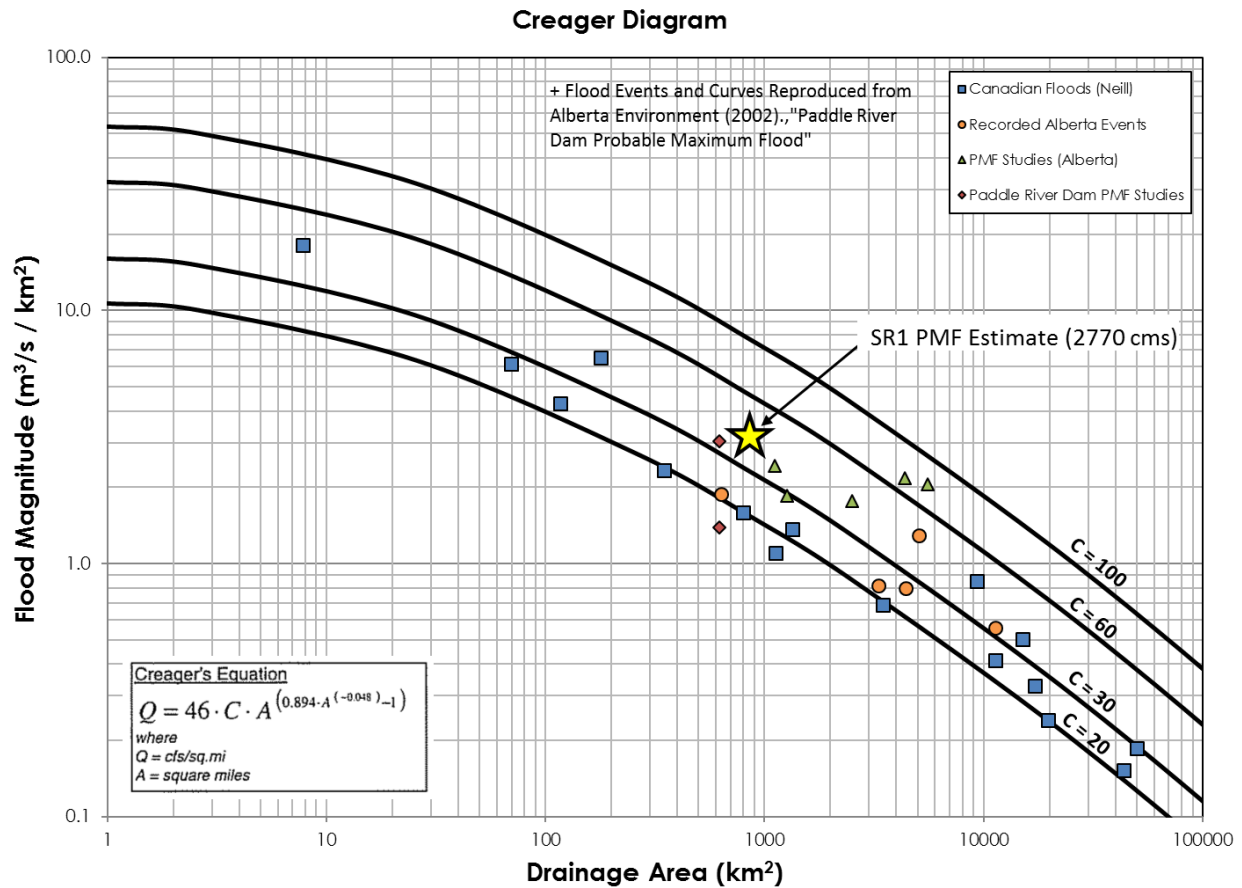
Figure IR520-1 Comparison of PMF Estimates

- a. Details regarding the derivation of the probable maximum flood (PMF) are provided in the report titled Probable Maximum Flood Analysis, attached as Appendix IR520-1.
- b. Figure IR520-1 provides a comparison of the Project's PMF estimate to other studies in the region and the Creager plot. As demonstrated in the figure, the Project PMF estimate is equal to or greater in magnitude than any of the recorded Alberta or Canadian floods of historic record. The Project PMF estimate plots within the median range of past PMF studies in Alberta.

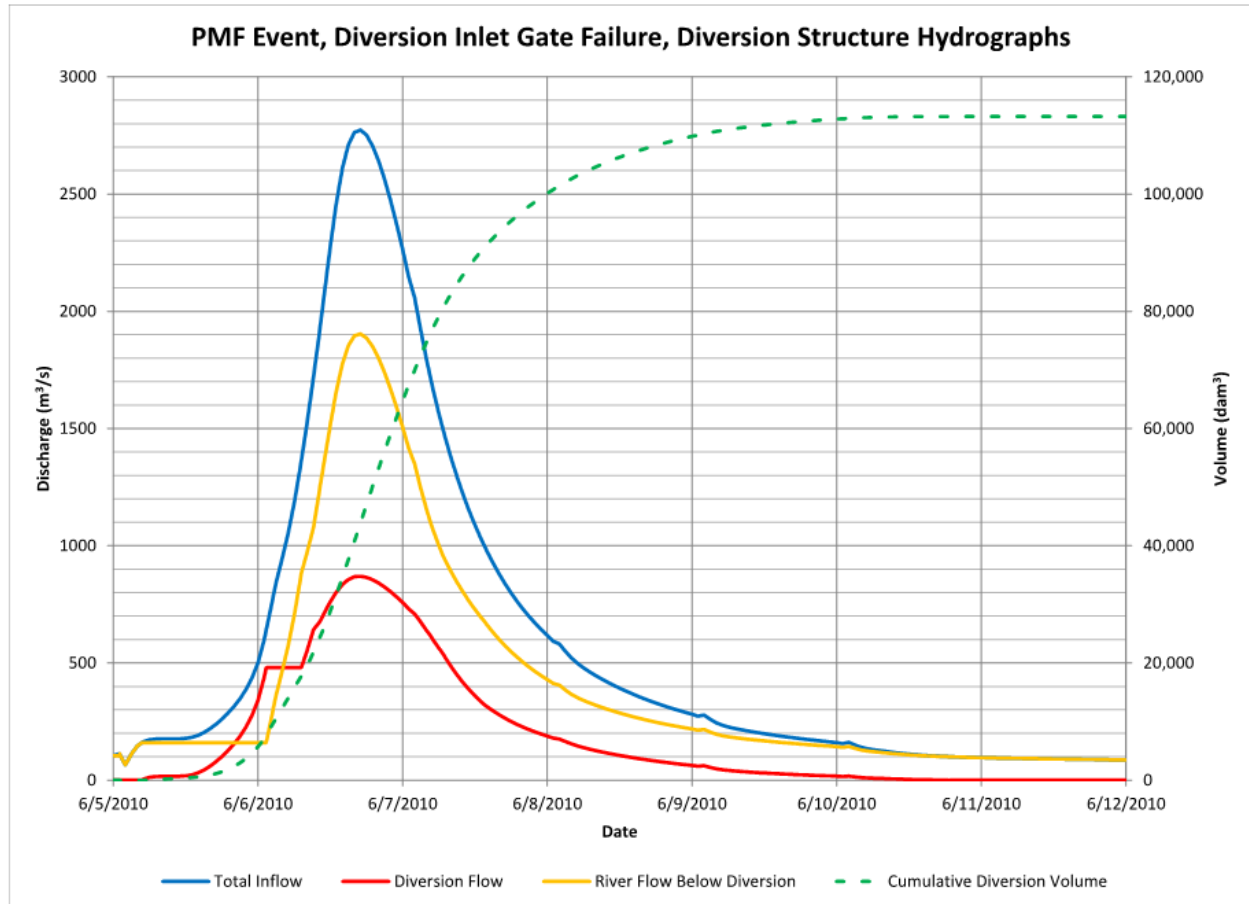
Figure IR528-1 Calculated Diversion Structure Hydrographs

Figure IR528-1 presents the calculated inflow hydrograph.
