APPENDIX F TO FIELD SERVICES SUBMISSION

Wood File: BX30653

**Re: Substantial Completion Report
Calf Shelter, Calf/Feeder Pens, Catch Basin
NE-10-009-27-W4M, near Fort Macleod, Alberta**

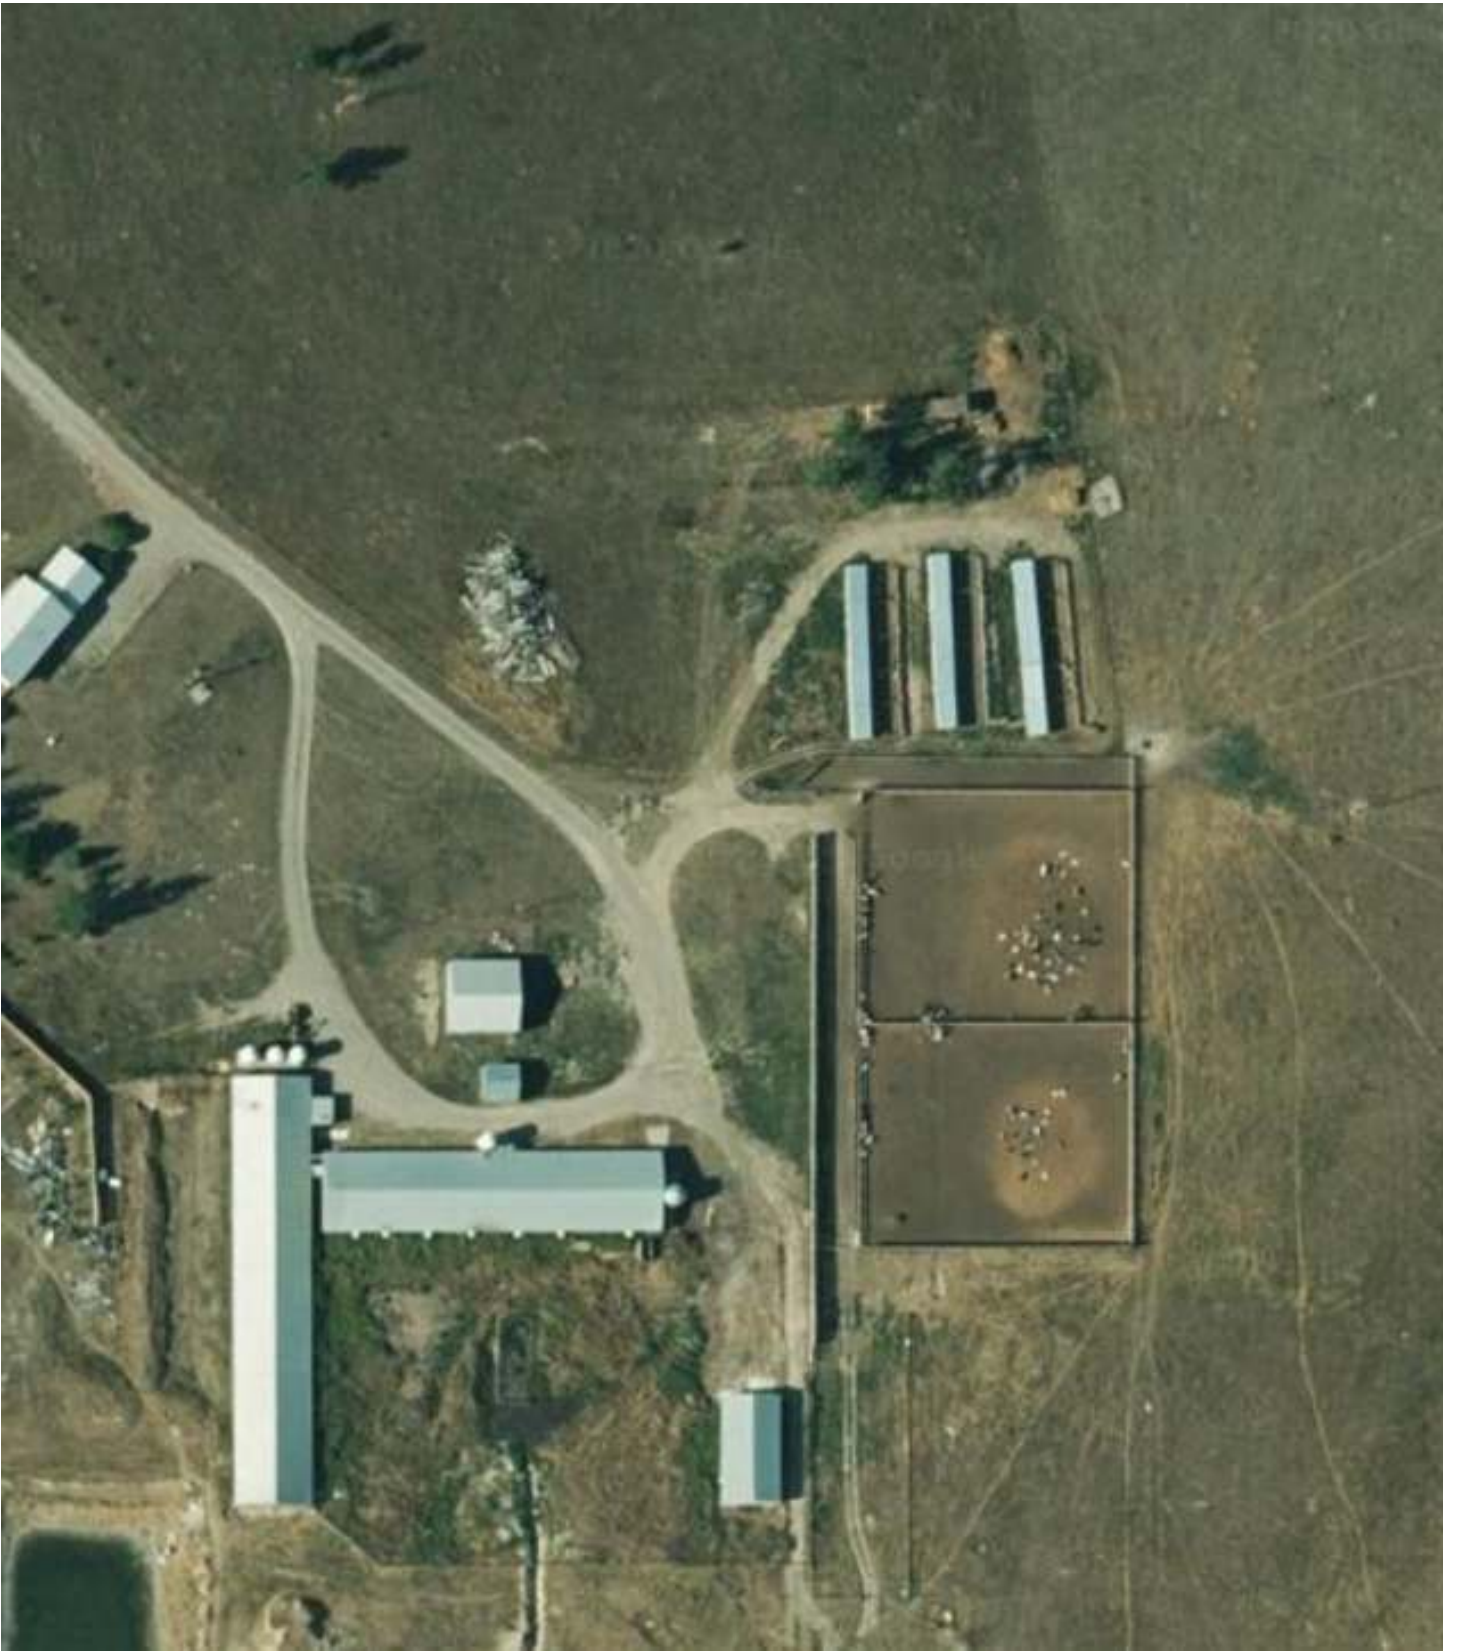
Attachment: Figure 1 – Site Plan

The calf shelter RCC mat encompasses an area of about 15 m wide by 80 m long, located directly east of the residence, and north of the barns (see Figure 1). The new feedlot pens encompass an area of about 37 m wide by 97 m long, located just southeast of the calf shelter building (see Figure 1). At the time of Wood's field review, the catch basin had been formed, but the liner was not installed. The catch basin measured roughly 20 m wide by 30 m long by 1.8 m deep, with side slopes of approximately 3H:1V.
